L634-
A.03.25

To: After Sales Official Network
Subject: RH Kidney rework
Date: 19/12/2025
Pages: 6

Campaign name:
RH Kidney rework

Model:
Temerario

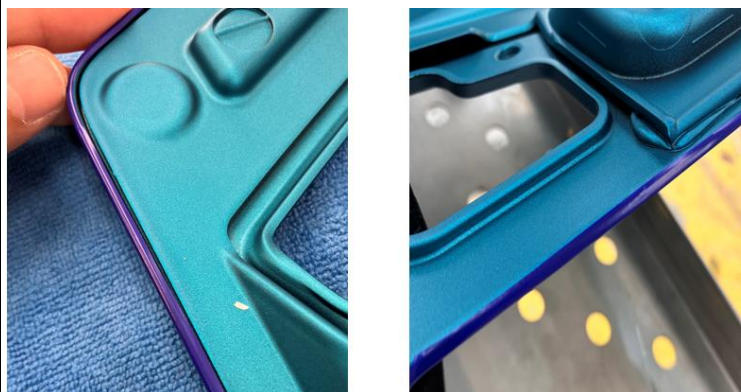
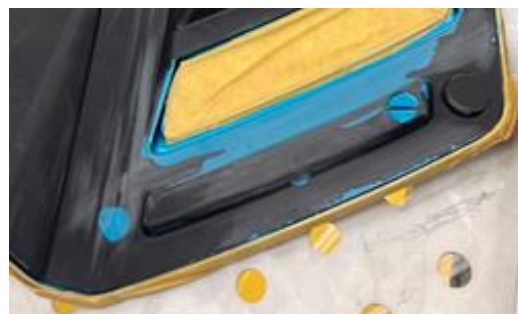
4. Mask the component by following these steps:
 - a. Use 3M 6405 6 mm vinyl tape to mask the component, wrapping it around the inner edge and sealing the tape inside the slit. For the remaining part of the edge that does not have a slit, simply mask it flush with the edge. See the following figures:

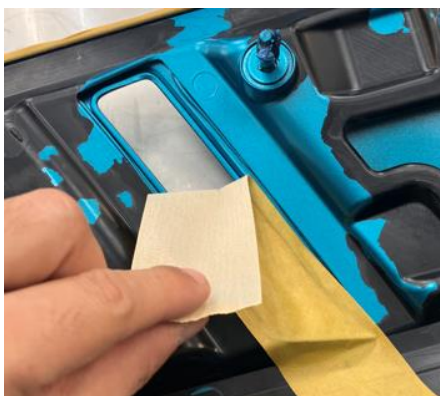
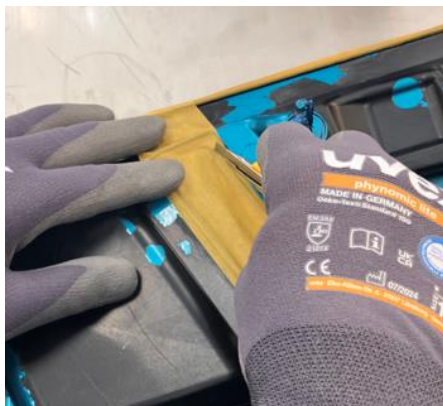
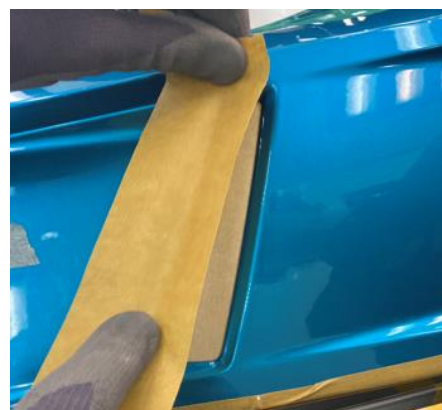
- b. Use 3M 401E paper tape to seal the kidney vents from the inside. Then, using a cutter, trim off the excess tape and seal the masking by placing an additional piece of tape on the outside of the vent. See the following figures:

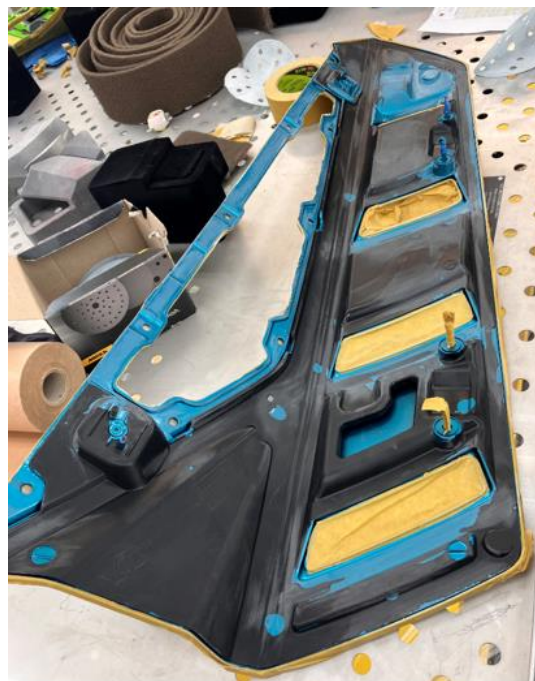
- c. Finish the external masking by wrapping the kidney with masking paper and sealing the ends with paper tape. The kidney, both internally and externally, should ultimately appear as shown in the following figures:
