Subject: Air Conditioner Water Drain Fixing  
Bracket Installation

Bulletin No: TS45-FC-2522

Vehicle Model: TS45

Description of the modification: This document describes the installation of the evaporator drainage bracket.

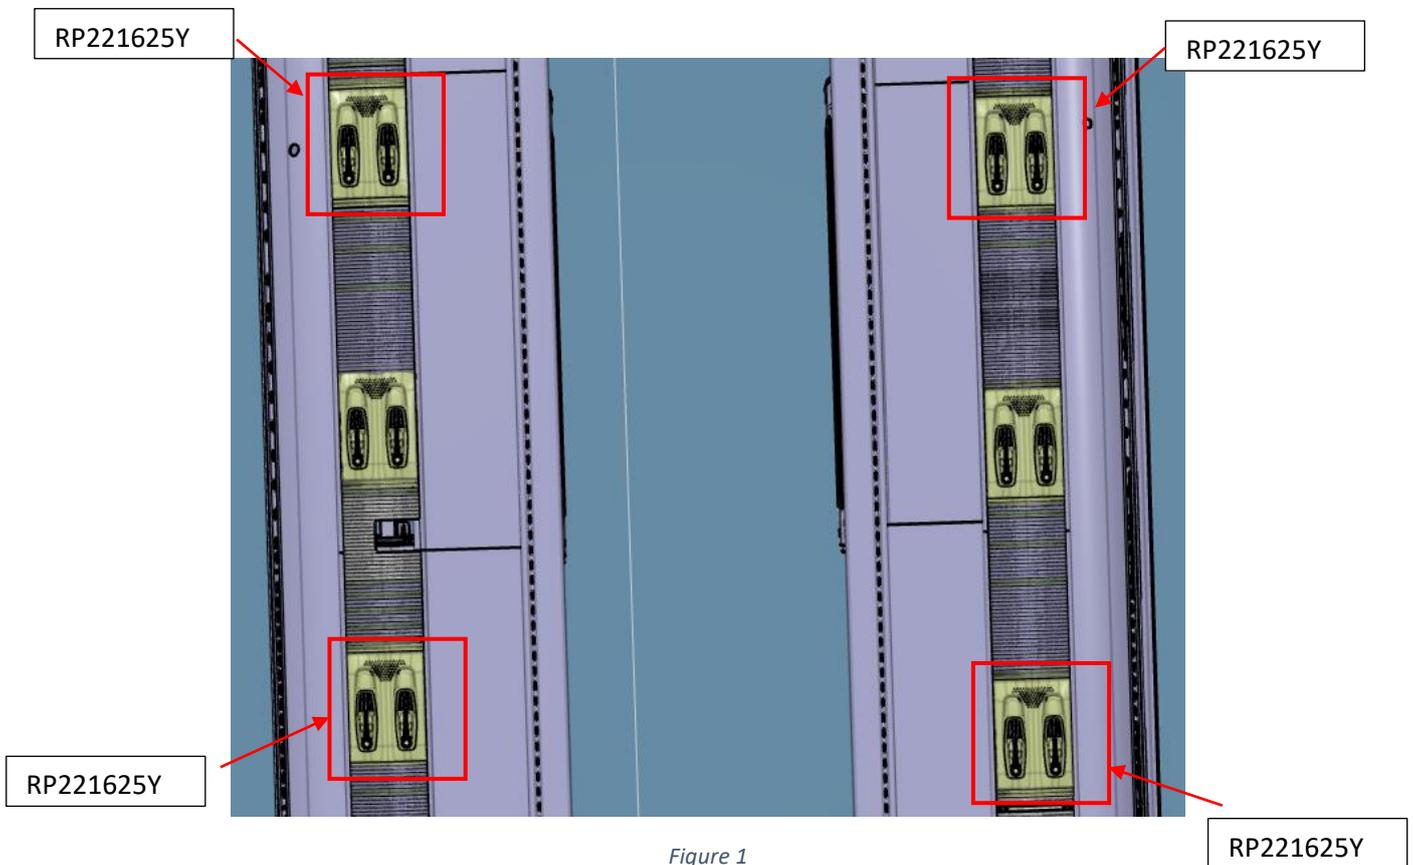
Figure 1

From the **RP221092Y**, the multisets numbered **RP221625Y** will be disassembled in the provided sequence and place below. These multisets are the ones near evaporators of the A/C system.

- Left Side: 3<sup>rd</sup>, 5<sup>th</sup>, 10<sup>th</sup> and 12<sup>th</sup> when counted from the entrance of the vehicle.
- Right Side: 3<sup>rd</sup>, 5<sup>th</sup>, 10<sup>th</sup> and 12<sup>th</sup> when counted from the entrance of the vehicle.

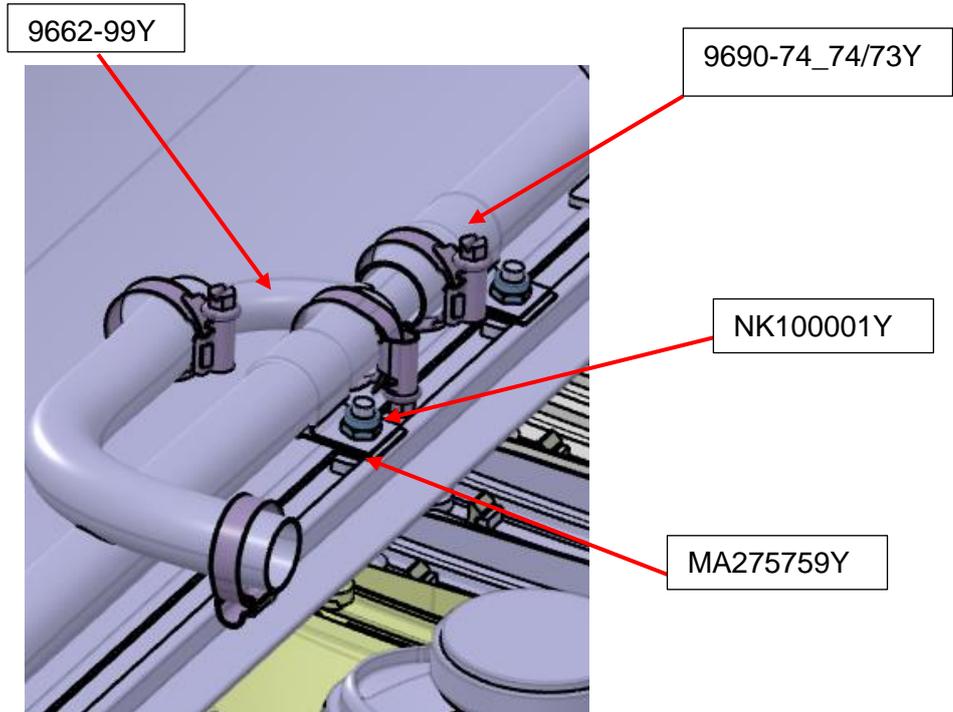
Figure 2

The nut, part number: NK100001Y, on clip numbered MA275759Y will be disassembled at the junctions defined below.

- Left side: Where the drain hose part no: **9690-74\_74Y** and the H-adaptor part no: **9662-99Y** meet.
- Right side: Where the drain hose part no: **9690-74\_73Y** and the H-adaptor part no: **9662-99Y** meet.

It should be noted that, for some locations, at the junction specified, there are two clips, part no: **MA275759Y**; the nut on the one indicated in below image should be disassembled.

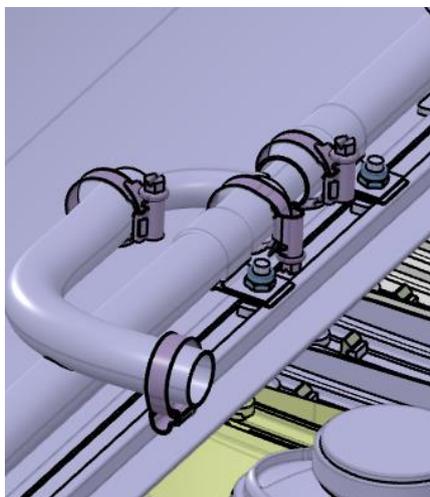
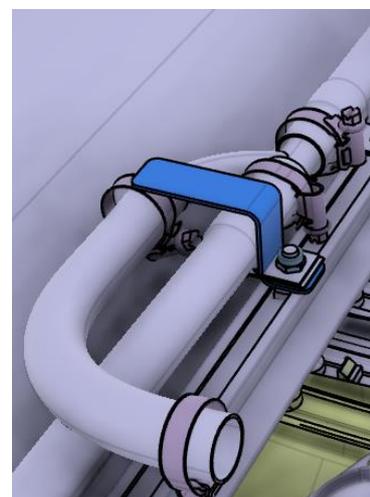
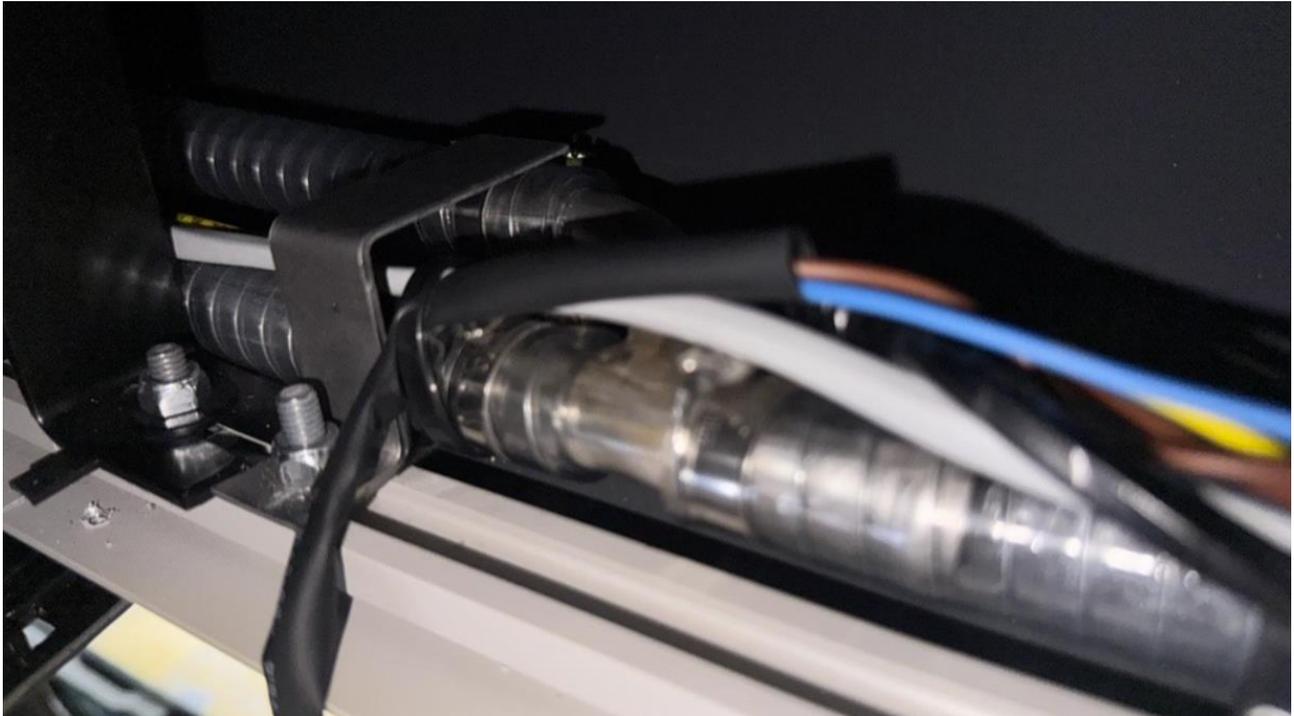
Figure 3

When the nut numbered **NK100001Y** on **MA275759Y** is removed, the bracket numbered **9326-10950Y** will be installed onto, the clips with bolt numbered **5356-LGE-05-06Y** and the corresponding nut numbered **NK100001Y**. Ensure that the installation is performed with the **9662-99Y** positioned parallel to the horizontal plane, with **9326-10950Y**'s longer section oriented on top.

Example installation position and orientation are illustrated in the image below and installation steps are given. Additionally, a real application image is provided as well.

CURRENT VERSION

NEW VERSION

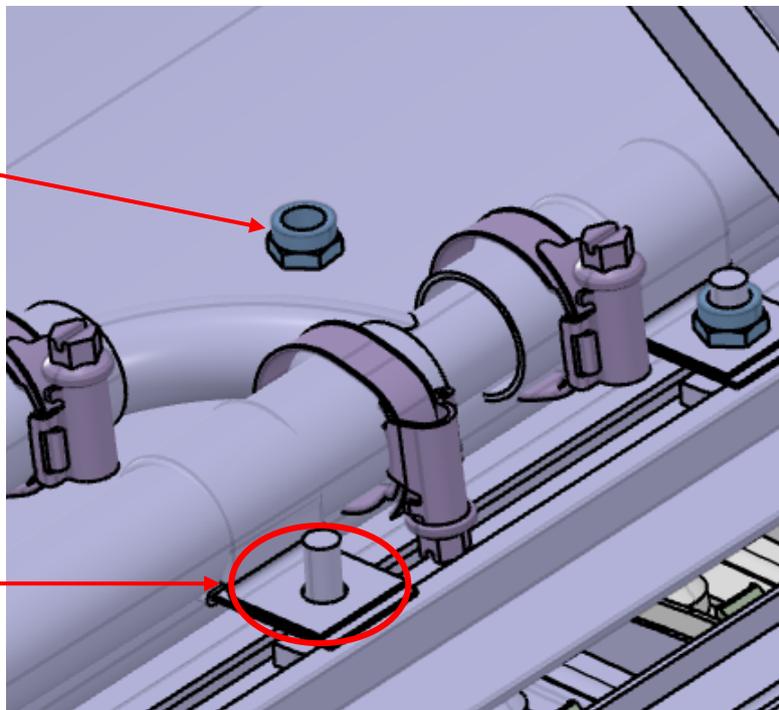
Figure 4 Bracket Installation step.1

Remove the bolt  
NK100001Y from the  
clip MA275759Y

Where the bracket  
9326-10950Y will be  
placed

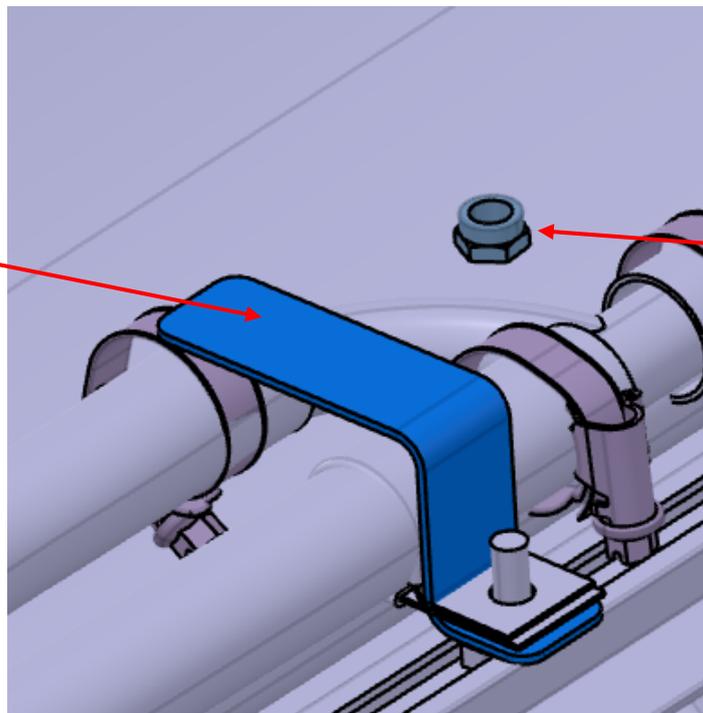
Figure 5 Bracket Installation step.2

Place the new bracket 9326-10950Y in its place, on top of the clip MA275759Y

NK100001Y

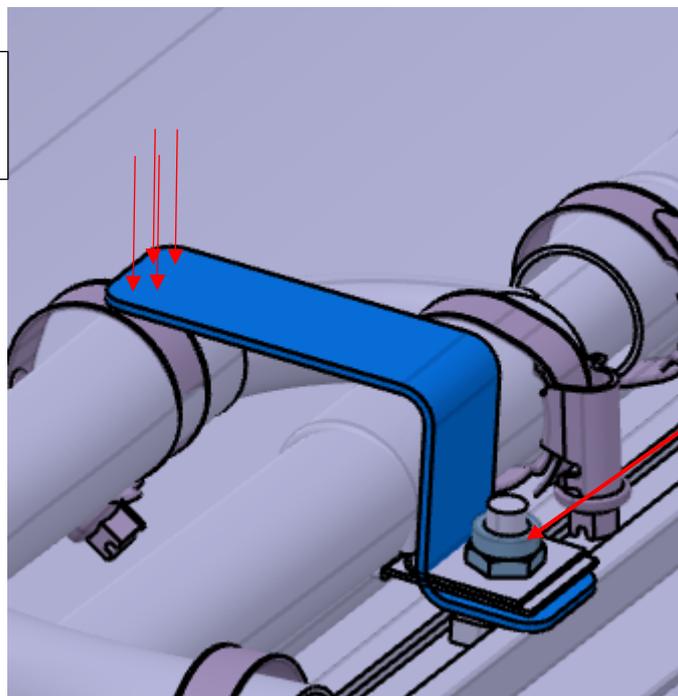
Figure 6 Bracket Installation step.3

Make sure the bracket 9326-10950Y pushes down on the H-adaptor 9662-99Y

Use the same nut NK100001Y to fix the bracket 9326-10950Y to its place

**ATTENTION:** When the assembling process is ongoing, make sure that there are no electrical cables under the bracket, and the bracket pushes down to the specified location in the above figure 6.
