Title: 2021 A26 (A26B) - Intermittent Shutdown

Applies To: 2021 A26 ESN 4600000 - 4699999

This document will guide the user through diagnosing an intermittent shutdown complaint on a 2021 A26 (A26B), whether the vehicle is coming to a stop or sitting at idle.

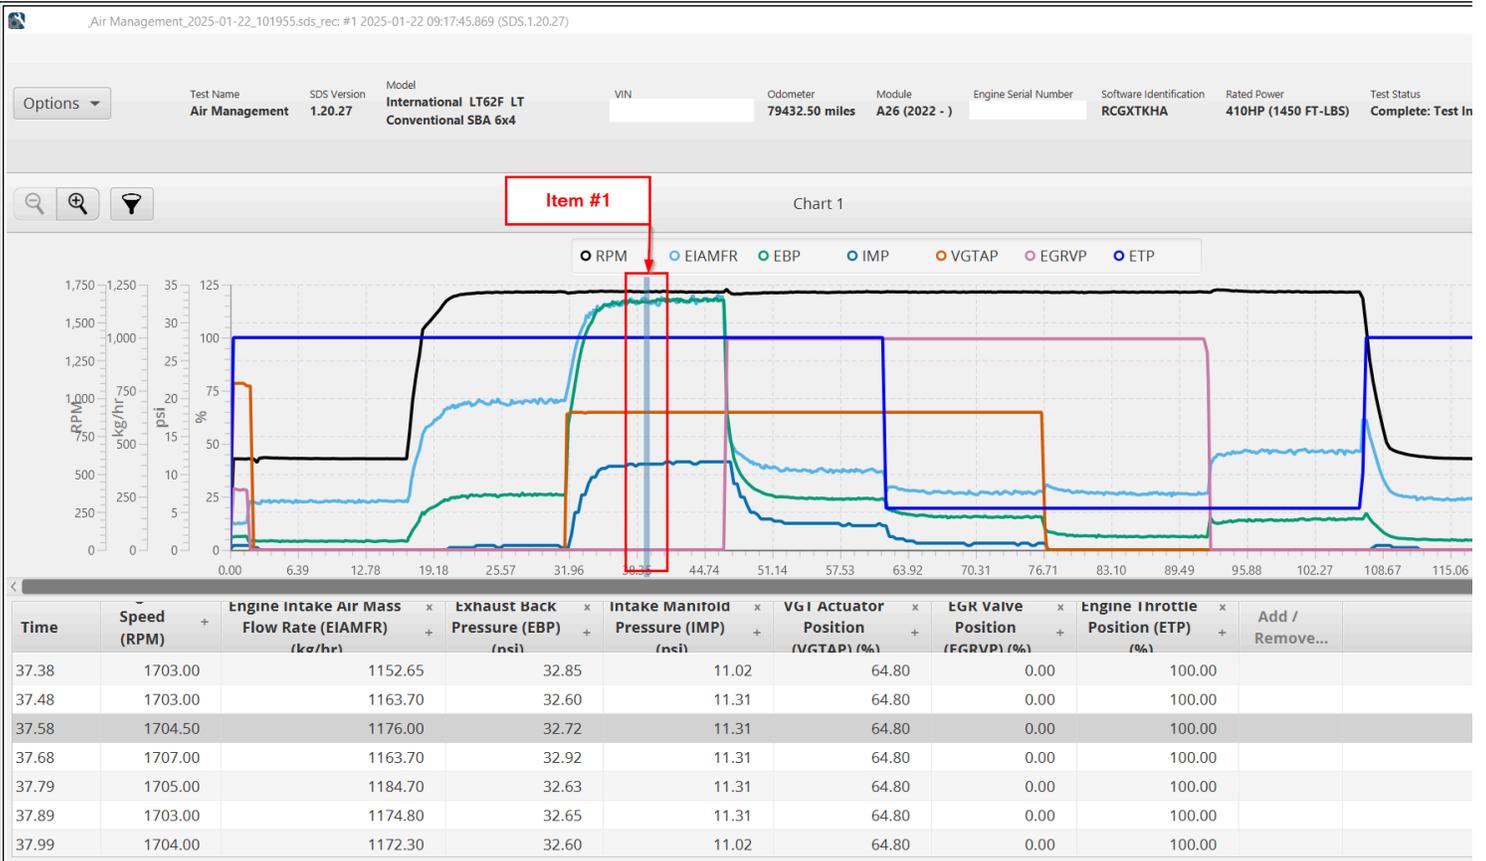
Step #4 - Image #2: AMT review selection point

Item 1: AMT Selection Point

Step	Confirm base airflow.	Decision
#5	<p>Perform an Air Management Test (AMT).</p> <p>Select the halfway point between the VGT Actuator command to 60% and EGRV command to 100%, see Image #2 for selection point example:</p> <p>Is MAF between 1200 - 1500, IMP between 10 - 20, and EBP between 20 - 40?</p> <p>NOTE: To access a GUIDE session with no active fault, follow the steps below;</p>	<p>Yes.</p> <p>Proceed to step 6.</p>
		<p>No.</p>

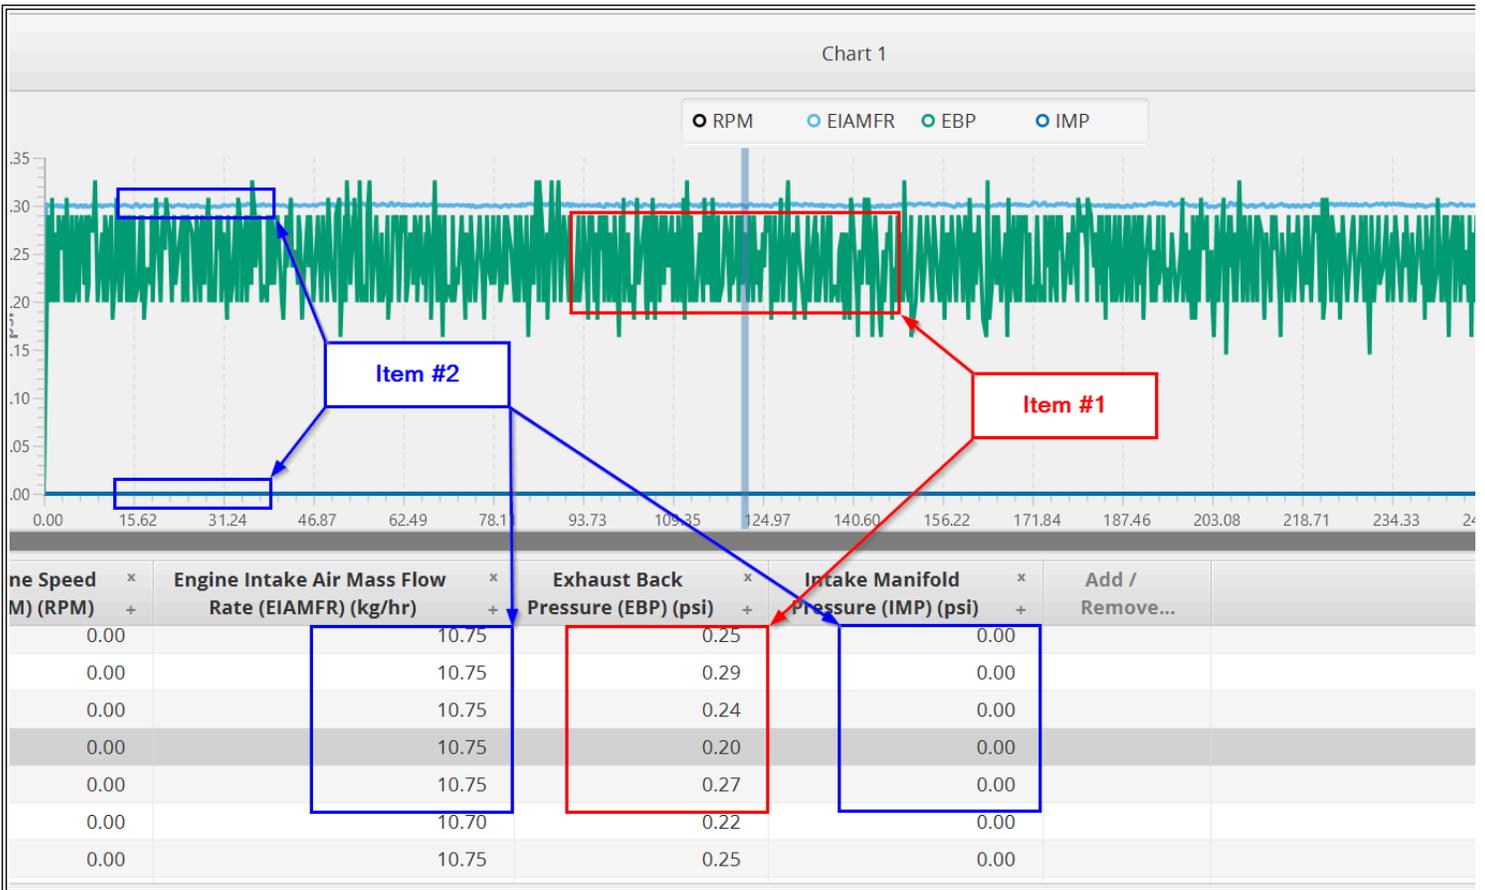
Step #5 - Image #3: KOEO

Item 1: Normal EBP reading

Item 2: Normal IMP and MAF values at KOEO

Step	Check for biased sensors.	Decision
#6	<p>Perform a 5-minute KOEO signal monitor session with SDS.</p> <p>Review the session and confirm the IMP sensor is reading 0, EBP centerline is equal to or less than 0.25 psi, and MAF sensor is reading less than 25 kg/hr without fluctuating. See Image #3 for KOEO example:</p> <p>Are all sensors reading as intended?</p>	<p>Yes.</p> <p>Proceed to step 8.</p>
		<p>No.</p> <p>Proceed to step 7.</p>

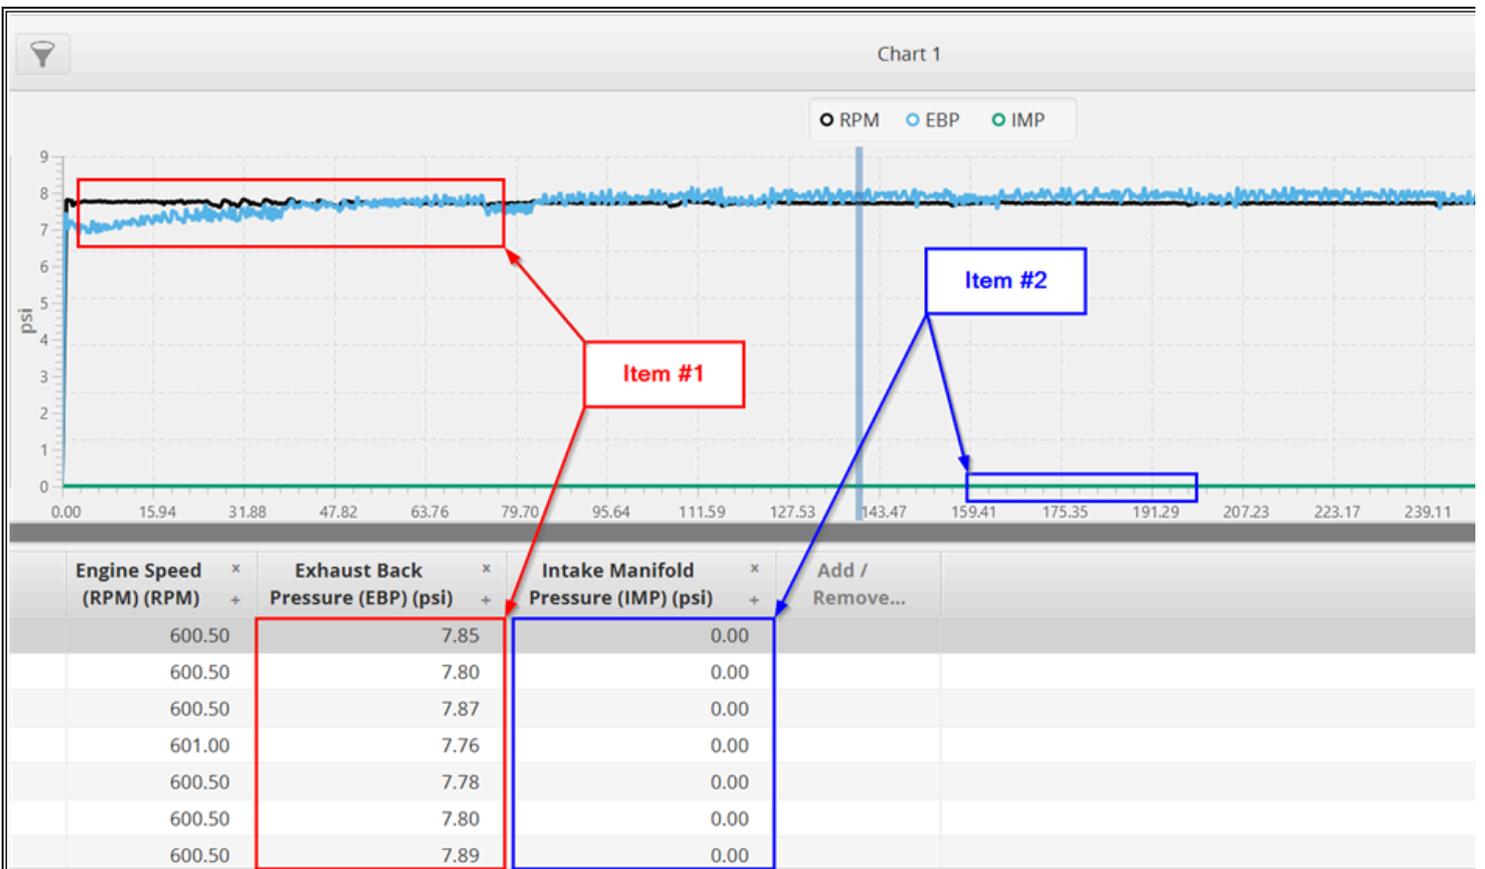
Step #7 - Image #4: KOER

- Item 1: Normal EBP fluctuation.
- Item 2: IMP should typically read 0 psi at idle.

Step	Check for biased sensors.	Decision
#8	<p>Perform a 5-minute KOER signal monitor session with SDS.</p> <p>Review the session and confirm IMP is at or close to 0, and EBP is fairly steady and below 10 psi. See Image #4 for KOER example:</p> <p>Are the sensors reading as intended, and not fluctuating rapidly?</p>	<p>Yes.</p> <p>Proceed to step 10.</p>
		<p>No.</p>

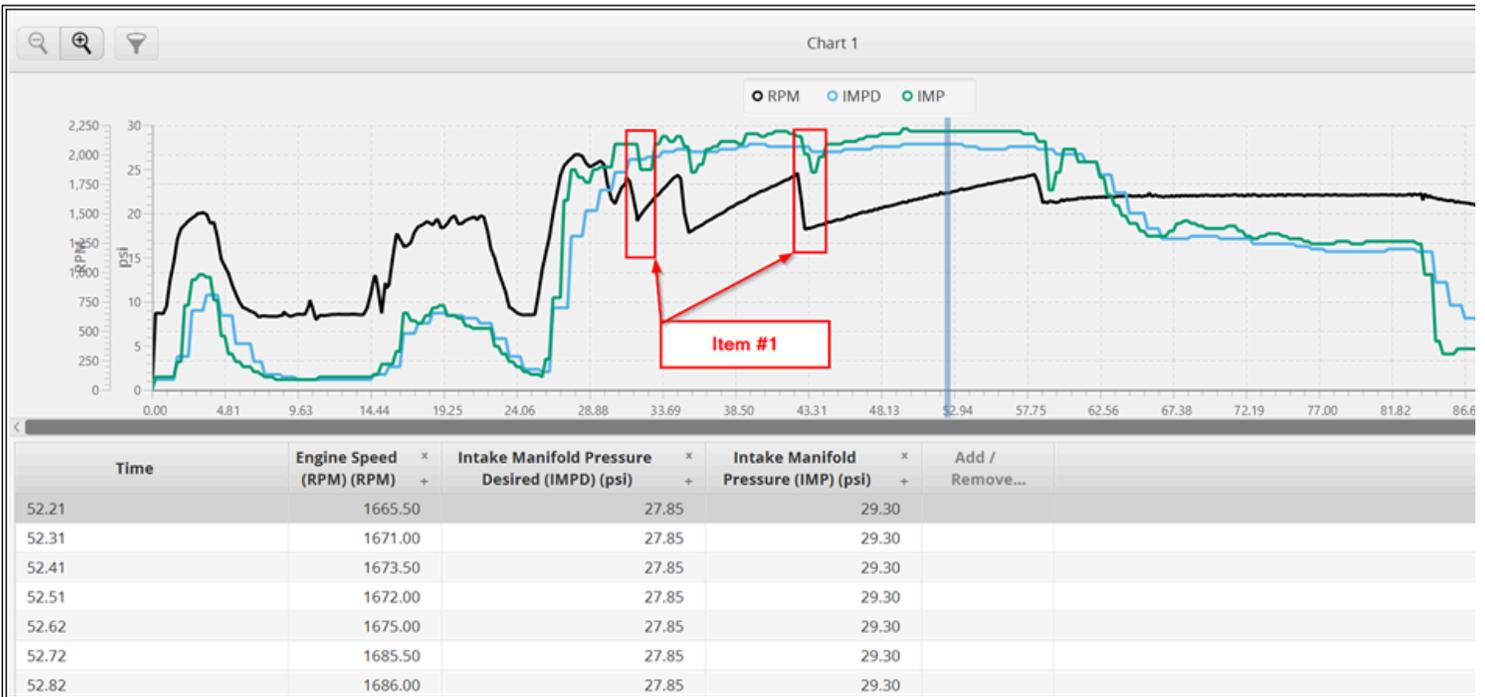
Step #9 - Image #6: Intake Manifold Pressure vs. Desired

- Item 1: Example of IMP dropping below desired. Should be considered normal when engine RPM drops due to shift events.

Step	Confirm engine performance.	Decision
#10	<p>Perform a 0-60 / Lugdown</p> <p>Review DPF Differential Pressure, Intake Manifold Pressure compared to desired, and Fuel Rail Pressure compared to desired:</p> <p>Is DPF Differential Pressure below 0.5 psi, the Intake Manifold Pressure meeting or exceeding desired values, and the Fuel Rail Pressure following desired values?</p> <p>NOTE: IMP and FRP may not exactly follow desired values as the transmission shifts gears, and the engine RPM drops drastically. The values should be reviewed while the engine RPM is climbing and the engine is under load.</p> <p>DPFD example - Image #5</p> <p>IMP example - Image #6</p> <p>FRP example - Image #7</p>	<p>Yes.</p> <p>With customer permission, install an IMP isolation kit. Review the parts information and kit installation instructions.</p>
		<p>No, DPFD is above 0.5 psi.</p> <p>Remove the DOC and DPF for inspection. Inspect them per the re-use guidelines in the manual. If they pass for re-use, have the DOC cleaned, and the DPF cleaned and baked.</p> <p>Once completed, re-test for the symptom, and if the symptom persists, follow the "yes" result from this step.</p>

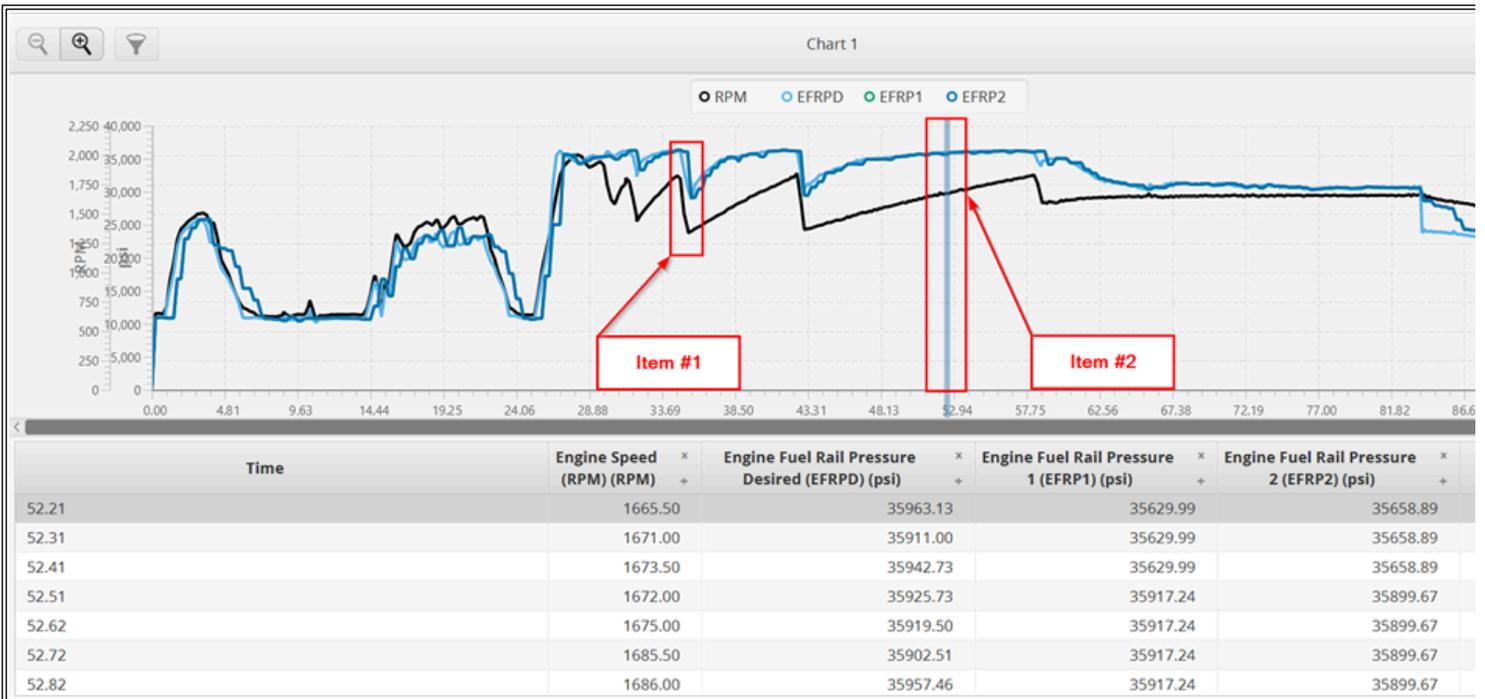
Step #9 - Image #7: Fuel Rail Pressure vs. Desired

Item 1: Example of FRP lagging slightly behind desired during shifting events.
 Item 2: Recommended selection point. Final gear shift, engine under load.
