Technical Service Bulletin: TSB250065

Released Date: 02-Dec-2025

Fuel System Diagnostic Service Tool Update

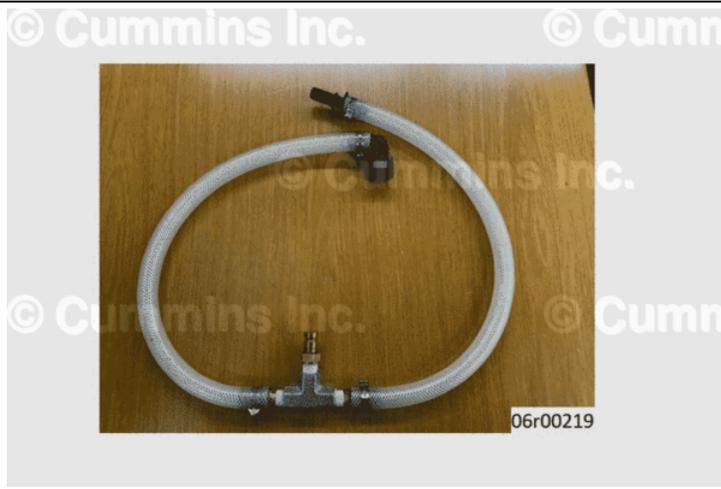
Figure 1, Existing Service Diagnostic Line, Part Number 4918895.

Steps For Modifying Existing Service Tool, Part Number 4918895:

- Remove Compuchek™ fitting from T-adapter fitting.
- Remove hoses with hose barbs from T-adapter fitting.
- Use thread sealant on all NPT threaded fittings.
- Install hoses with hose barbs on new ¼ inch NPT cross fitting horizontally from each other.
- Install a Compuchek™ fitting in the top of the cross fitting.
- Install the new Compuchek™ fitting in the bottom of the cross fitting.

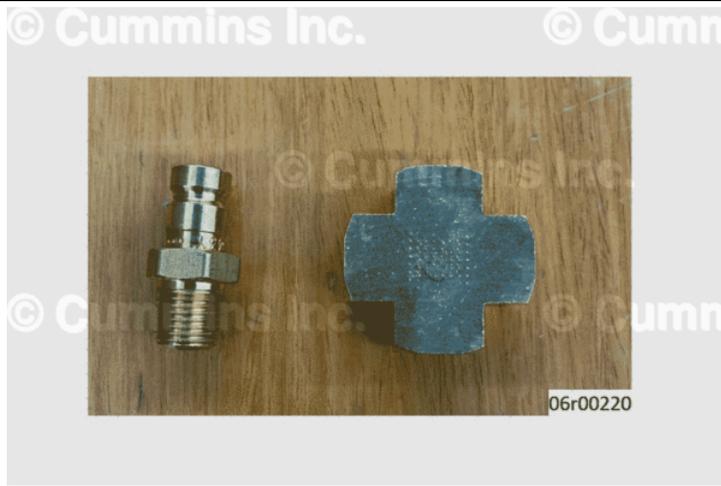
Figure 2, (Compuchek™ Fitting and ¼ inch NPT cross fitting) Needed to Update Service Tool.

- ¼ inch NPT cross fitting
- ¼ inch NPT Compuchek™ fitting, Part Number 3376860
- Polytetrafluoroethylene thread sealant or equivalent

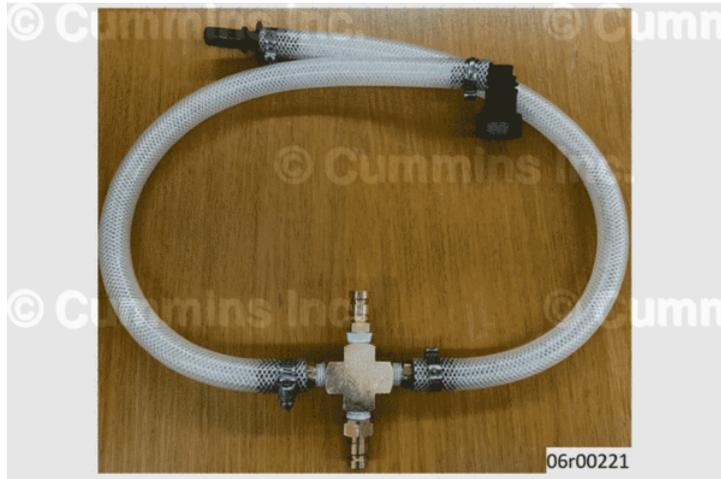
Figure 3, Updated Service Diagnostic Line.

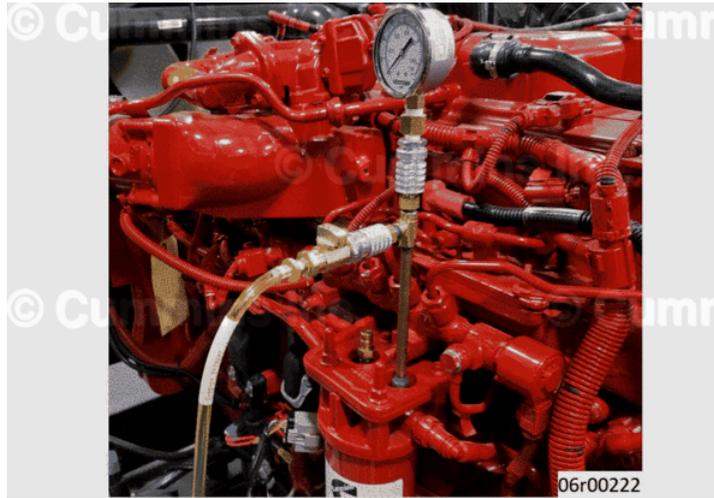
On some units the top of the fuel filter housing is **not** easily accessible, making installation of the T-adapter fitting to perform the low-pressure fuel system checks difficult.

Figure 4, Existing Tool for Low-Pressure Fuel Filter System Check.

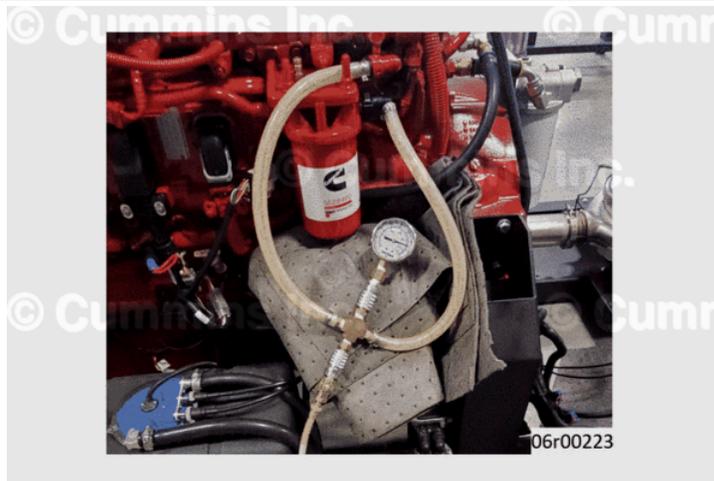
Figure 5, Updated Service Tool Option for Low-Pressure Fuel Filter System Check.

- New parts are offered that enable the modification of the existing adapter so the low-pressure fuel filter system check can be performed when the remote mount fuel filter housing is **not** easily accessible.
- Update the existing service tool so the low-pressure fuel system can be measured at the outlet of the fuel filter housing.
- New Service tool is available
