## 21MY ONWARD F-PACE REAR TAIL LAMP FUNCTION

- 21MY-On F-PACE

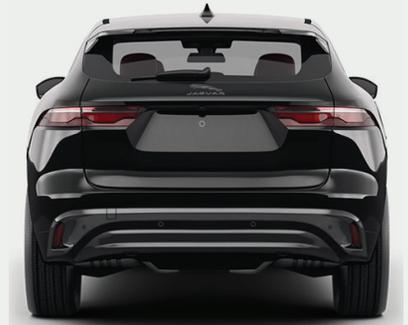
BCM - SSM 76374 - Tail Lamp Turn Signal Fast Flash

- Review lamps for physical defect and rectify if found.
- If no immediate physical defects found, proceed with completion of TOPIx application **SSM 76374 - Tail Lamp Turn Signal Fast Flash** located under BCM Module
- Allow vehicle to sleep then confirm update lamp function prior to release.
