Vermeer MV Solutions, Inc.

FIELD CAMPAIGN KIT #: VMV000108
For Dealer Reference: Service Bulletin #: SMV2026-001

Boom Raise Cylinder Pins and Retaining Clips Update Kit

CAMPAIGN TYPE:	Mandatory – Product Compliance DEALER INSTALLATION ONLY
CAMPAIGN CATEGORY:	Kit and Bulletin

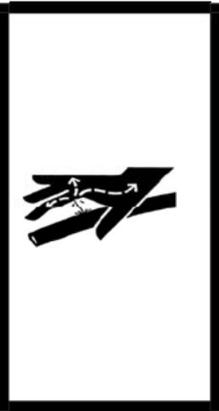
1. Stow boom in the most rear position according to Figure A and use appropriate shutdown procedures per your model type. Follow your operators and maintenance book for shutdown procedures.

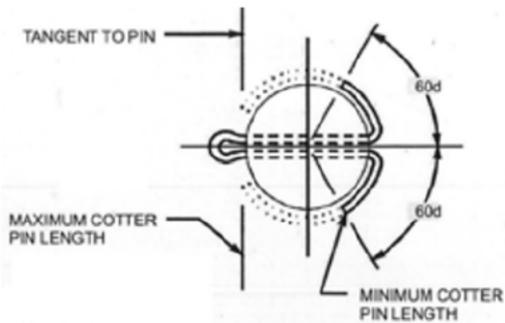
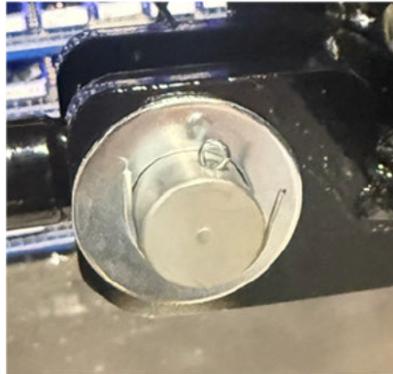
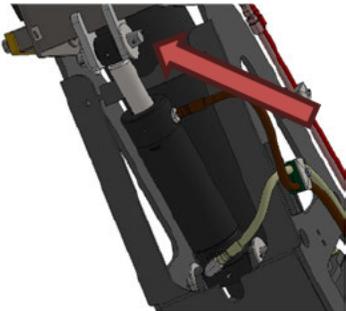
Purpose: *BOOM CAN FALL UNEXPECTEDLY. During manufacturing, the incorrect boom raise cylinder retainer clips may have been installed. The retaining clips can become displaced during operation and the boom may fall. Death or serious injury is possible if the boom falls and strikes or crushes an operator or crew member. Machine or property damage is also possible.*

2. Position ladder so that you will maintain steady balance and keep three points of contact. Do not to remove pin during these proceeding steps.
3. Remove existing clips from the base boom rod side pin.
4. Install washers and cotter pins according to Figure A at the boom raise/lower cylinder rod side pin location shown below.

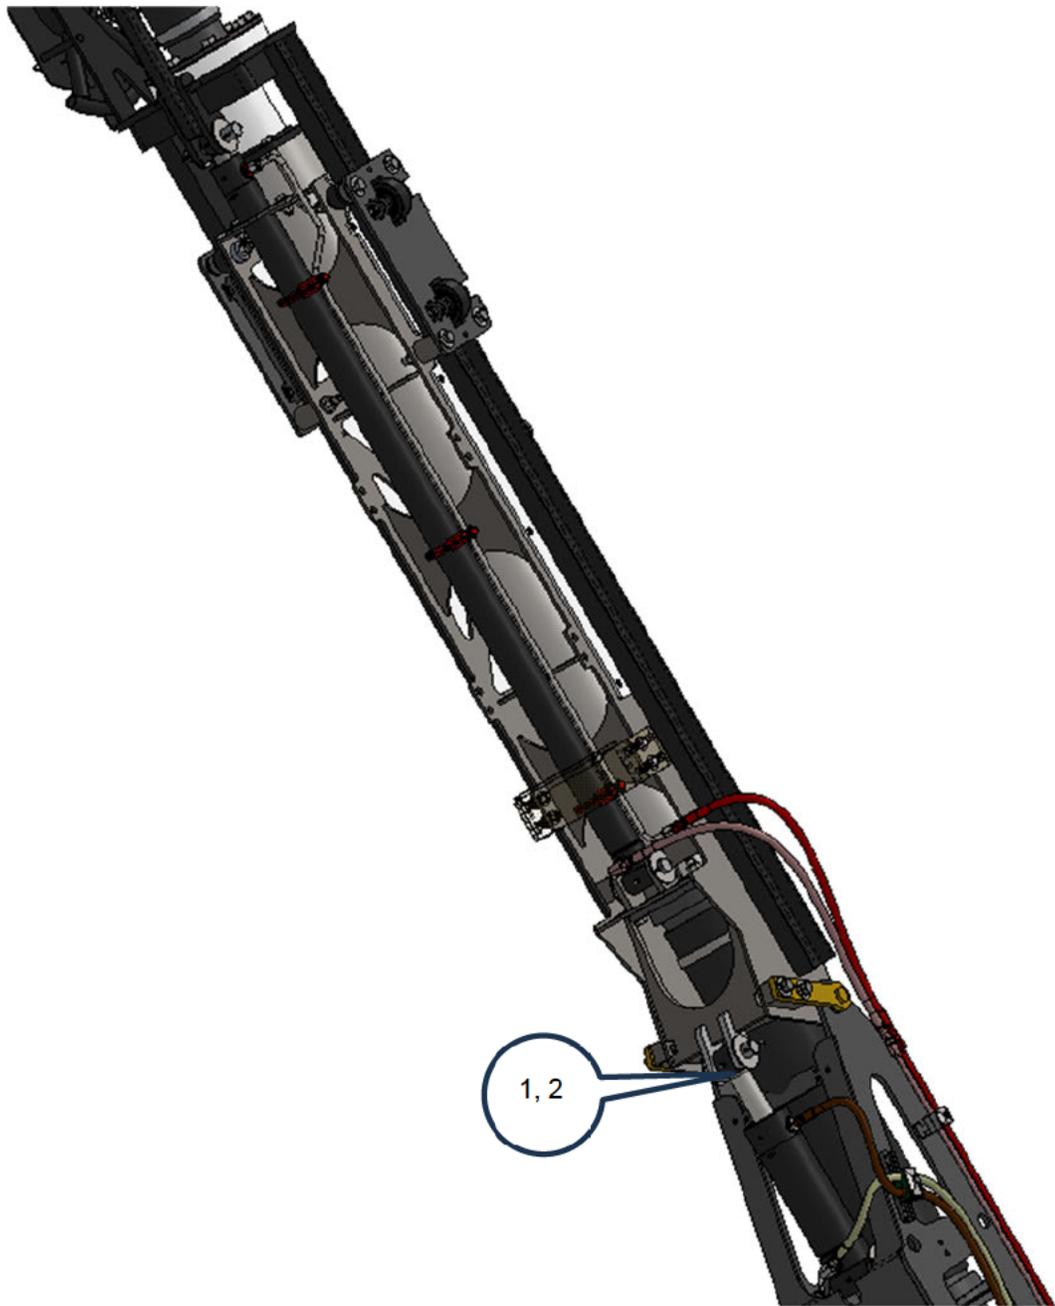
Figure 1 parts list

<u>REF. NO.</u>	<u>PART NO.</u>	<u>DESCRIPTION</u>	<u>VMV01 QTY.</u>
1	U200170	WASHER FLAT 1.000	2
2	U320070	PIN,COTTER .188X2.000	2
		Kit includes all items in Figure 1 parts list.

6. Remove Figure 1 \ 1.1 and place in the manual storage box so unit owner can place with existing parts manual.
