# Technical Service Bulletin

GROUP <b>CAMPAIGN</b>	NUMBER <b>26-01-001H</b>
DATE <b>JANUARY 2026</b>	MODEL(S) <b>IONIQ 9 (ME1A EV)</b>

**SUBJECT:** HIGH MOUNTED STOP LAMP ADHESIVE RESIDUE INSPECTION & STOP LAMP REPLACEMENT (LIMITED COVERAGE CAMPAIGN LA5)

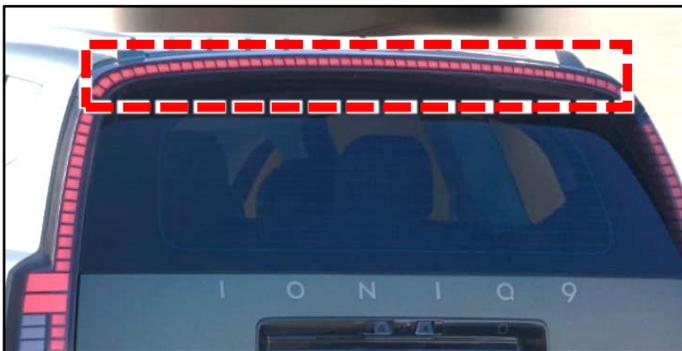
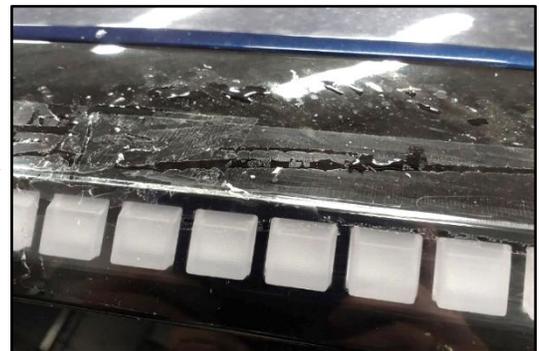
**Description:** Certain IONIQ 9 (ME1A EV) vehicles may exhibit adhesive residue on the high mounted stop lamp. This can occur when the clear protective film has had prolonged exposure to sun and heat, causing some of the adhesive to remain on the black plastic housing after removal. This bulletin provides instructions to inspect and, if necessary, replace the high mounted stop lamp on affected vehicles.

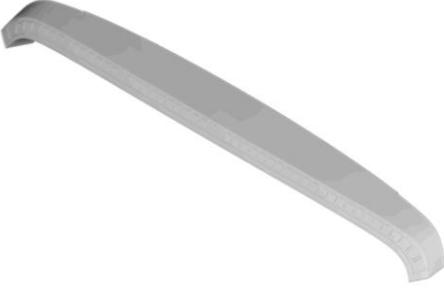
Model	Part Name	Part Number	Figure	Remarks
IONIQ 9 (ME1A EV)	Lamp Assy - High Mounted Stop	92700-TD000

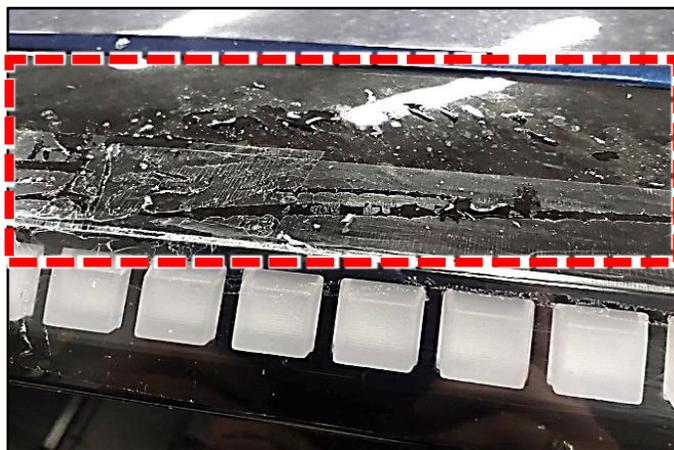
1. Inspect the black plastic housing on the high mounted stop lamp for adhesive residue.

- **Residue:** Continue to step 2.
- **NO Residue:** This TSB does **NOT** apply. Continue to step 3 for Digital Documentation.

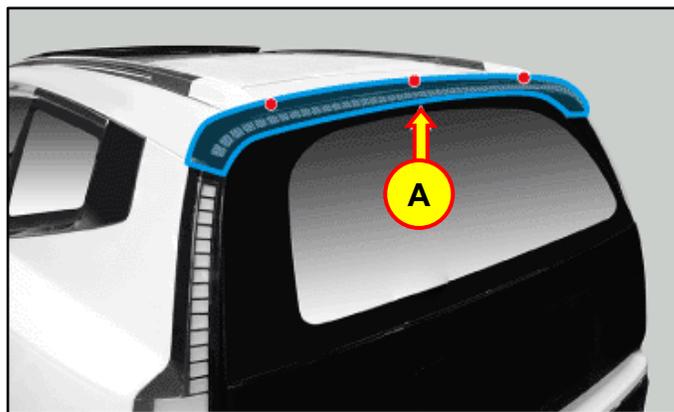
2. Replace the high mounted stop lamp (A) with a new part by referring to the shop manual:

- **Body (Interior / Exterior / Electrical) > Light & Vision System > High Mounted Stop Lamp > Removal and Installation**

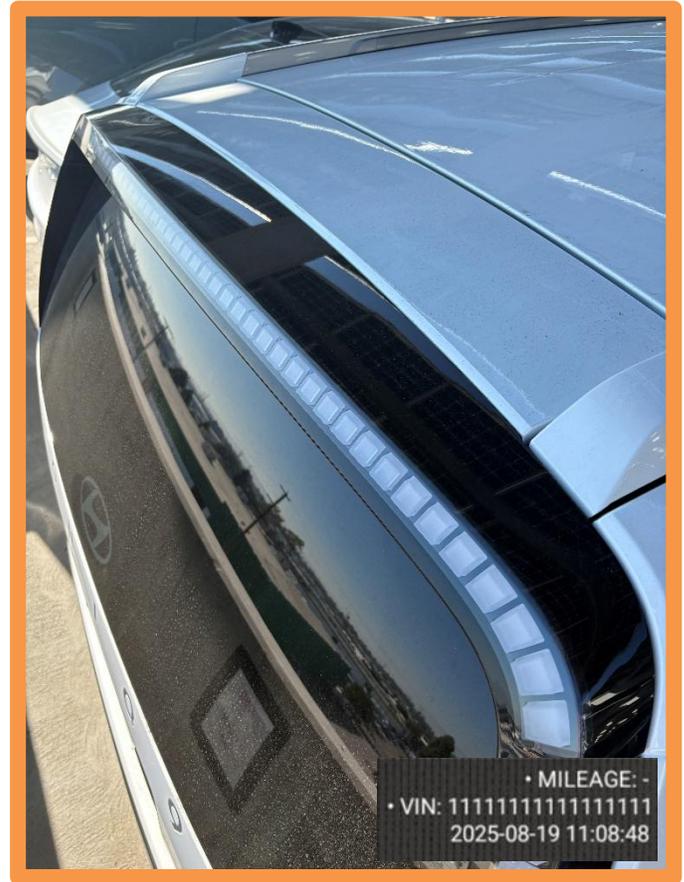
Using the STUI camera function, take a photo of the high mounted stop lamp installed on the vehicle.

**NOTE:** If the STUI camera function is **NOT** used, write the last 6 digits of the VIN and date of repair on a piece of paper to include in the photo.
