# Service Bulletin

Bulletin No.: PIT6452B

**Subject: Poor Heater Performance On Drivers OR Passengers Side**

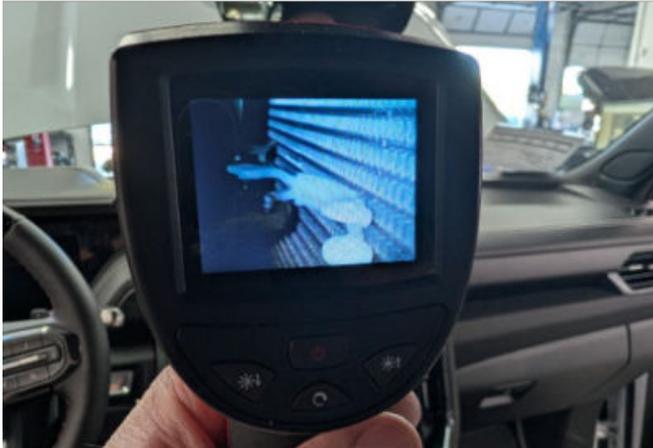
7020910

- Access the view through the upper vents or the HVAC evaporator temperature sensor openings.
- Using a borescope, inspect for a disconnected temperature door link.

**Note:** The mode will have to be set to the vent position, and you will have to enter at the center dash vent for the affected side.

- Move both the driver's and passenger's temperature doors through their full range of travel while monitoring with the borescope.
- Watch for any binding or resistance that may cause the white temperature door link to separate from the doors or produce a popping noise.

If any door exhibits these symptoms, proceed to Step 2.
