177 118 247 AMG 45 Models - Noises from the rear axle differential, particularly when cornering slowly

Topic number	LI35.31-P-074854
Version	3
Function group	35.31 - Rear axle center assembly
Date	1/22/26
Validity	AMG-specific rear axle differential on AMG 45 model series 177; 118; 247
Reason for change	Remedy added

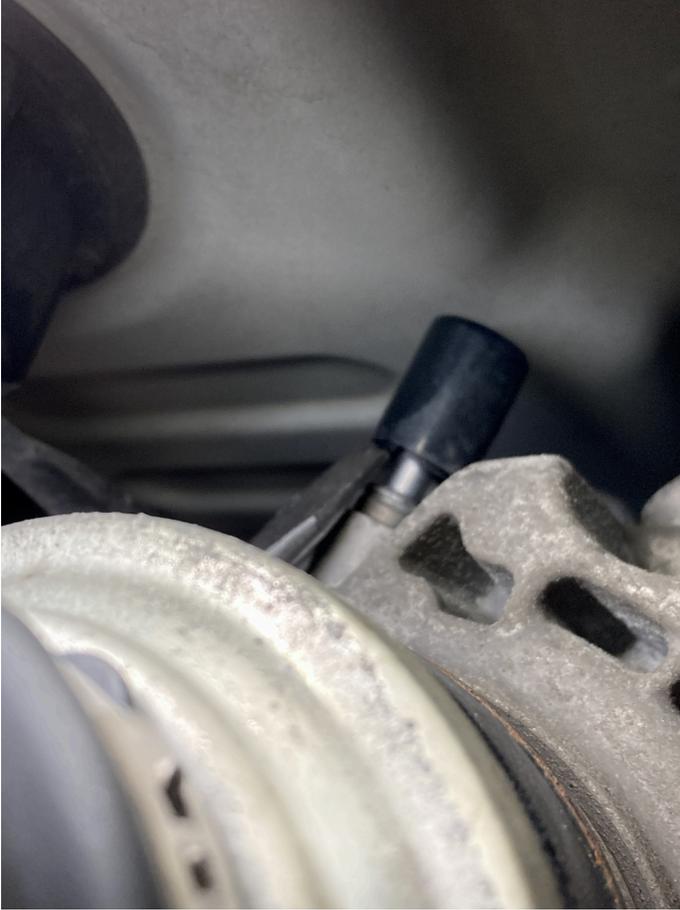
Figure 1 Old breathers
Bild 2.jpg	Figure 2 Rear axle differential screw

1. Raise the vehicle with the vehicle lift
2. Detach the old breathers (2x) from the clutch housing right and left using a suitable tool (Figure 1)
3. Support rear axle differential

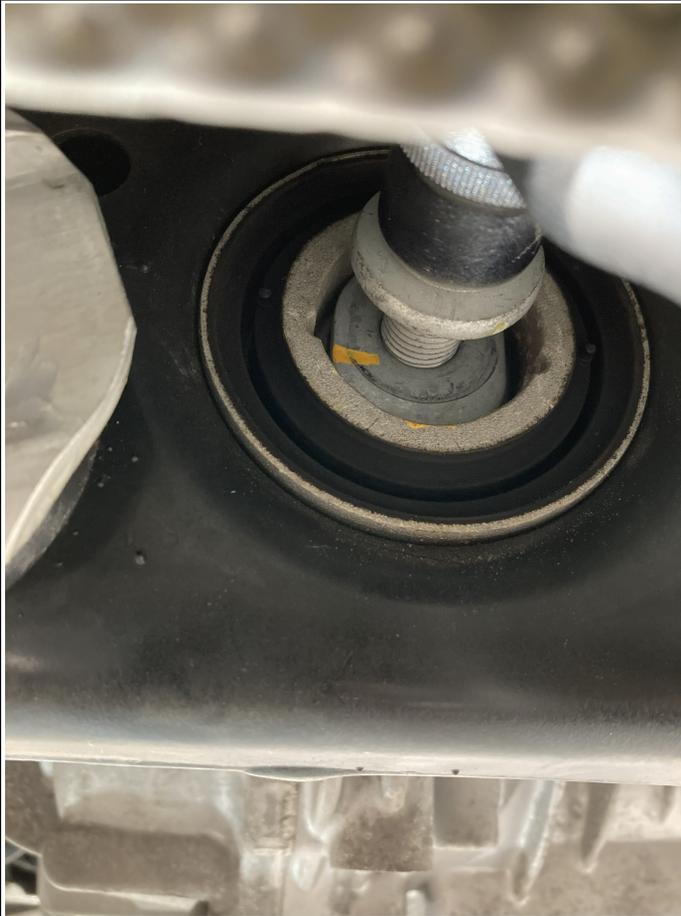
Bild 3.jpg

Figure 3 Position of new vent hose

5. Lower rear axle differential
6. Clean the upper bore (Figure 6) on the left side of the rear axle carrier
7. Place the new vent hose with the Y-vent connector from right to left in front of the right rear axle shaft over the rear axle differential (Figure 3)

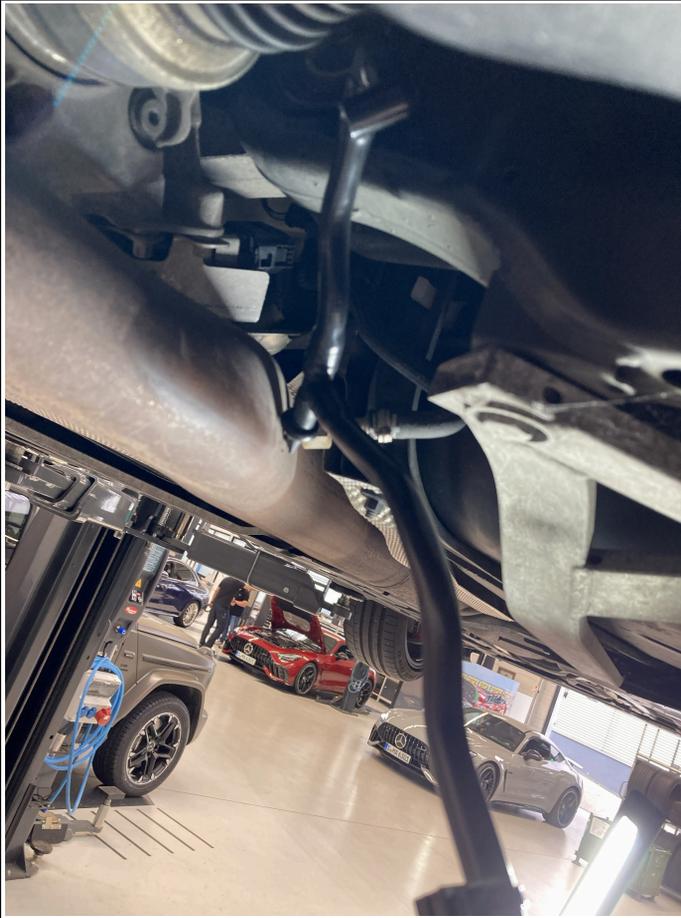
Bild 4.jpg

Figure 4 Vent connection left

8. Slide the angle connectors onto the vent connections onto the rear axle differential on the left (Figure 4) and right (Figure 5)
9. Install the vent connection of the new line on the left side into the upper bore (Figure 6) of the rear axle carrier (Figure 7)

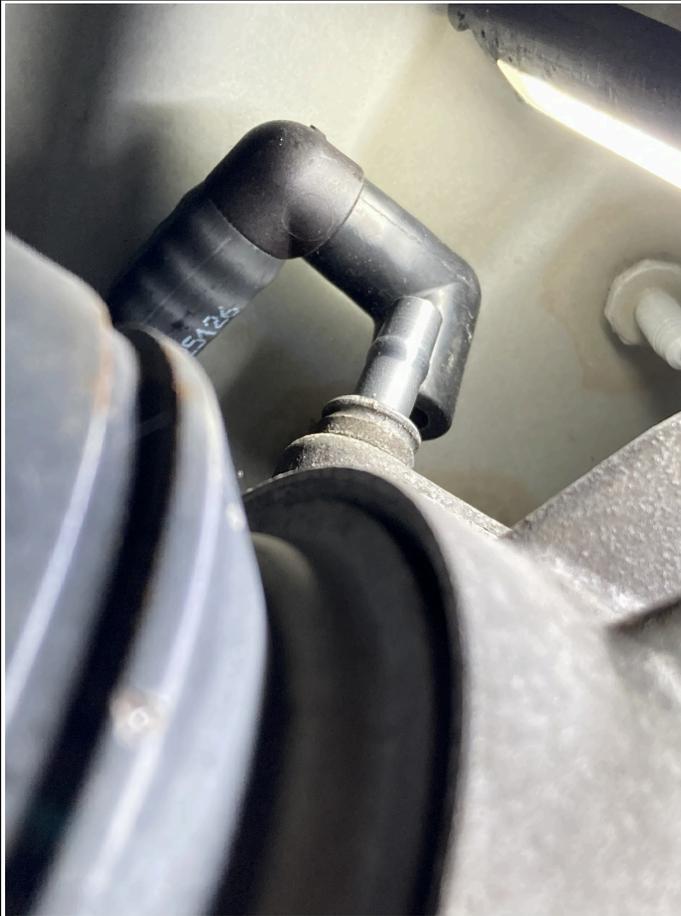
Bild 5.jpg

Figure 5 Vent connection right

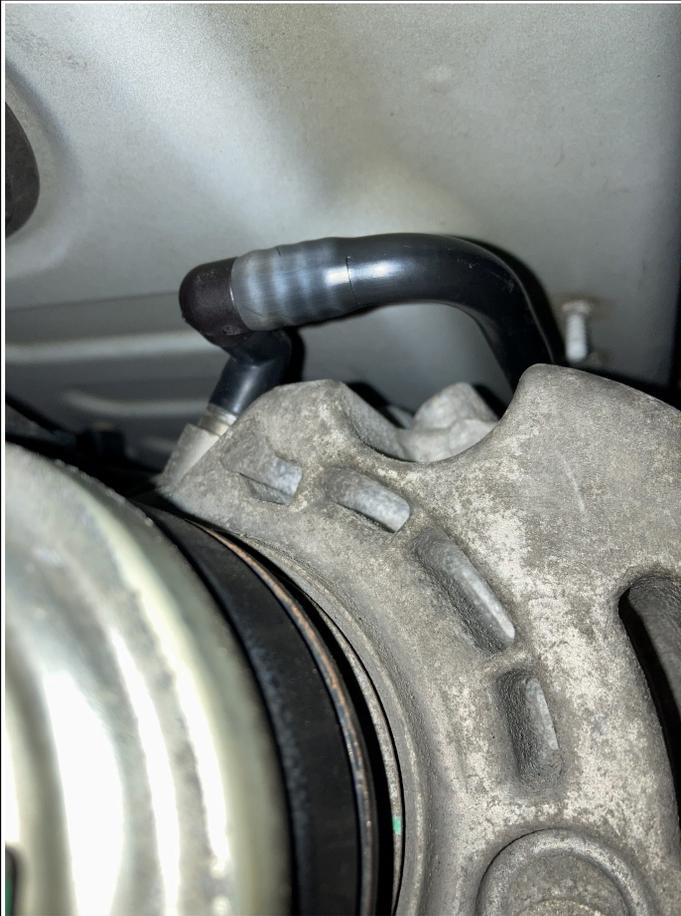
Bild 6.jpg

Figure 6 Upper bore in rear axle carrier

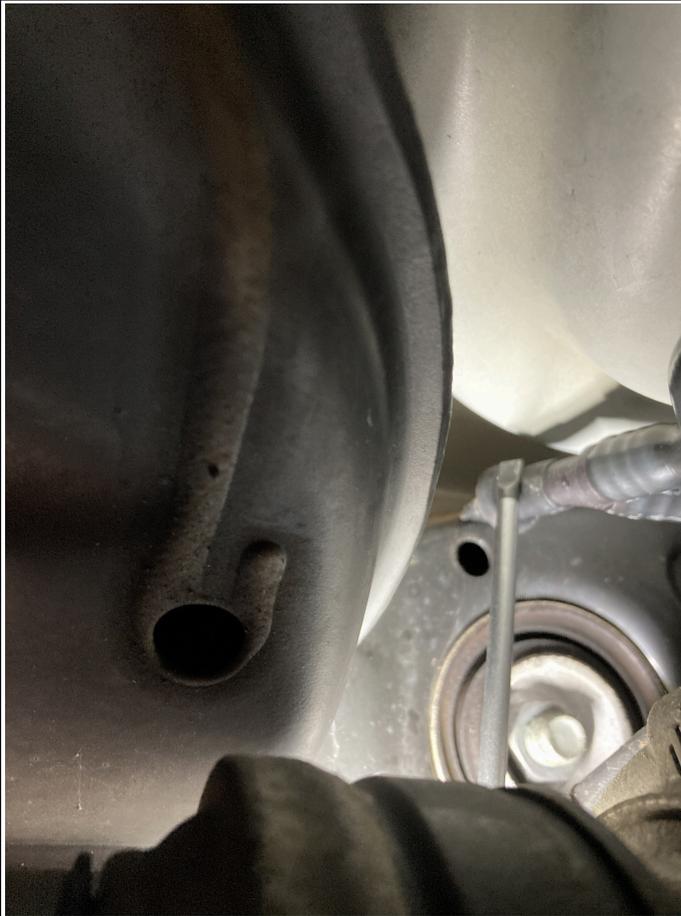
Bild 7.jpg

Figure 7 Vent connection installed in rear axle carrier

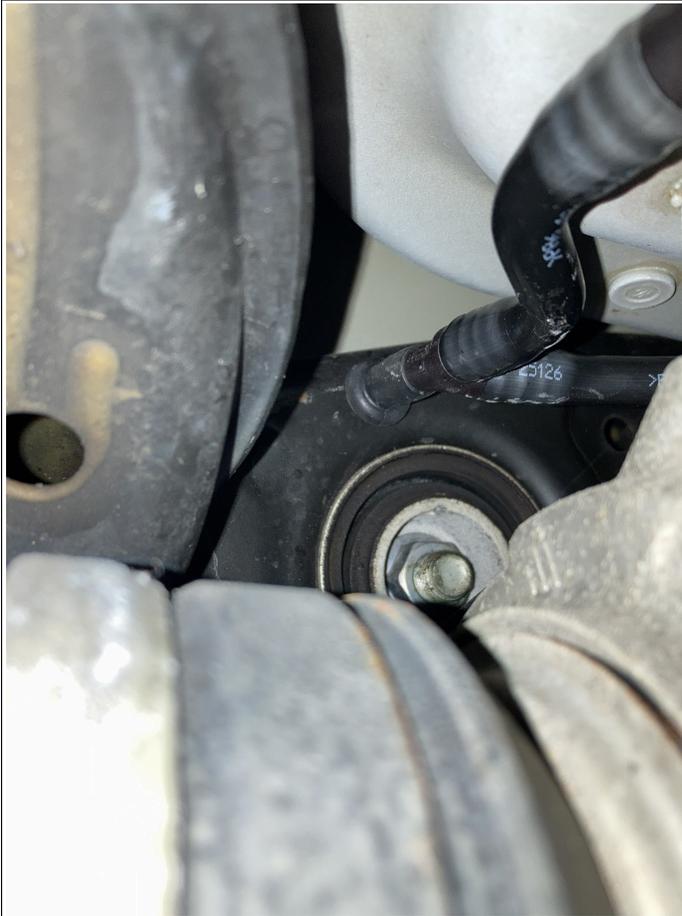
Figure 8.png

Figure 8 Placement of fastening clip on rear axle differential housing

10. Attach the fastening clip (pre-assembled on the new bleed line) to the rear axle differential housing. (Figure 8)
11. Lift the rear axle differential and install the screw from the rear axle carrier (M14 torque 150 Nm)
Note: pay attention to the position of the adjustment disc!
