Technical Service Bulletin

GROUP CAMPAIGN	NUMBER 26-01-009H
DATE JANUARY 2026	MODEL(S) IONIQ 5 N (NE EV N)

SUBJECT: REMOVE/RETAIN LEFT FOOT BRAKING (LFB) FEATURE - VCU SOFTWARE UPDATE (SERVICE CAMPAIGN 9C6)

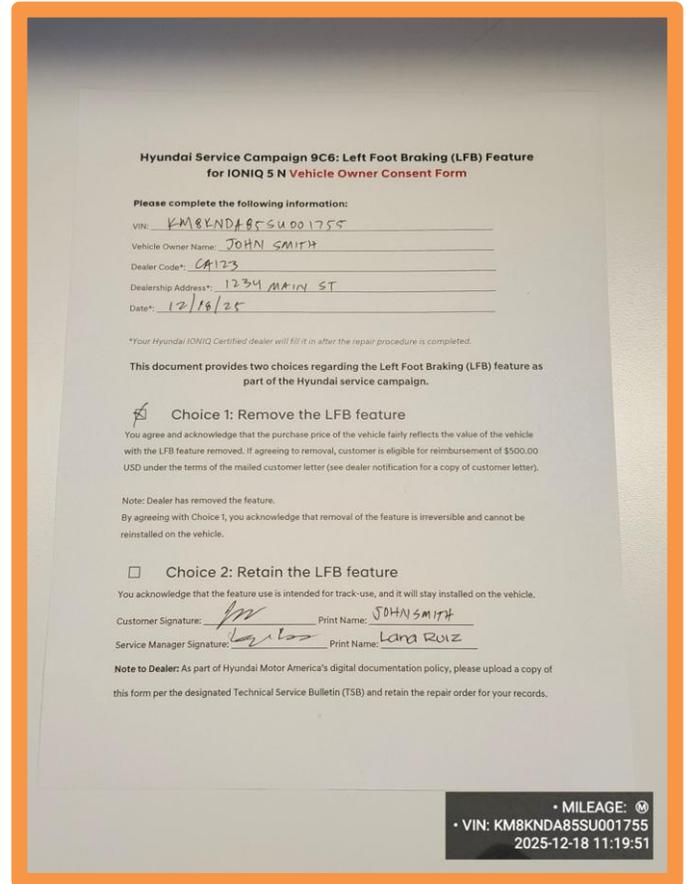
Using the STUI camera function, take a photo of the completed and signed vehicle owner consent form. The photo should clearly show the choice selection and signatures of the customer and Service Manager.

NOTE: If the STUI camera function is **NOT** used, write the last 6 digits of the VIN and date of repair on a piece of paper to include in the photo.

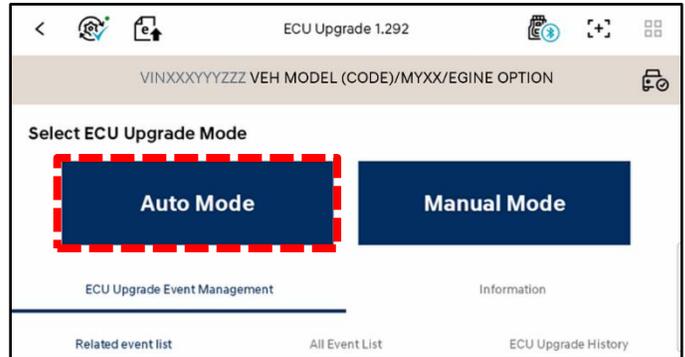
1. Perform the ECU update in **Auto Mode**.

Refer to **TSB # 25-GI-011H**, “**ECU Update Procedure for Tablet-Based GDS-Smart**”, for additional information.

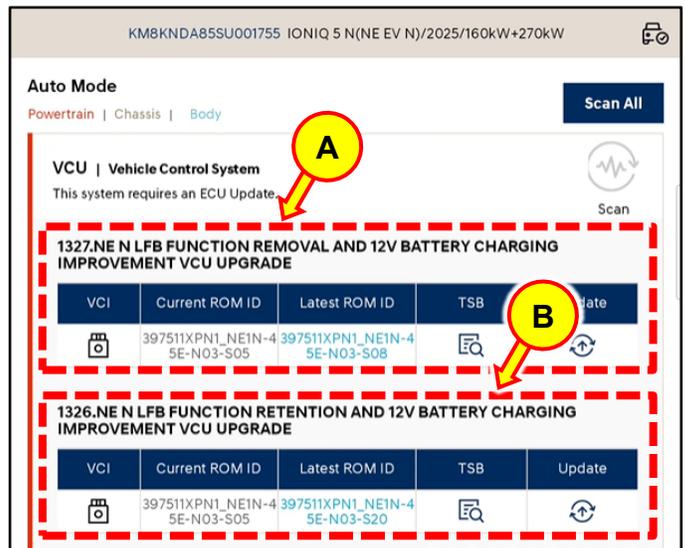
2. Verify the ROM ID by selecting the **VCU** system to scan the vehicle’s current ROM ID.

- If the owner has elected to **remove** the LFB feature, select event # **1327 (A)**.
- If the owner has elected to **retain** the LFB feature, select event # **1326 (B)**.

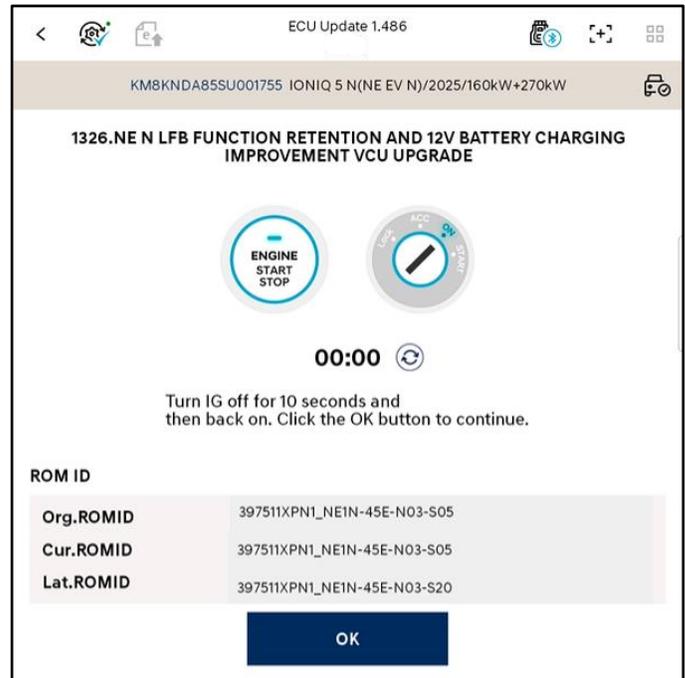
3. After the ECU update process shows 100% complete, follow the prompts on the screen to cycle the ignition **OFF** for at least **10 seconds** to reset the control unit (certain models may take up to **30 seconds**).

Use the **Refresh** button to reset the timer.

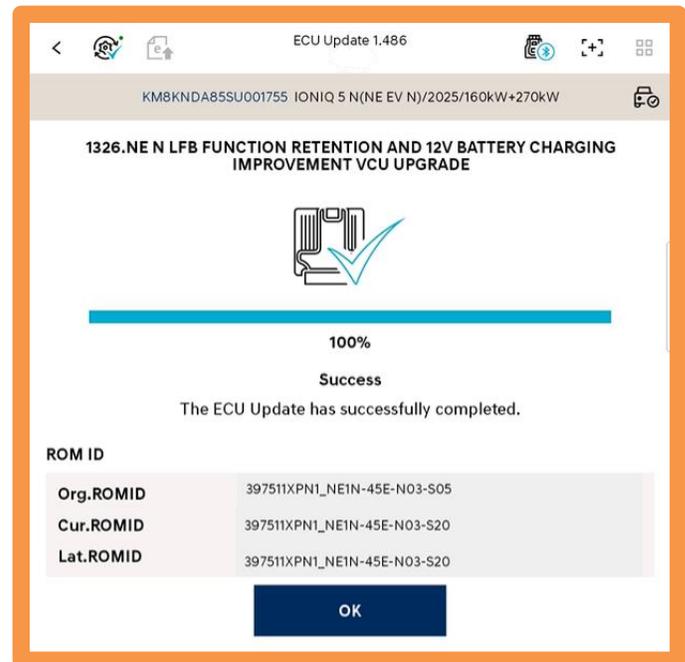
Using the tablet or GDS screen capture function, take a screenshot of the ECU Update "Success" result screen.

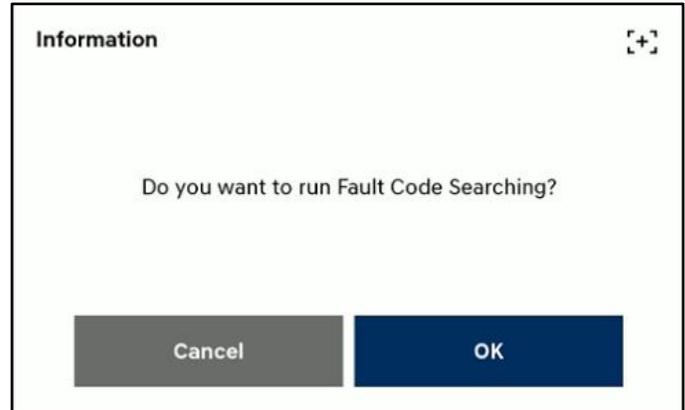
5. Perform an **All Systems Fault Code** search and erase DTC history that had incidentally occurred from the ECU update.

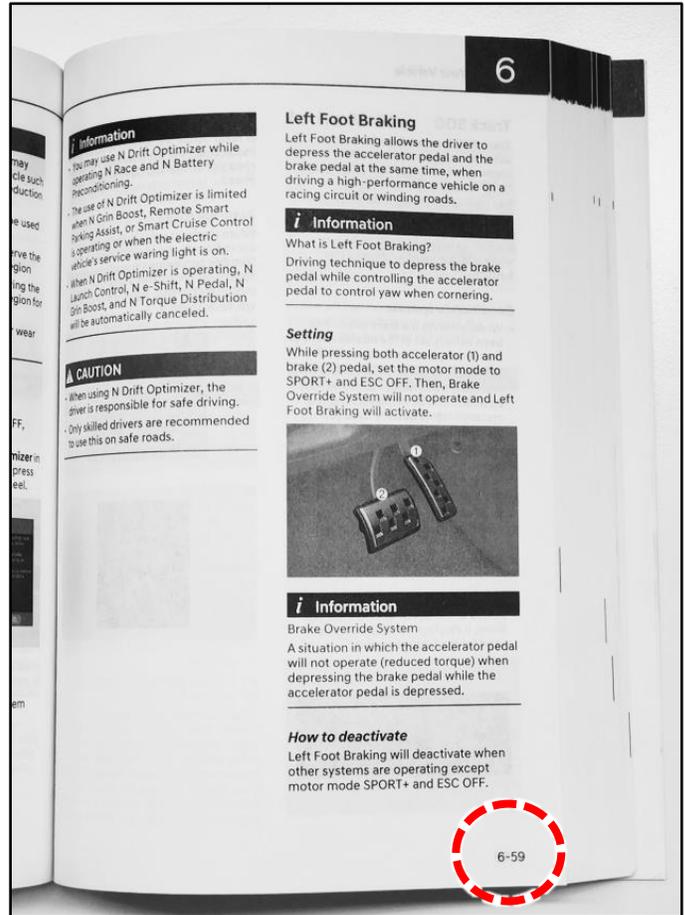
2. Open the manual to the **Left Foot Braking** section on **page 6-59**.

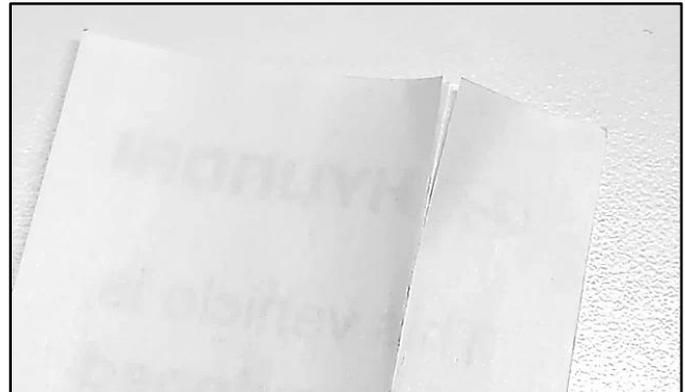
3. Remove the backing from the sticker.

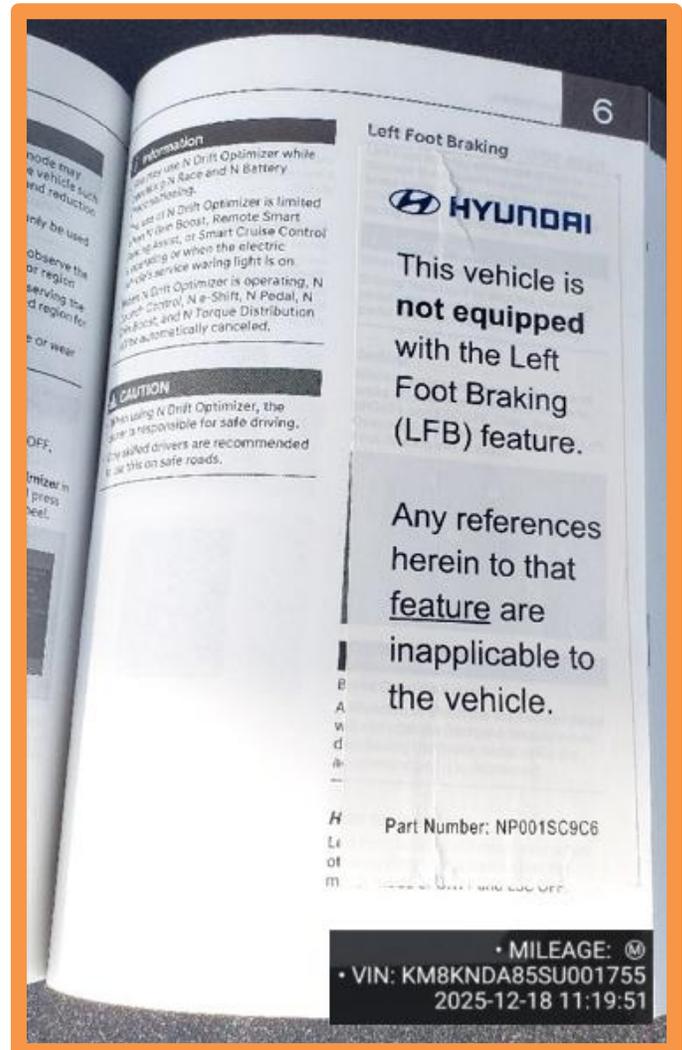
4. Apply the sticker to the page so that it covers the **Left Foot Braking** information.

Using the STUI camera function, take a photo of the sticker covering the LFB section.
