Technical Service Bulletin

GROUP	NUMBER
CAMPAIGN	26-01-006G
DATE	MODEL(S)
JANUARY 2026	GV70 (JK1) GV80 (JX1)

SUBJECT: WATER LEAK FROM CLOGGED SUNROOF DRAIN HOSE
(LIMITED COVERAGE CAMPAIGN L08G)

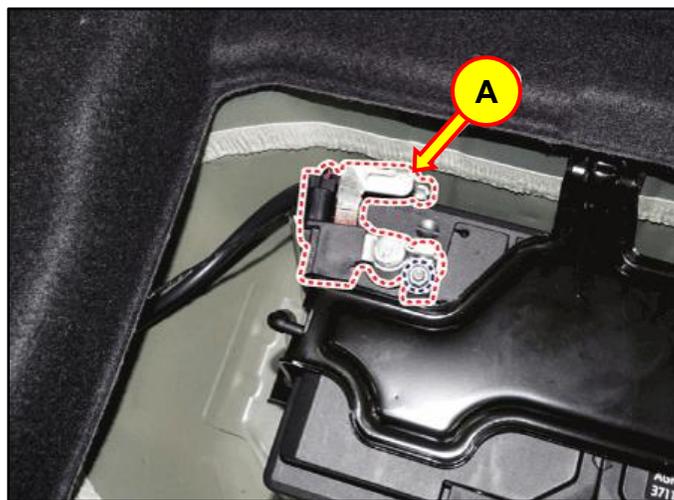
1. Move both front seats as far rearward as possible.
2. Disconnect the negative (-) battery terminal (A).

lb-ft	6.5
lb-in	78
N.m	8.8

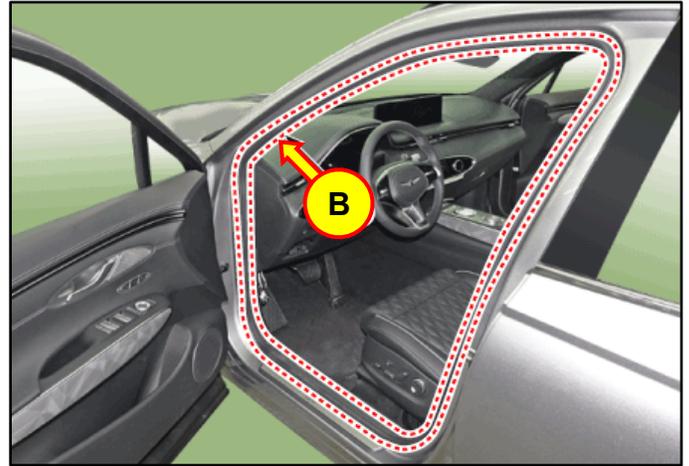
2. Open the front door and remove the front door body side weatherstrip (B).

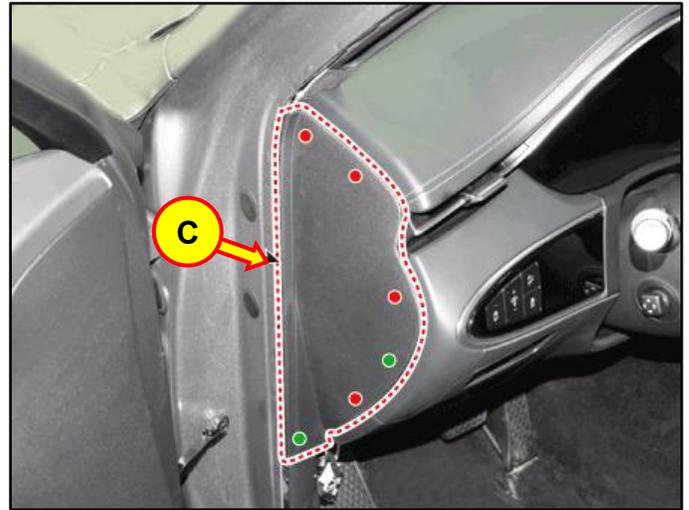
3. Remove the crash pad side cover (C).

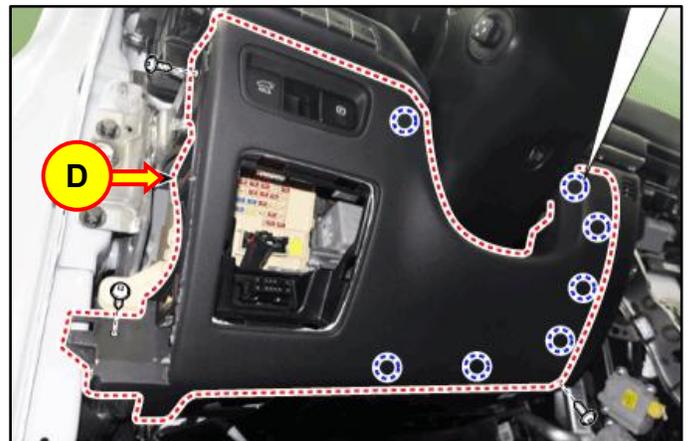
4. Remove the crash pad lower panel (D) after removing the screws.

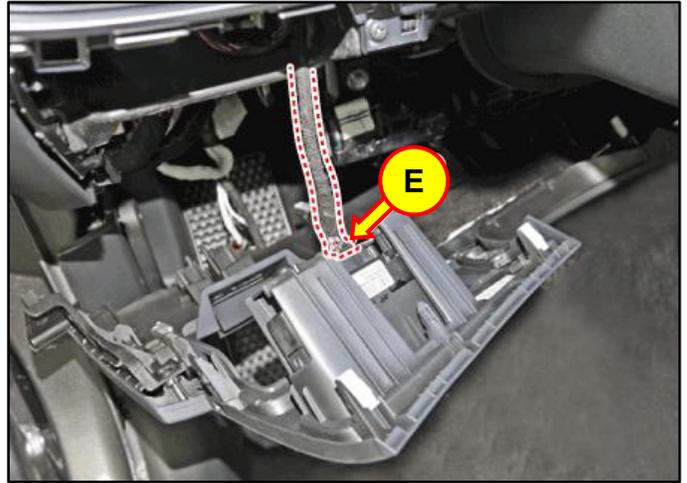
5. Disconnect the crash pad lower panel connector (E) by pressing the locking pin.

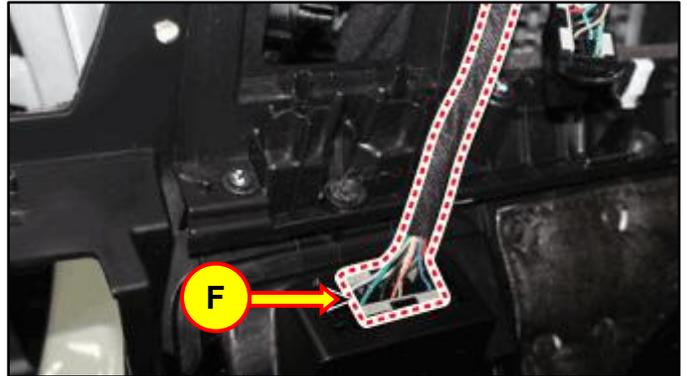
6. Disconnect the DLC connector (F) by pressing the locking pin.

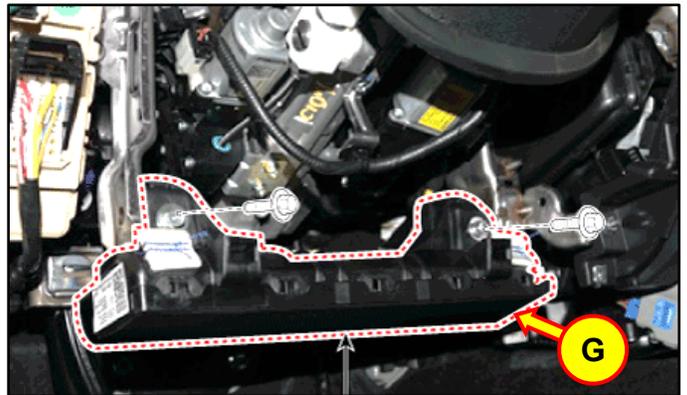
7. Remove the knee airbag module (G) after removing the bolts.

lb-ft	7.3
lb-in	87
N.m	9.8

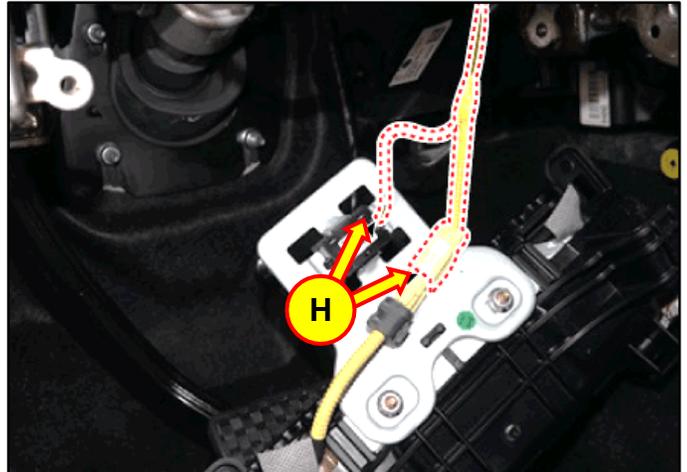
8. Disconnect the knee airbag connectors (H) by pressing the locking pins.

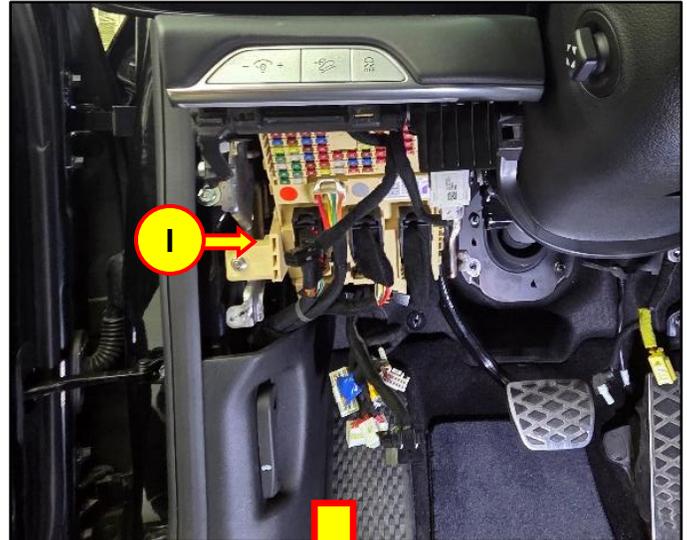
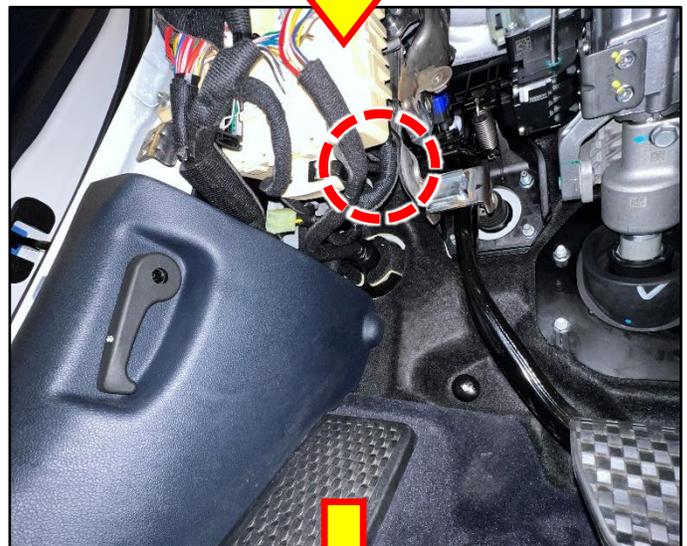
9. Locate the front left side sunroof drain hose plug underneath the crash pad and behind the Integrated Central Control Unit (ICU) (I).

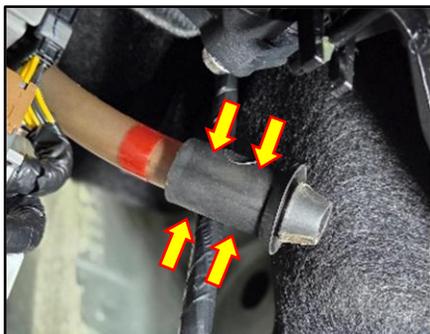
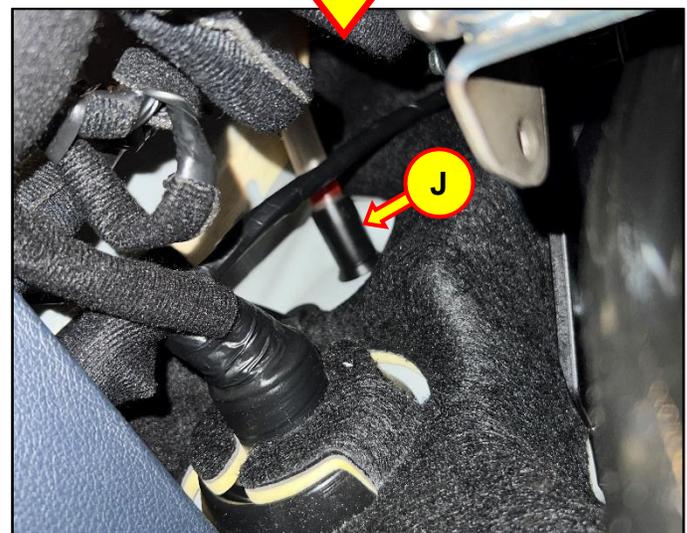
10. Remove the front left side sunroof drain hose plug (J).

Squeeze the plug by hand several times to facilitate removal.

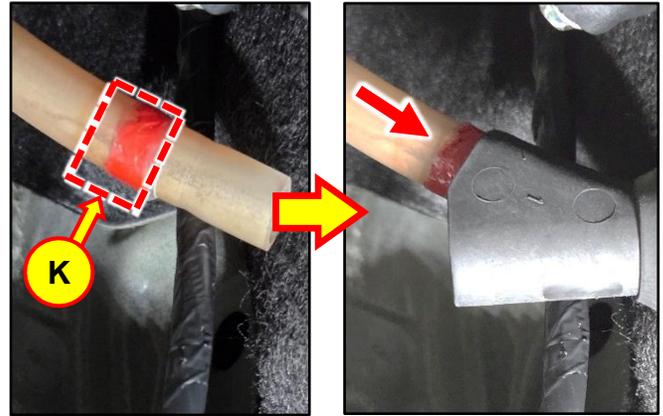
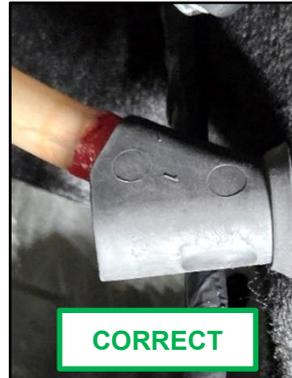
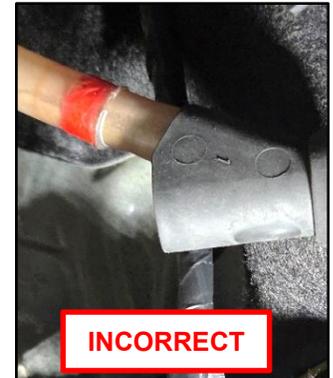
11. Install the drain hose into the new drain plug.

- When inserting the drain hose, be sure to push the taped portion (K) all the way into the drain plug.
- After installation, lightly shake the hose by hand to confirm it is properly seated in the drain hose plug.

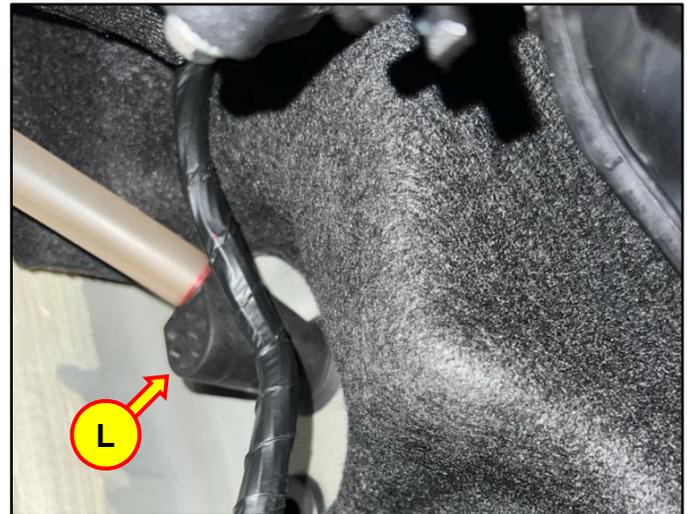
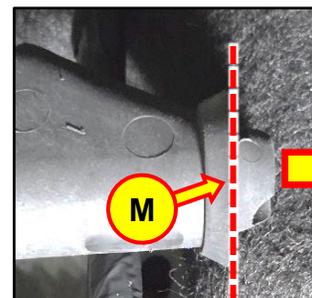
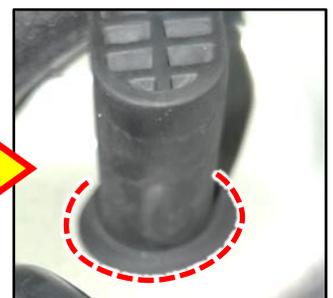
12. Install the new drain hose plug (L) into the vehicle body as shown.

Ensure that the rim (M) of the plug is flush with the vehicle body panel when installed.

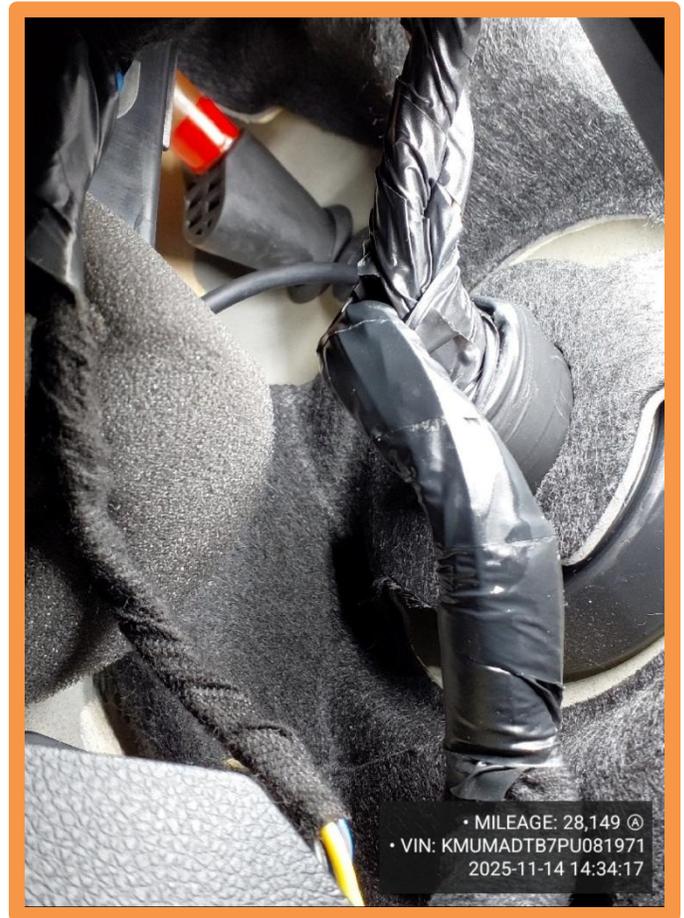
Using the STUI camera function, take a photo of the new drain hose plug and drain hose installed on the vehicle body.

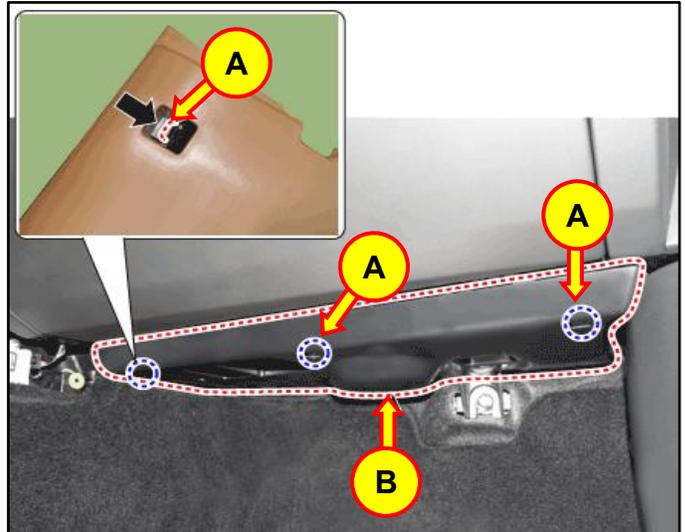
1. Press the locking pins (A) and remove the crash pad under cover (B).

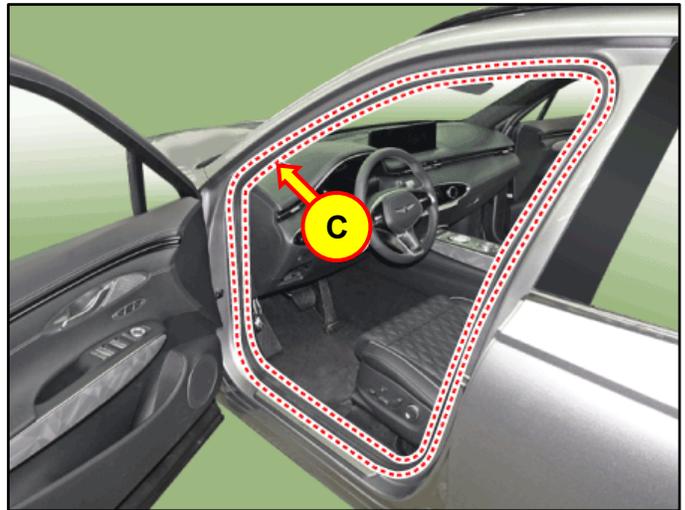
2. Remove the front right door body weatherstrip (C).

Front left shown as an example.

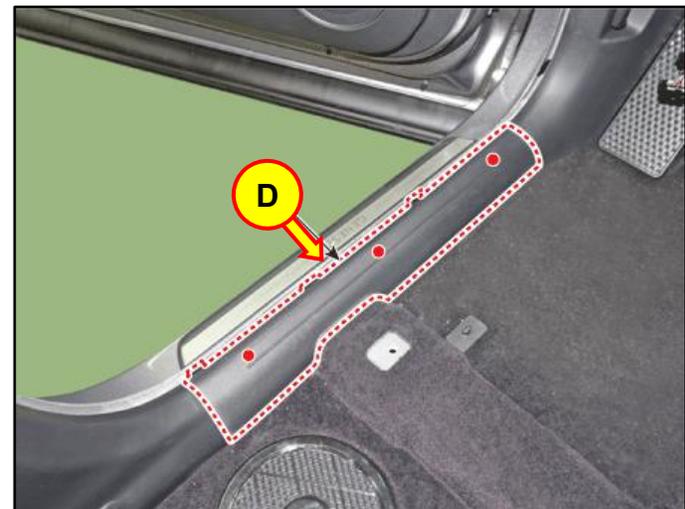
3. Remove the front right door scuff trim (D).

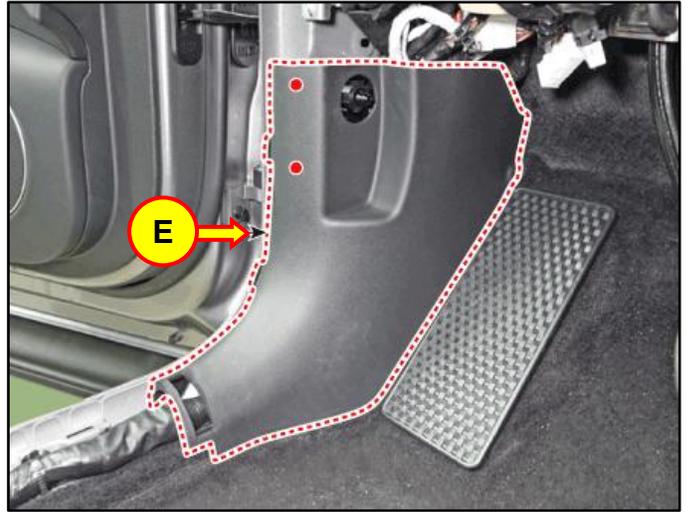
4. Remove the front right cowl side trim (E).

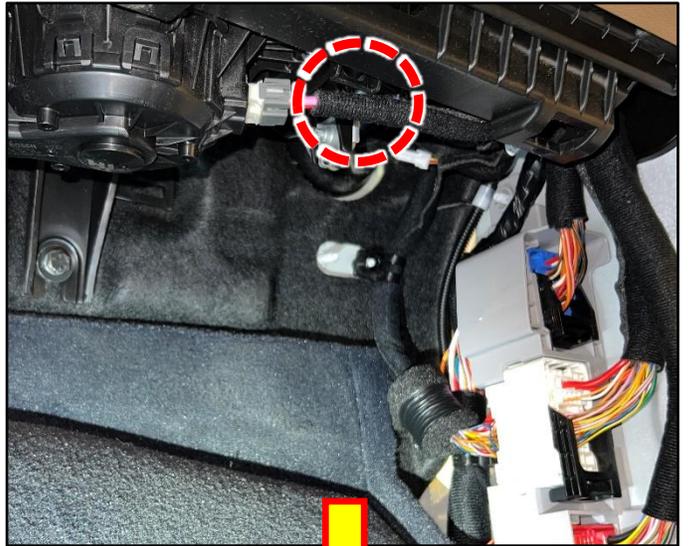
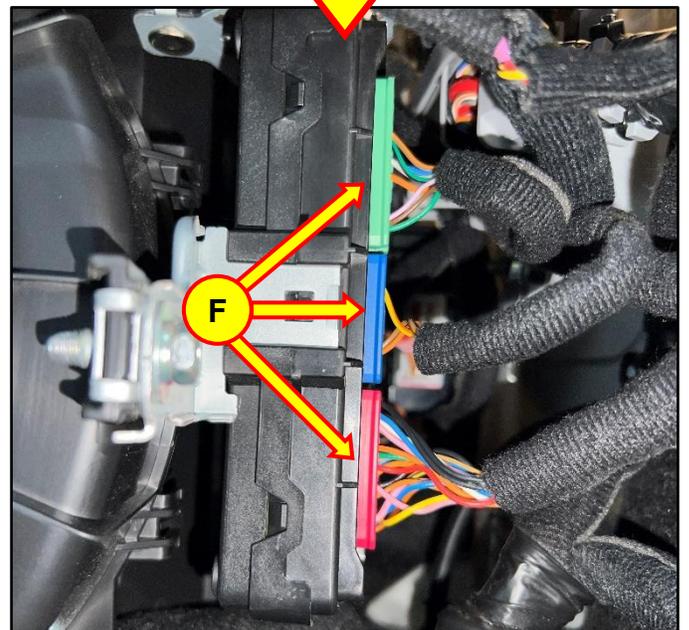
5. Disconnect the 3 connectors (F) for the Integrated Body Control Unit (IBU) underneath the crash pad.

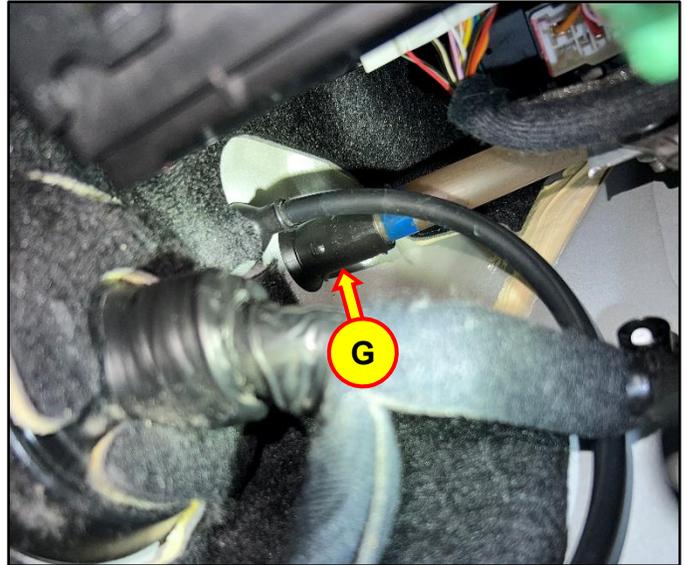
6. Locate and remove the front right sunroof drain hose plug (G) behind the crash pad and above the IBU connectors.

The IBU connectors and wiring harness may need to be moved out of the way to obtain access to the drain hose plug. The IBU does **NOT** need to be removed.

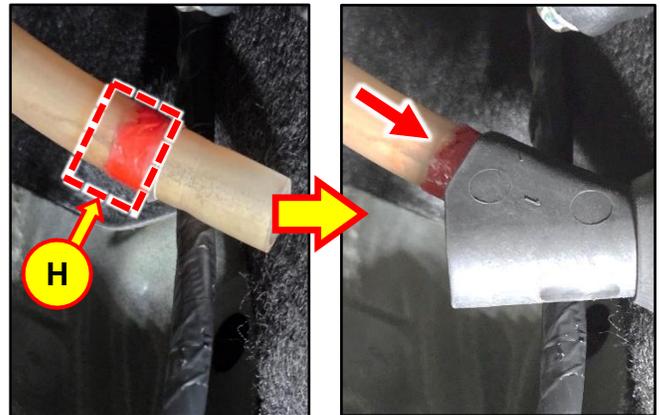
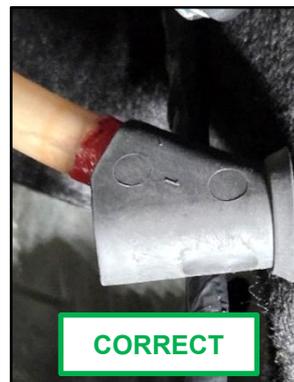
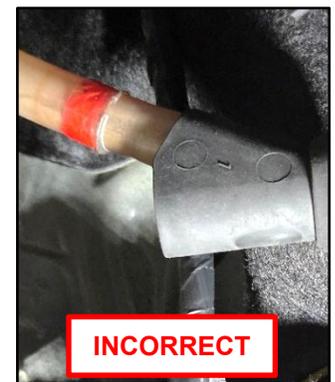
7. Install the drain hose into the new drain hose plug.

- When inserting the drain hose, be sure to push the taped portion (H) all the way into the drain hose plug.
- After installation, lightly shake the hose by hand to confirm it is properly seated in the drain hose plug.

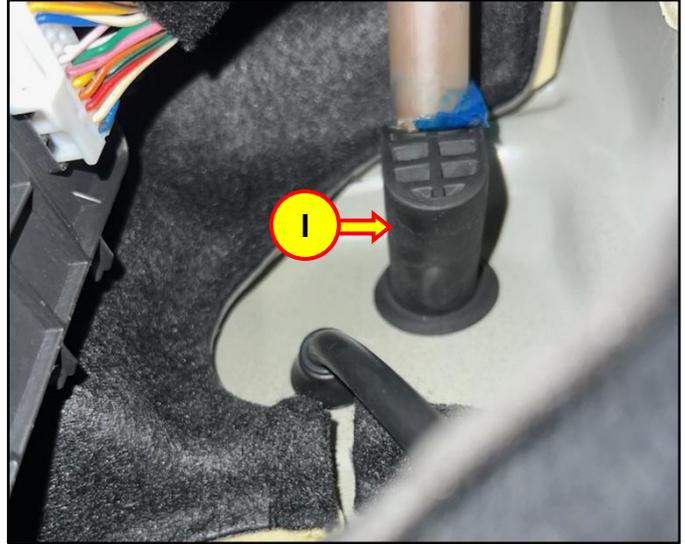
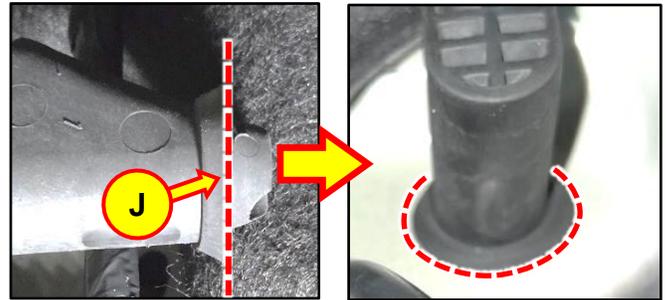
8. Install the new drain hose plug (I) into the vehicle body as shown.

Ensure that the rim (J) of the plug is flush with the vehicle body panel when installed.

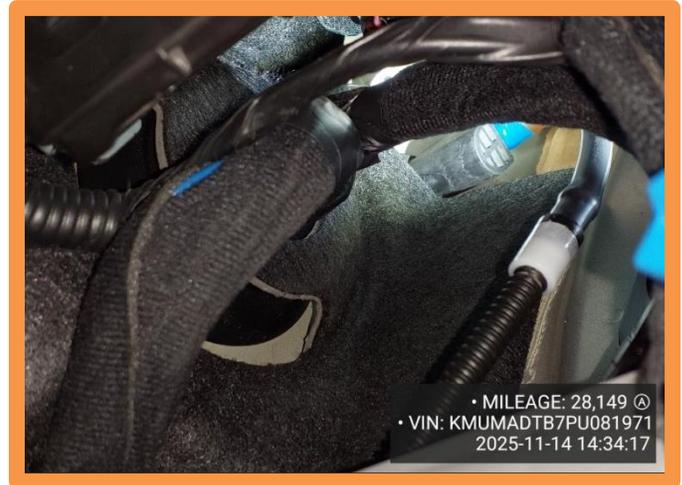
9. Using the STUI camera function, take a photo of the new drain hose plug and drain hose installed on the vehicle body.

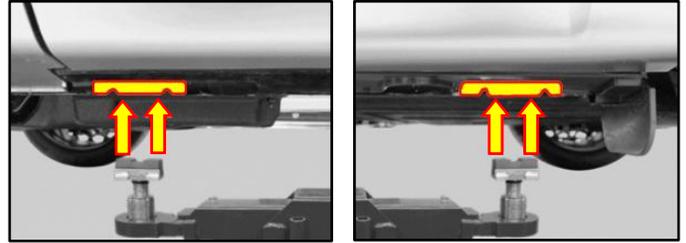
1. Visually check that the lift blocks are properly seated on the vehicle support points and raise the vehicle.

Raising the vehicle from anywhere other than the support points may damage vehicle components.

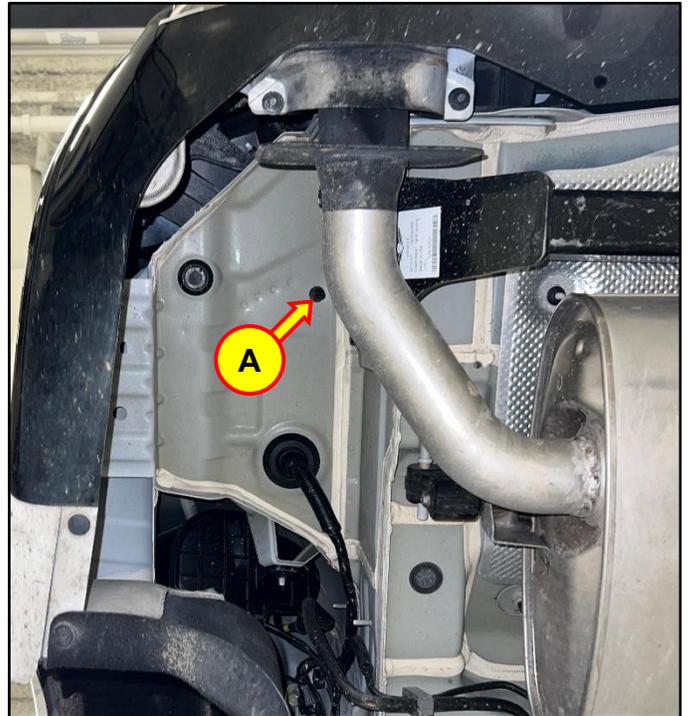
2. Locate the rear left drain hose plug (A) above the muffler.

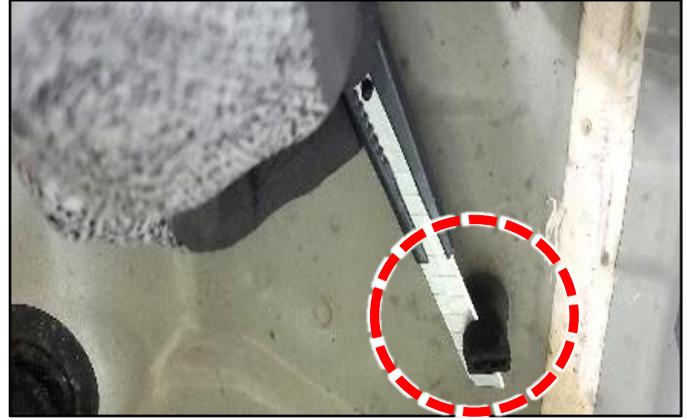
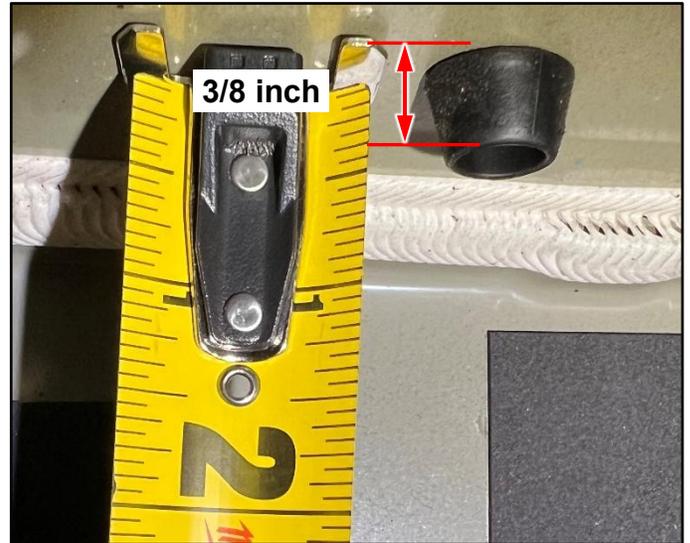
3. Measure and cut off the tip of the rear drain hose plug as shown.
- **3/8 inch (10 mm)** away from the body panel

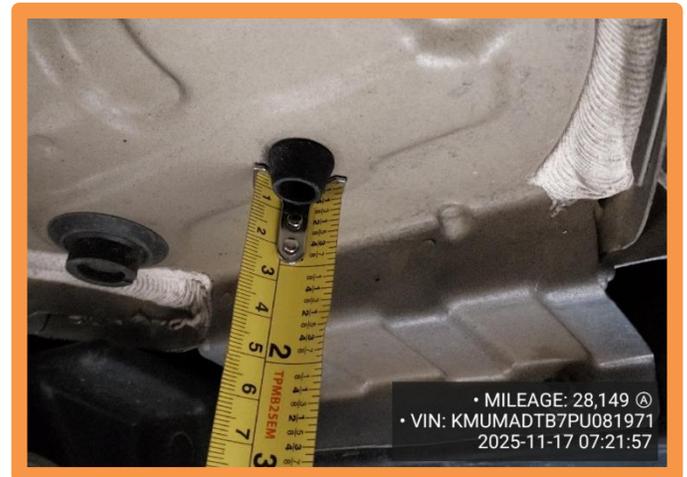
Using the STUI camera function, take a photo of the modified drain hose plug.

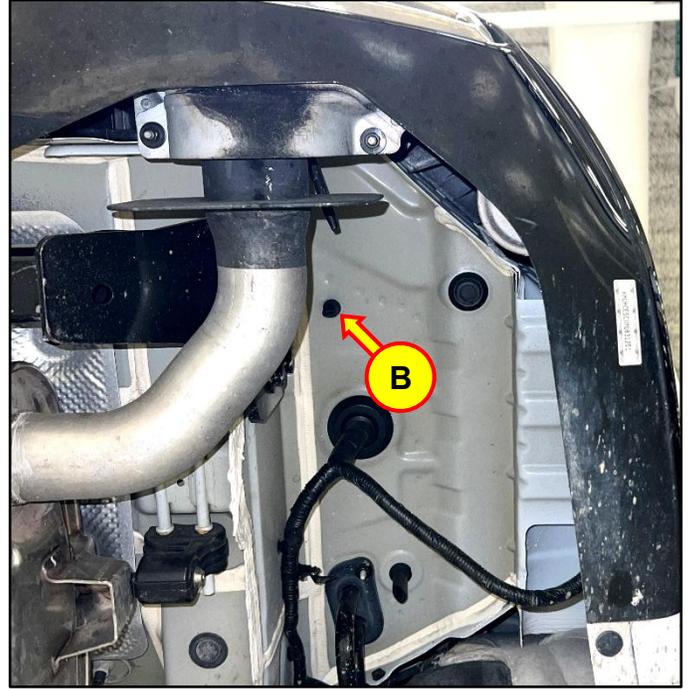
5. Locate the rear right drain hose plug (B) above the muffler.

6. Repeat steps 3-4 on the rear passenger side drain hose plug.
7. The service procedure is now complete.
