MAS004988 RU 25-34

Rapid Update 807 GranTurismo Folgore – A-pillar replacement

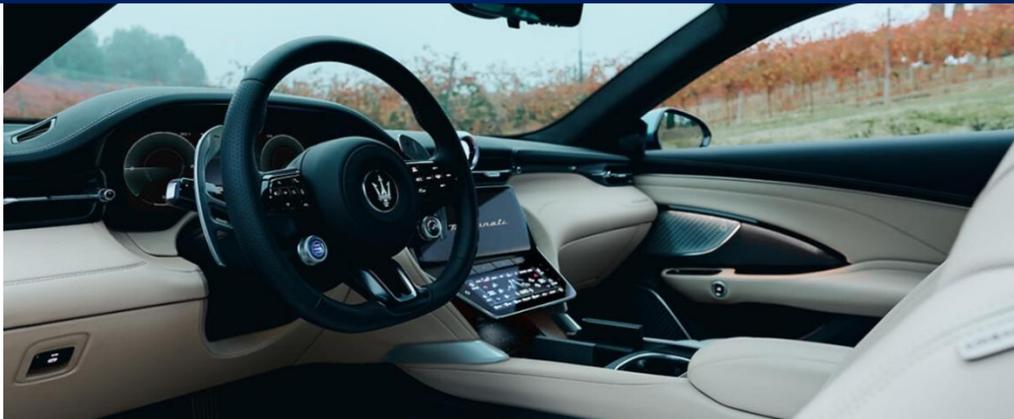
A batch of components intended for assembly may contain contamination, which could affect the positioning of the trim fabric and lead to visible wrinkles. This condition is cosmetic only and does not impact the vehicle's safety or functionality.

Fix: Replace the left windshield A-pillar trim.

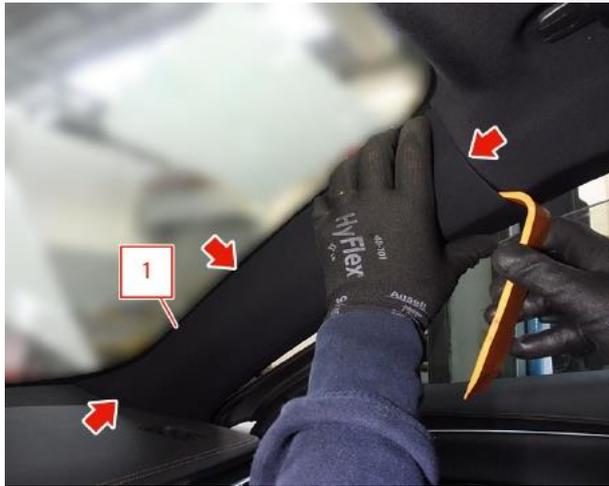
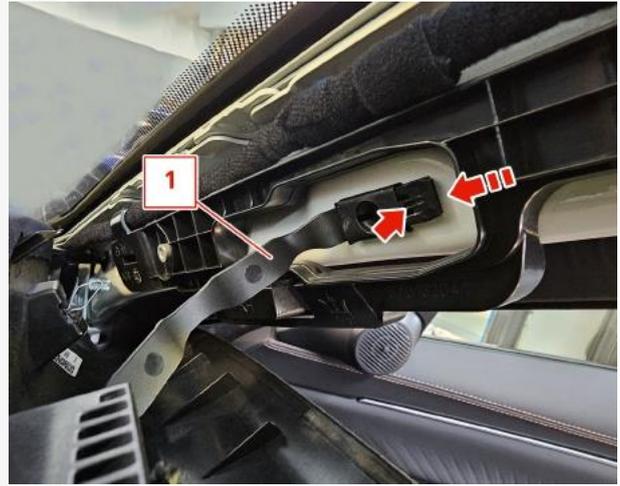
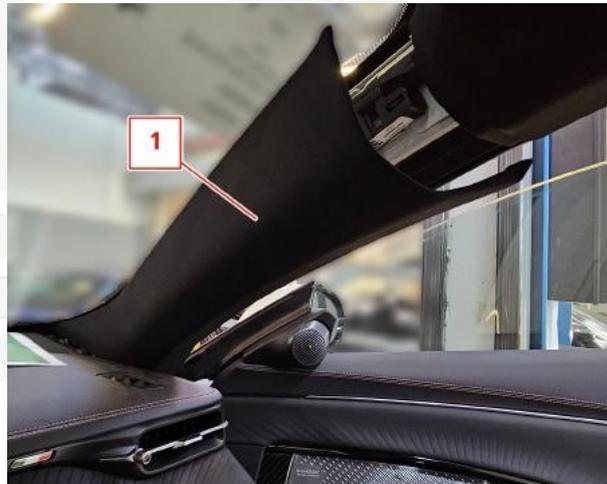
1. Always check ModisCS+ to see if the vehicle is involved in this action and if it has not been previously performed.
2. Make sure you use all the precautions to work inside the vehicle and avoid any type of dirt from ruining the interior of the vehicle.
3. Replace the covers following the procedure in the workshop manual:
 - a. **9.44.002 LH WINDSCREEN PILLAR COVER. Removal-Refitting or Replacement**

4. Reassemble all removed parts following the procedure in reverse order.
5. Procedure complete.
