## SIB 51 19 24

### EXTERIOR MIRROR GLASS STAINED/CLOUDY

2026-01-22

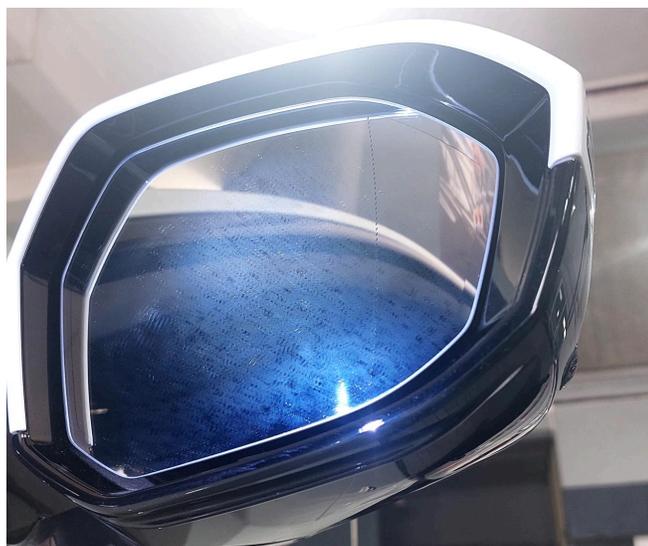
There is a matte “veil” or milky stain on the exterior mirror glass.

Passenger side mirror shown; situation can occur on either or both exterior mirrors.

Contamination from dirt and/or water calcium build up.

Clean and polish the mirror glass using a suitable glass cleaner/polish and a clean sponge.

1. Verify that the customer's concern is the issue stated above.
2. Clean and polish the glass using glass polish and a clean sponge.

**Note: The glass can be polished without removal of exterior mirror assembly or glass.**

3. Verify repair once completed.
