# SERVICE BULLETIN

Subject: TS35 Camera Connection Improvement

Bulletin No: TS35-FC-2501

Vehicle Model: TS35

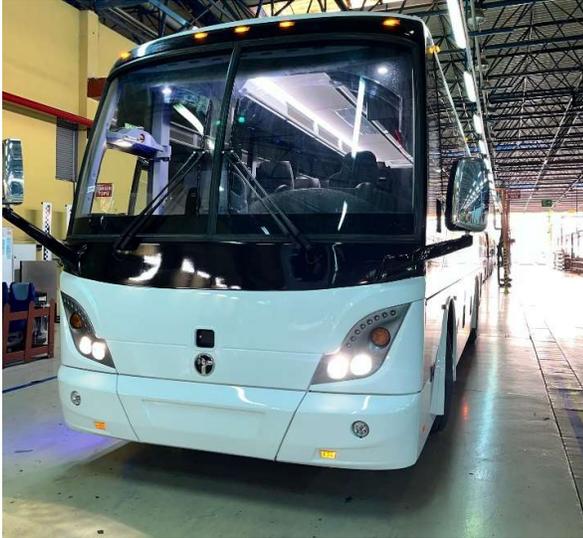
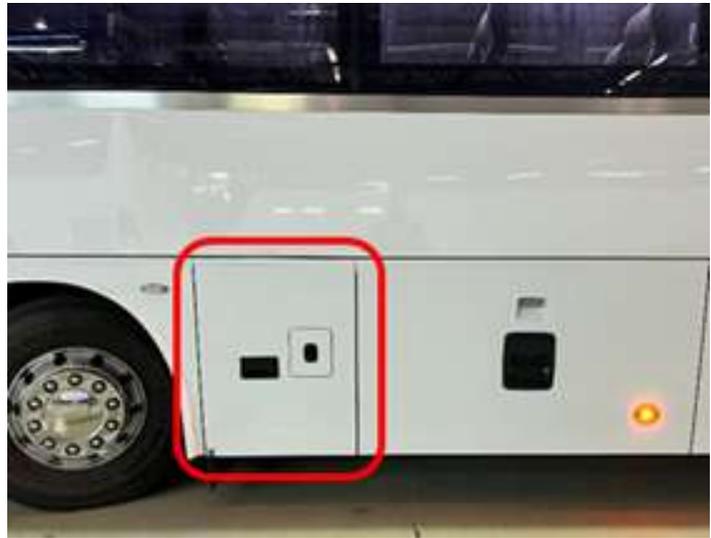
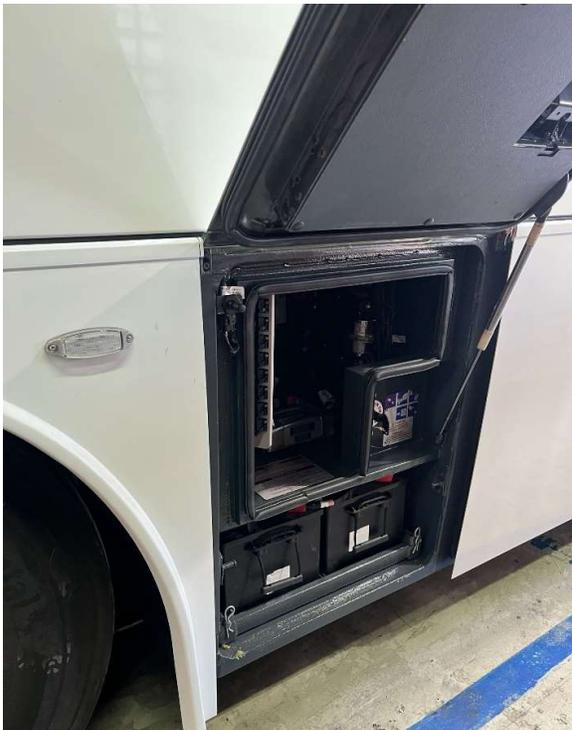
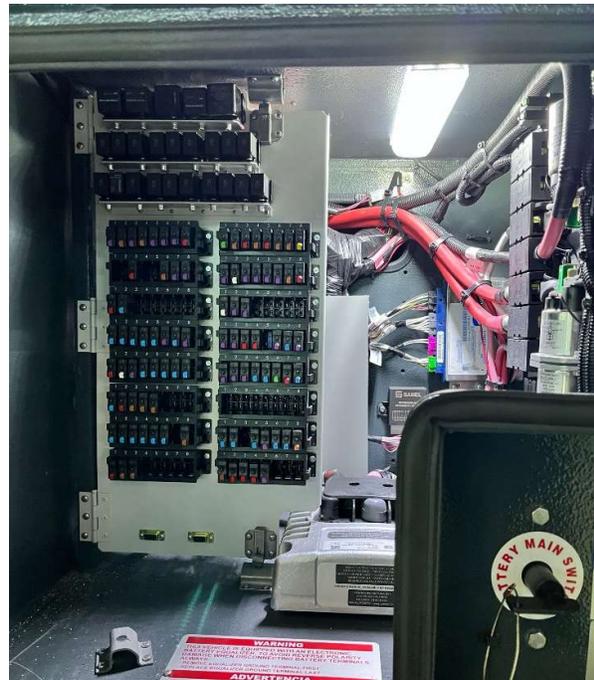
Relay Panel

- Open the vehicle's relay panel area.

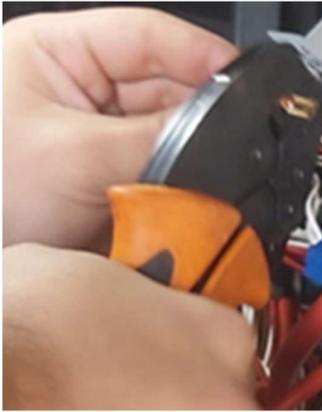
- 1) Cut 2 meters from cable number 9401-372.
- 2) Using a crimping tool, connect the 9402-78Y terminal to one end of the white cable numbered 9401-372 and the TH992002Y terminal to the other end.

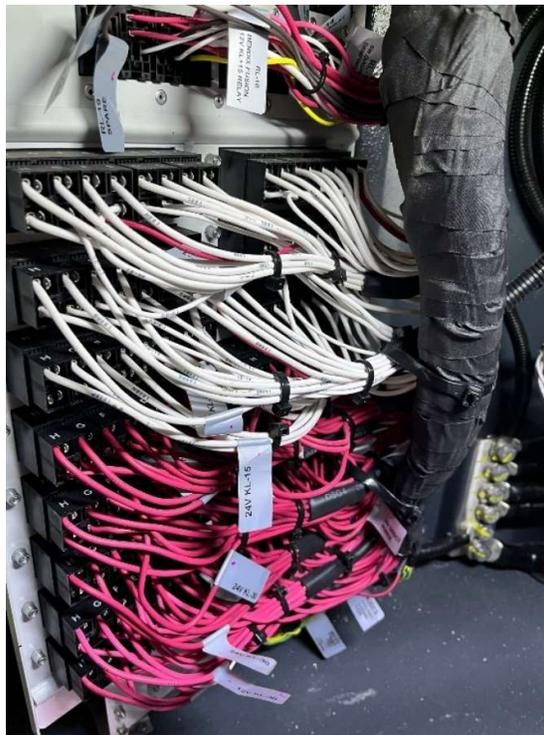
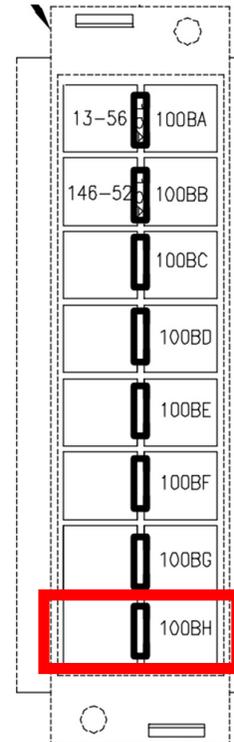
- 3) Connect the terminal of cable number 9401-372 to the empty pin of fuse number 100BH located in the relay panel area.

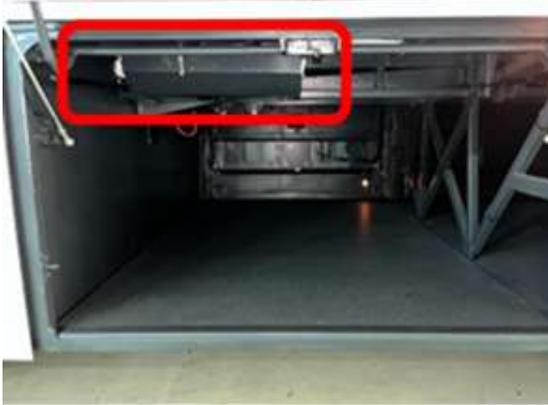
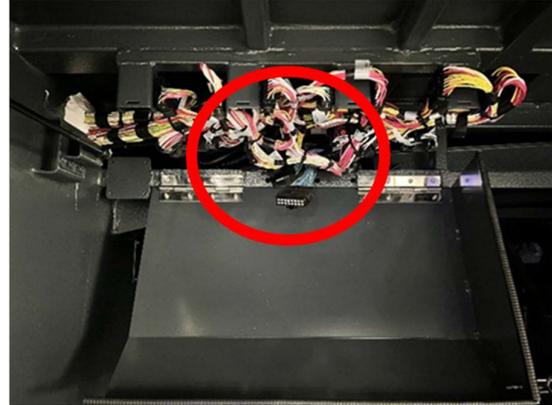
- 4) Open the compartment containing the transition sockets in the luggage area on the relay panel side of the vehicle.

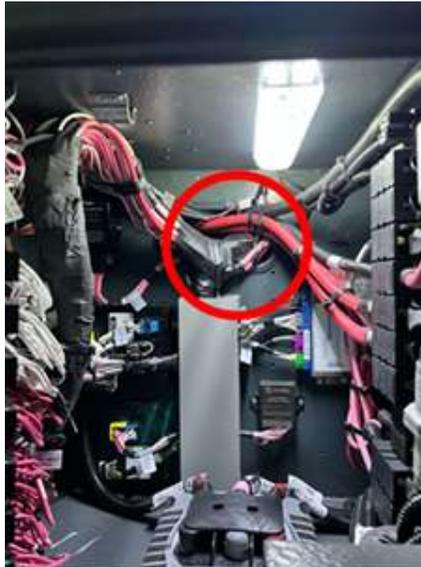
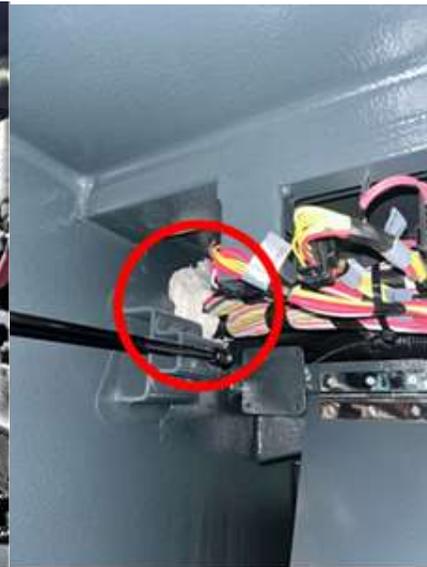
- 5) Pass cable number 9401-372 through the slotted spiral. Pass the cable you connected to the fuse through the gaps shown in the images below to the area where the transition sockets are located. Remove the sealant from the gap opening into the luggage compartment so that the cable can pass through.

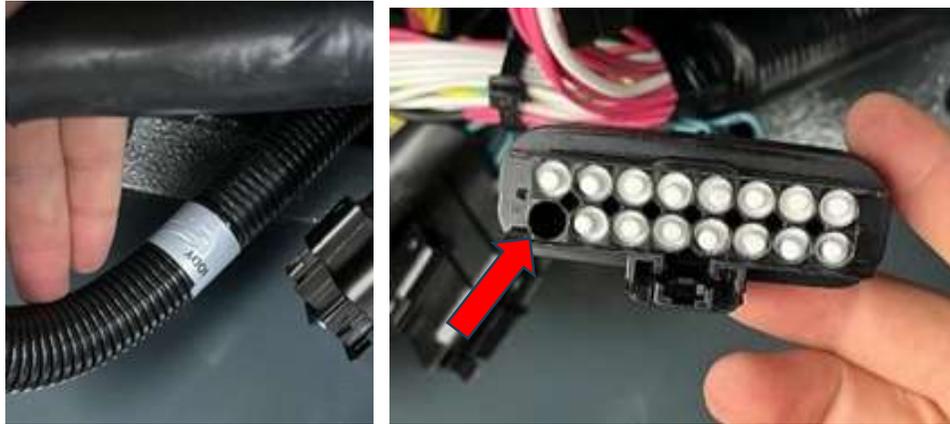
- Remove the white plug from the pin connected to the SP-08 cable (blue) in the F.BODY labeled socket in this area. Connect the end of the numbered 9401-372 cable, with the 9402-78Y terminal to this pin.

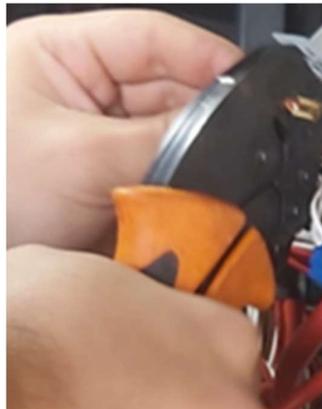
- 6) Using a crimping tool, attach terminal 9402-96Y to one end of numbered 9401-372 3 meter cable and terminal 9402-78Y to the other end.

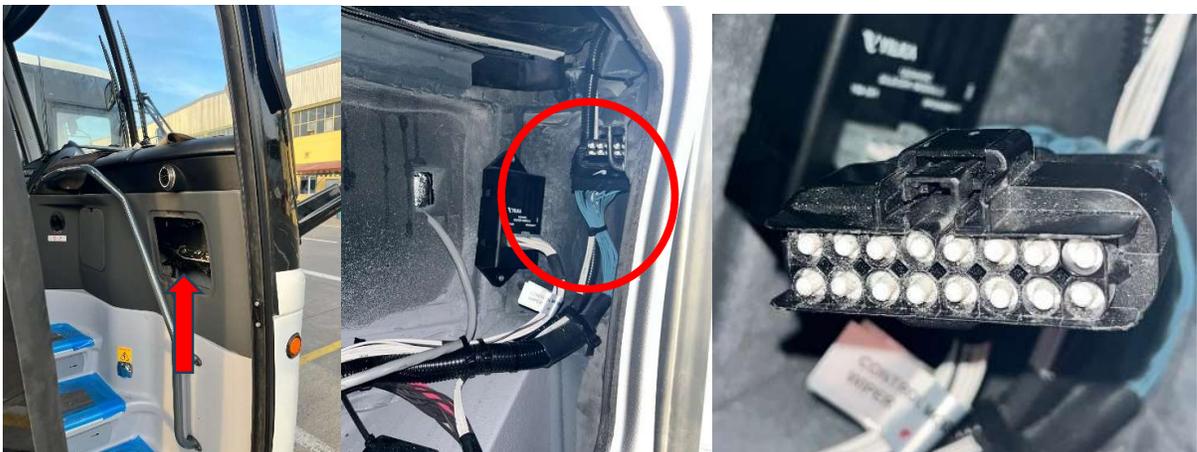
- 7) Open the cover on the dashboard area of the front door of the vehicle. Find the socket labeled F.BODY in this area.

- Connect the end of the numbered 9401-372 cable you connected to terminal 9402-78Y to the pin to which the SP-08 numbered cable is connected in this socket.

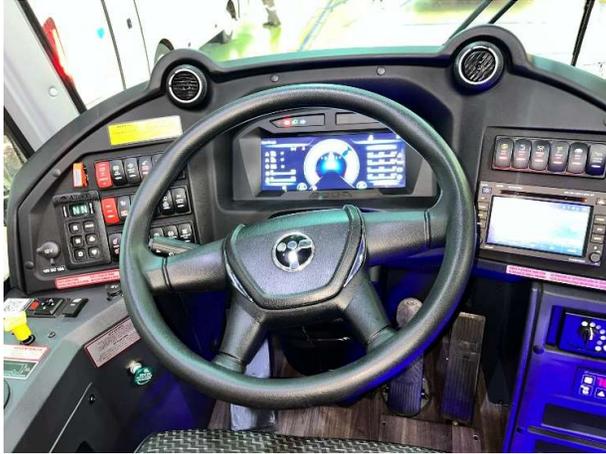
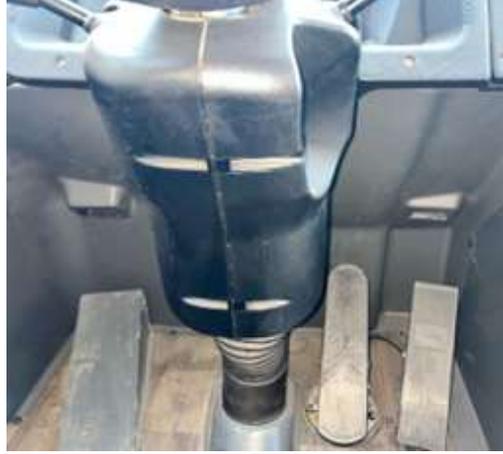
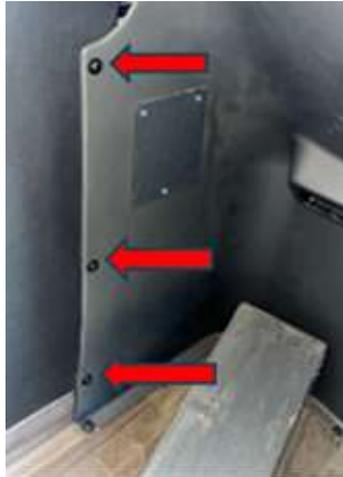
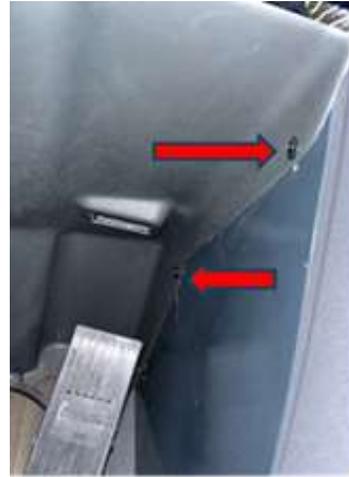
- Remove the cover section under the dashboard by unscrewing the screws.

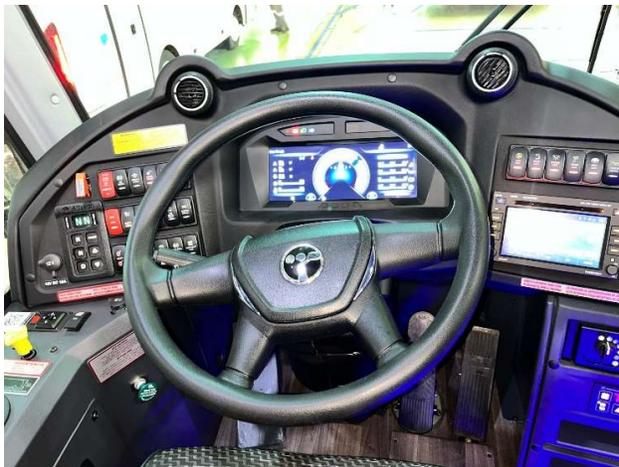
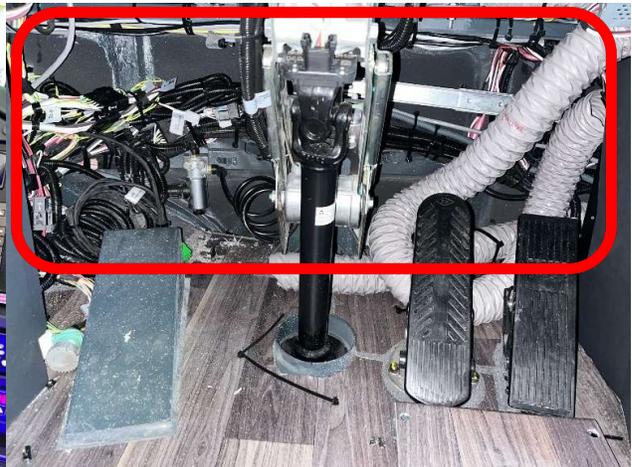
- 1) Locate the vehicle connection wiring for the rearview camera numbered HD554131Y located in the front body area.

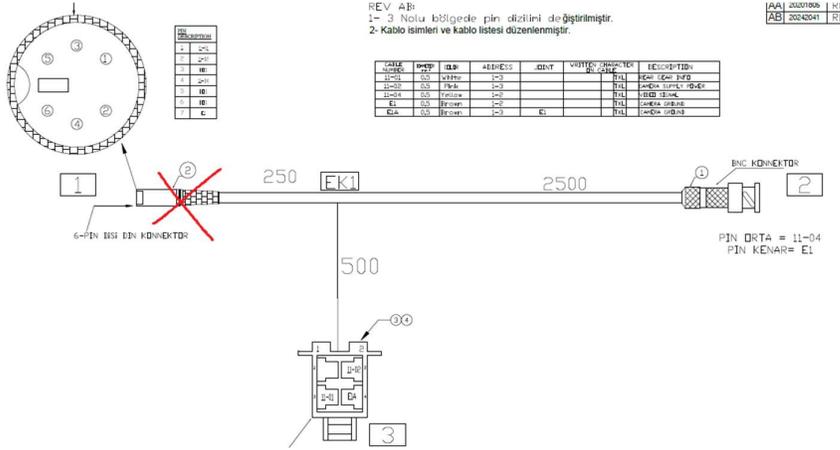
- 2) Find the RP999155 cable that connects to the camera, and disconnect the socket connection shown in the diagram between the RP999155 and HD554131Y 6 pin S-Video Connector.

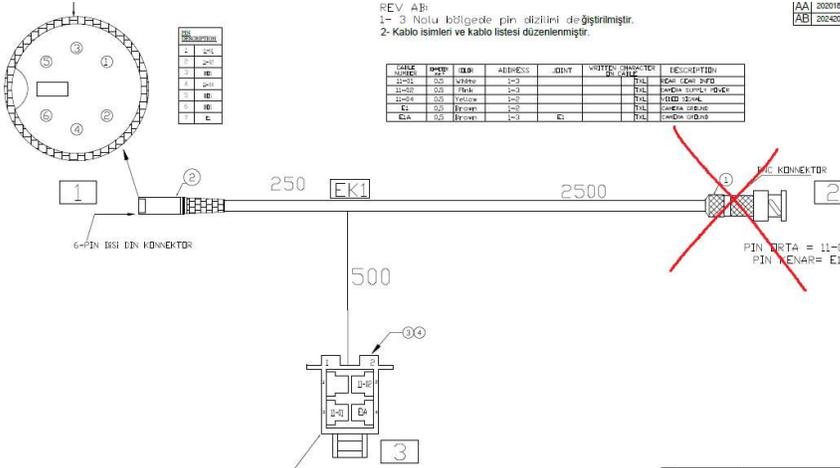
- 3) Disconnect the BNC connector of cable number HD554131Y from the Multiviu.

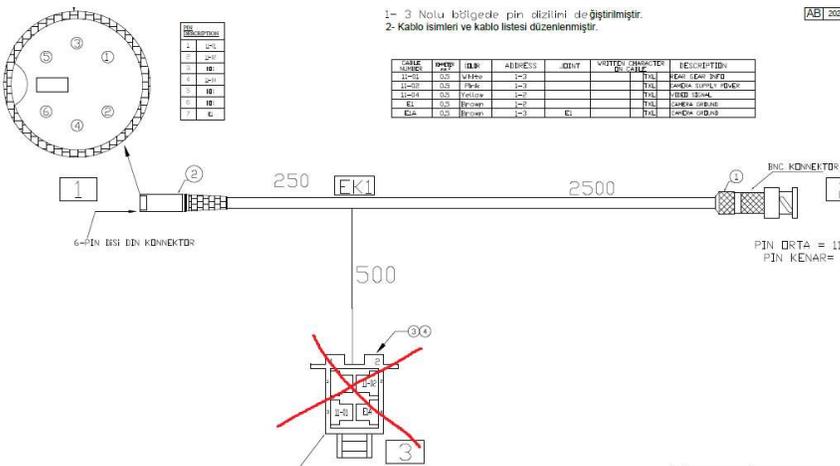
- 4) Disconnect the 4-pin socket connected to the vehicle wiring harness for cable number HD554131Y.

- The harness numbered HD554131Y will be scrapped.

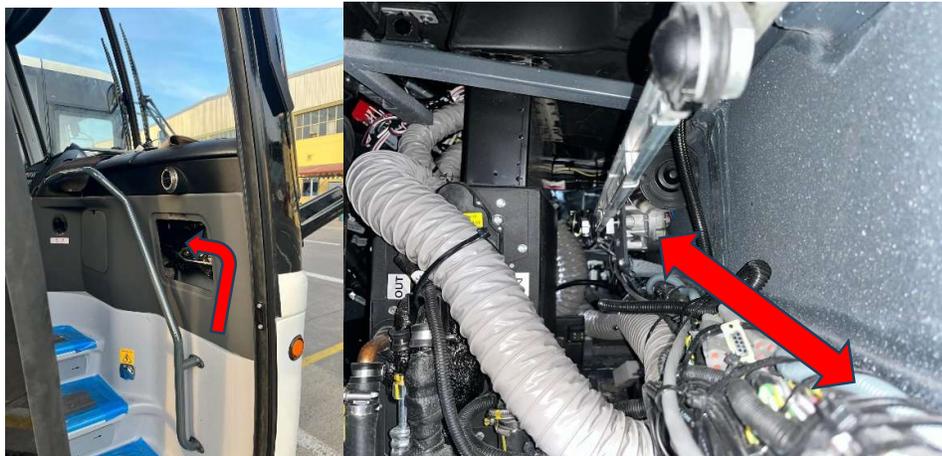
- 5) Disconnect the power cable connected to the pin 2 of socket 9460-573 and isolate it on the vehicle.
- 6) Take the numbered 9401-372 cable, which you previously connected to pin SP-08 in the socket labeled F.BODY in the front door dashboard area, and route it from the front door dashboard area to the steering wheel lower area through the slotted spiral, using the gap shown in the image below.

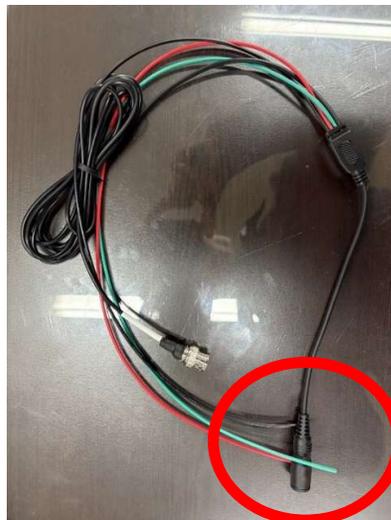
- 7) Connect the end of the numbered 9401-372 cable connected to terminal 9402-96Y to pin 2 of socket 9460-573, which is connected to the vehicle wiring harness of cable HD554131Y.
- 8) Find the RP999155 cable on the device that connects to the camera. Connect the socket connection shown in the figure between the RP999155 and RP554159, 6 pin S-Video Connector.

- 9) Connect the four-pin socket numbered 929504-1 of the harness numbered RP554159 to the socket numbered 9460-573.

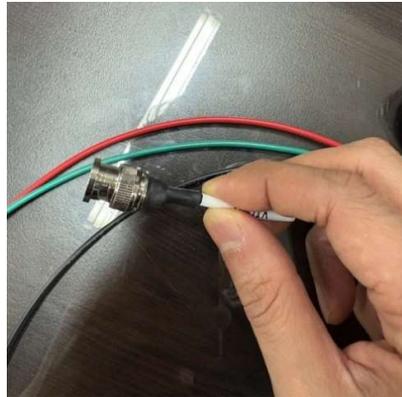
10) Connect the BNC connector to the BNC input on the Multiviu.

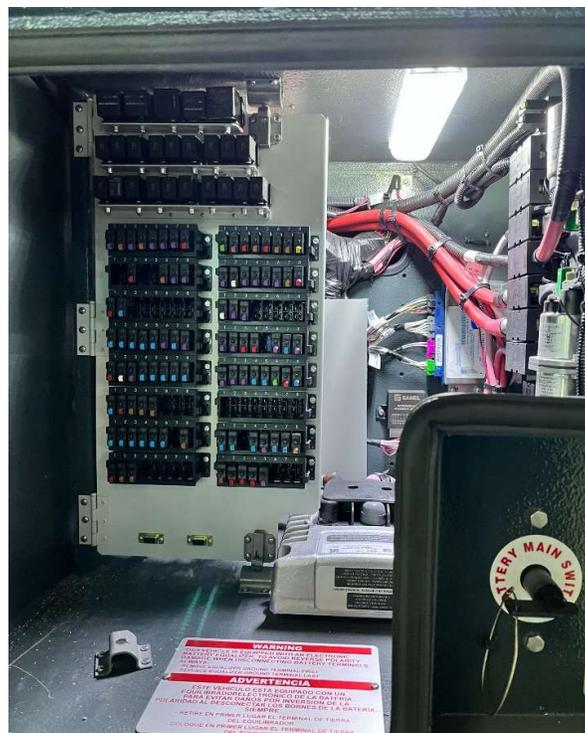
11) Insert the 3A fuse into the 100BH fuse slot on the fuse panel.
