SERVICE BULLETIN

Subject: TS45 Camera Connection Improvement

Bulletin No: TS45-FC-2523

Vehicle Model: TS45

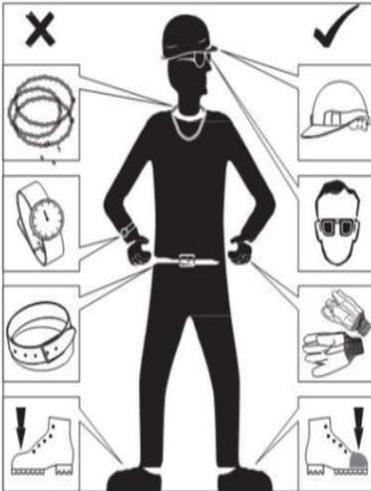
1. Mechanical Requested Dress Code

- ✓ Always wear protective clothing
- ✓ Do not wear any worn or loose-fitting clothing
- ✓ Remove jewelry before starting to work
- ✓ In case of long hair, use hairnet
- ✓ The illustration on the left shows some of the correct and incorrect clothing
- ✓ Sharp edged items should be avoided in order not to scratch vehicle (i.e. belts, watches, necklace)

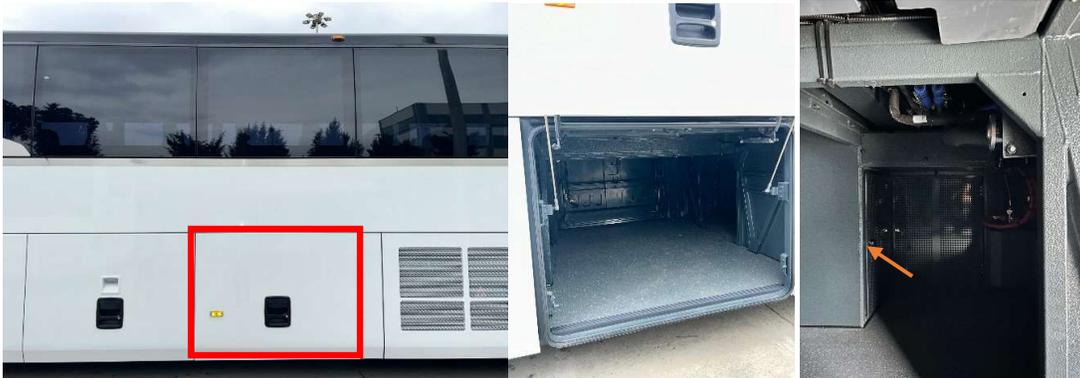
Transition Sockets Location: Behind the relay panel.

1. Cut the white cable numbered 9401-372, which is 5 meters long, into two pieces, one 2 meters long and the other 3 meters long.
2. Insert the 9402-152 terminal into the 2-meter-long white cable numbered 9401-372 Temsa.
3. Connect the cable with the terminal connection to pin 7 of socket P01A006-201_1A, to which fuse F110 is connected.
4. Insert terminal number 9402-78Y into the free end of the cable.
5. Put the cable attached to the terminal through the slotted spiral numbered 9404-94Y and route the cable to the location of the relay panel transition sockets.

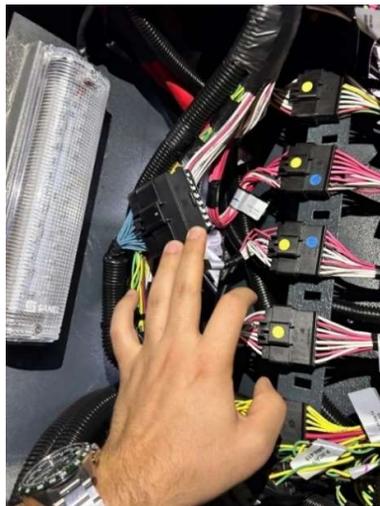
6. In the area where the relay panel transition sockets are located, find socket number SP44-03B, where the spare cables are connected.

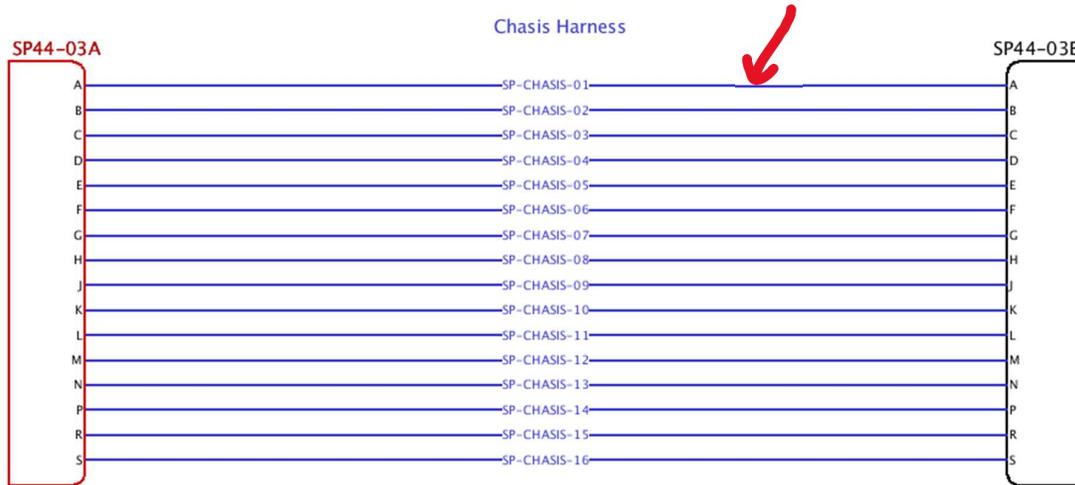
7. Remove the white plug on the A pin of the mating socket.
8. Connect the cable labeled with terminal number 9402-78Y to the A pin with the plug removed.

Note: Pay attention to the cable number connected to the A pin on the socket. The SP-CHASIS-01 cable connection is located on the A pin of the SP44-03B and SP44-03A sockets. Spare cables have blue color.

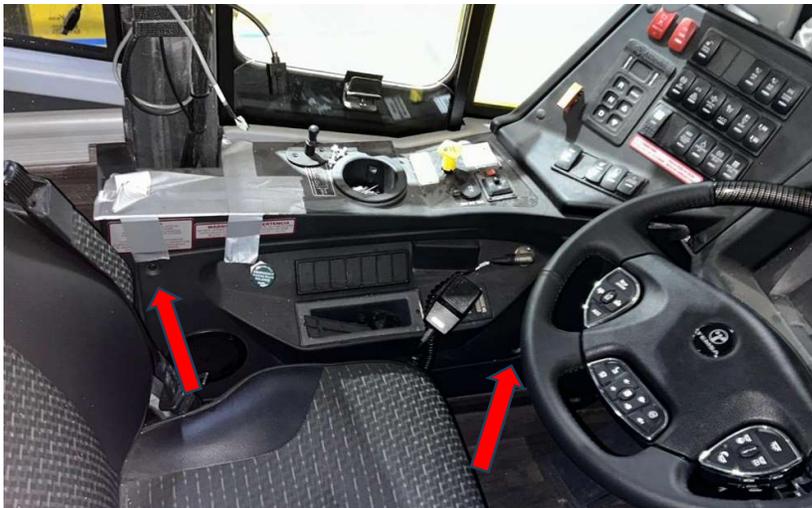
1. Remove the cover of the switchbox by unscrewing.

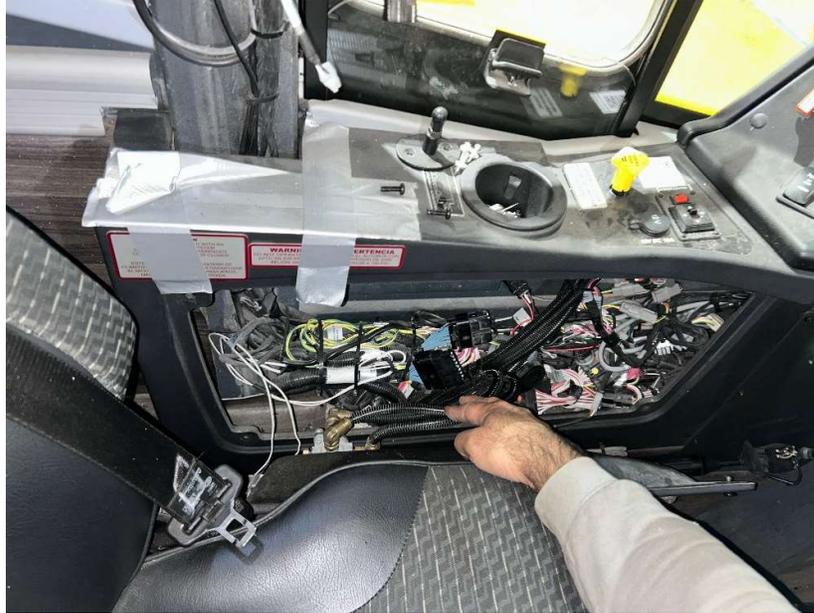
2. Find the spare cable socket numbered SP44-03A located in the switchbox area.

3. Disconnect the white plug on the A pin of the mating socket.
4. Insert the 9402-78Y terminal into the white cable with part number 9401-372, which is 3 meters long.
5. Connect cable number 9401-372, plugged into terminal number 9402-78Y, to pin A with the plug removed.

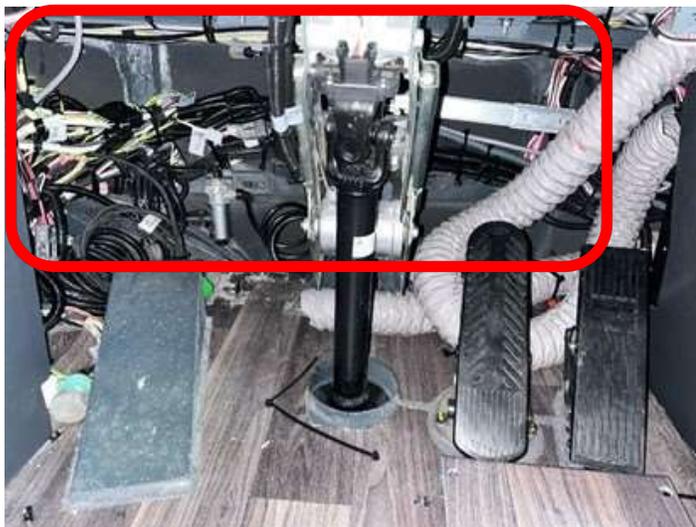
1. Remove the cover section under the dashboard by unscrewing the screws.
2. Find the vehicle connection wiring for the rearview camera numbered HD554131Y located in the front body compartment.

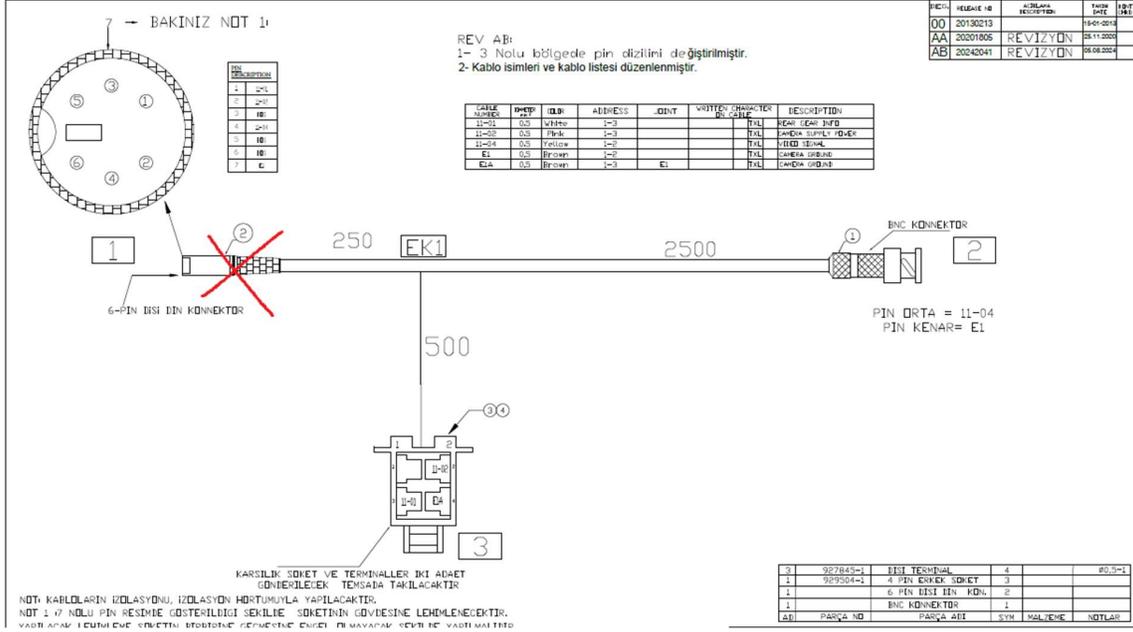
- Find the RP999155 cable on the device that connects to the camera, and disconnect the socket connection shown in the diagram between the RP999155 and HD554131Y 6 pin S-Video Connector.

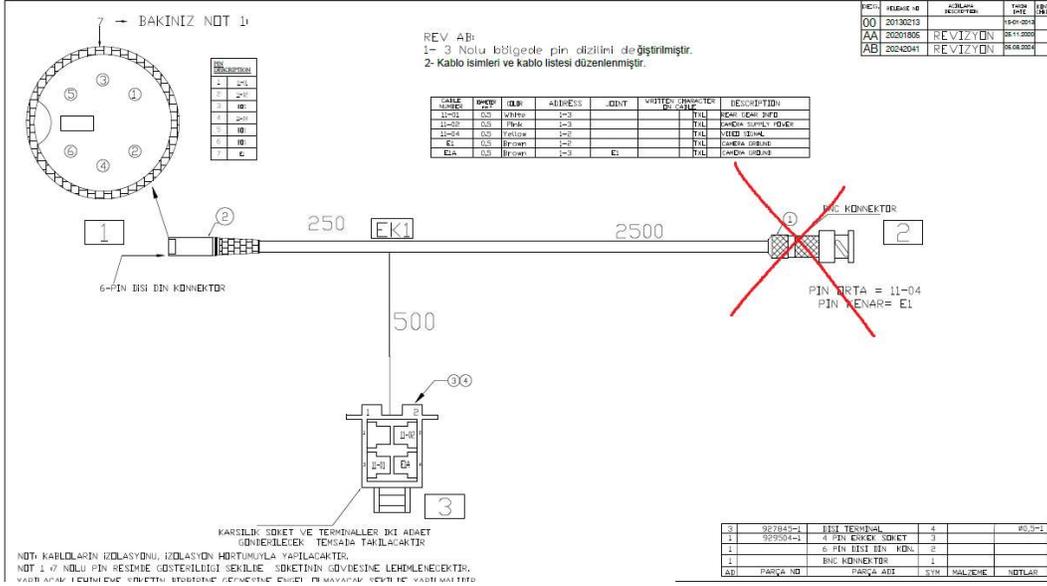
5. Disconnect the BNC socket from the Multiviu.

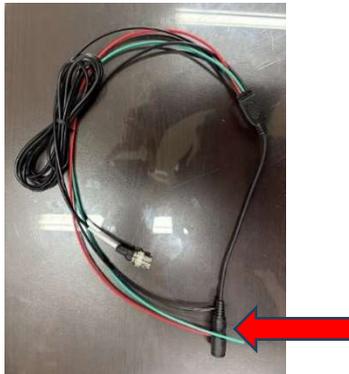
- Find the RP999155 cable on the device that connects to the camera. Connect the socket connection shown in the figure between the RP999155 and RP554159, 6 pin S-Video Connector.

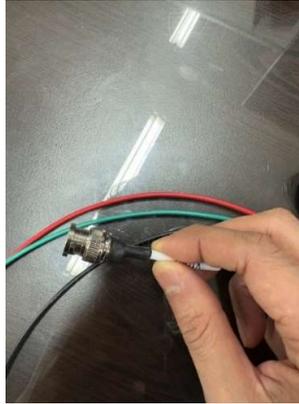
12. Connect the four-pin socket connection numbered 929504-1 of the installation numbered RP554159 to the socket numbered P9300.
13. Connect the BNC connector to the BNC input on the Multiviu (MVP12).

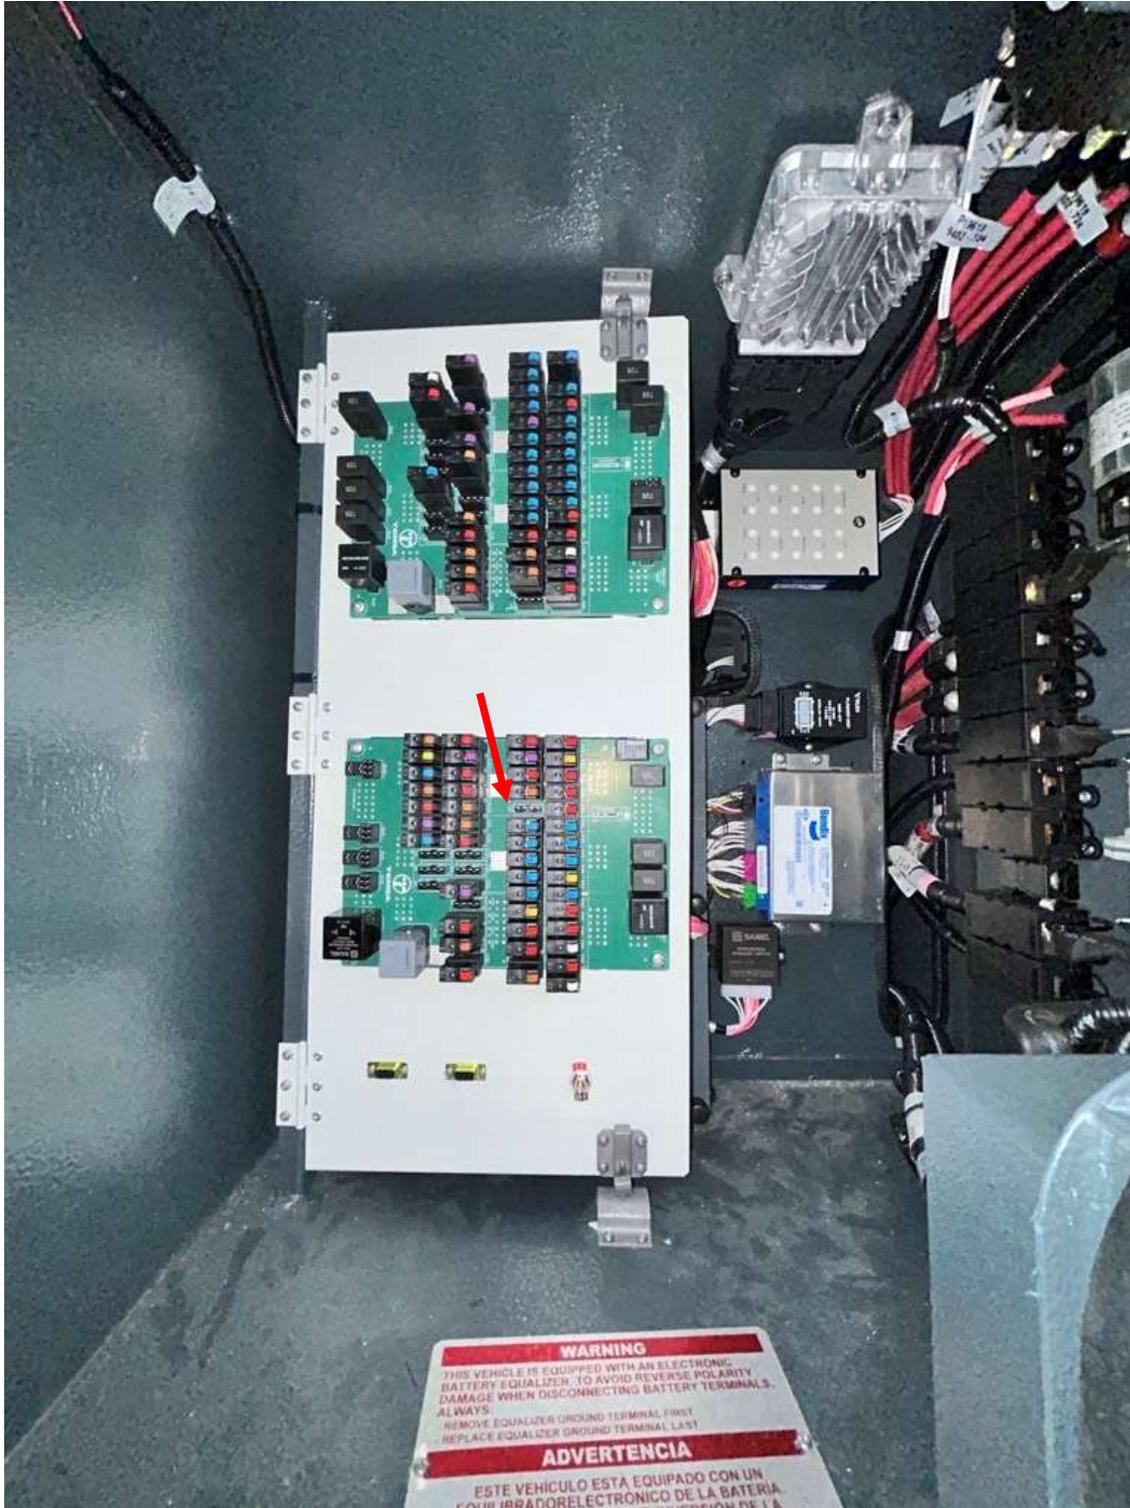
Front Relay Panel Image

14. Install the 9440-001Y numbered fuse with a value of 3A into the F110-numbered fuse slot on the 01A006-numbered fuse card located in the relay panel area.
