Subject: TS45 water leakage in the wiper hose connection hoses

Bulletin Type: Conditional Field Operations

Bulletin No: TS45-FC-2601

Description of the modification: This service bulletin has been prepared to prevent water leakage in the TS45 wiper hose connection hoses.

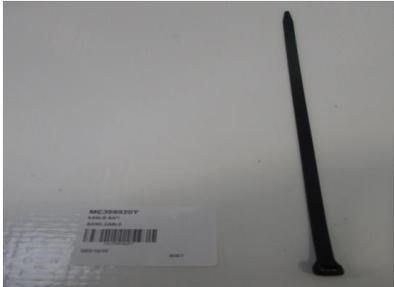
No	Part No	Part Name	Picture	Qty
1	MC398920Y	ZIP TIE

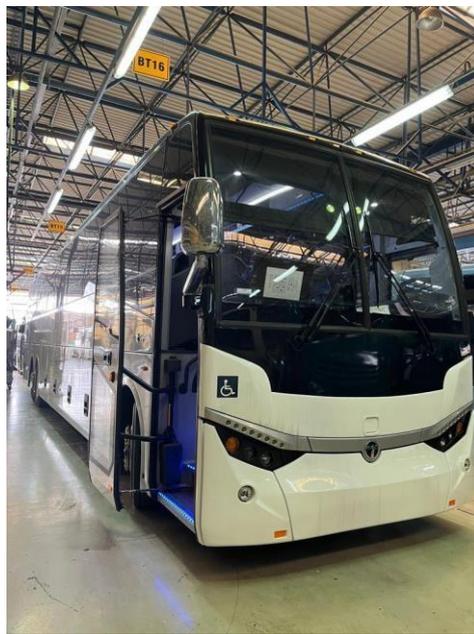
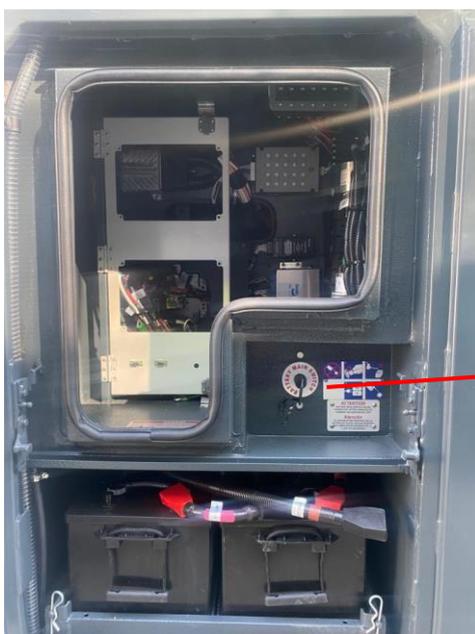
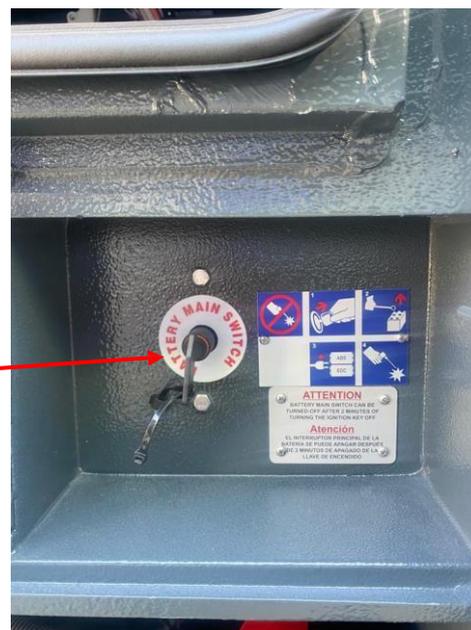
Figure-1

- a-Take the vehicle to the service and stop the engine,
- b-Before starting the process, be sure to turn off the vehicle switch. (See Figure-1).

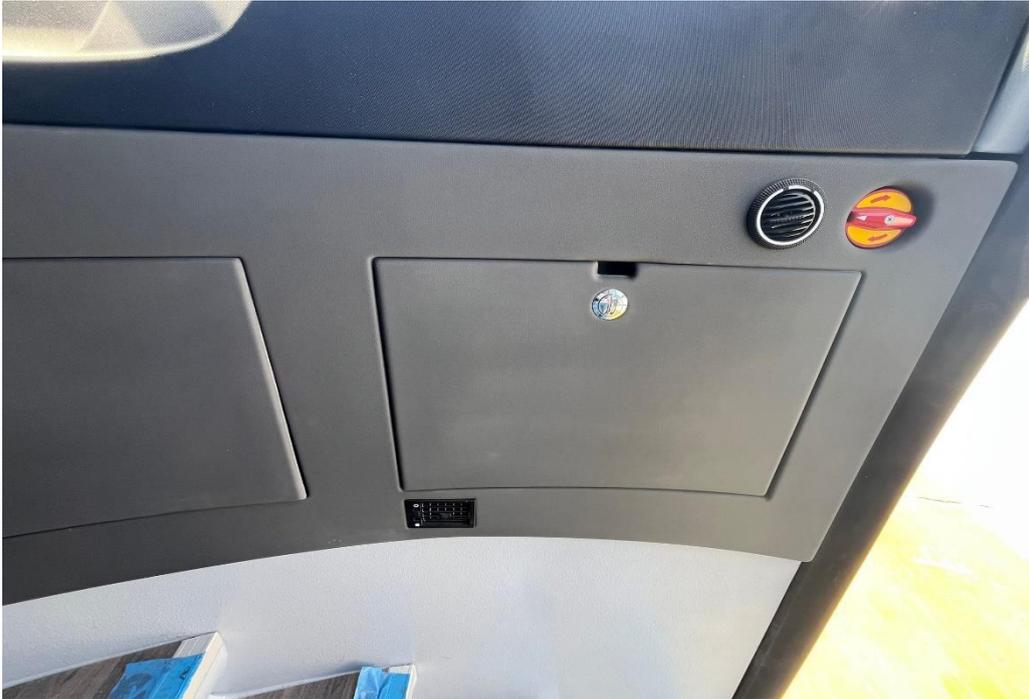
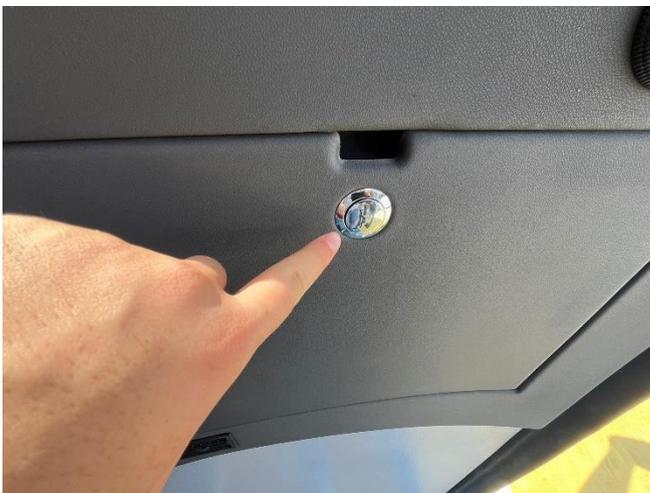
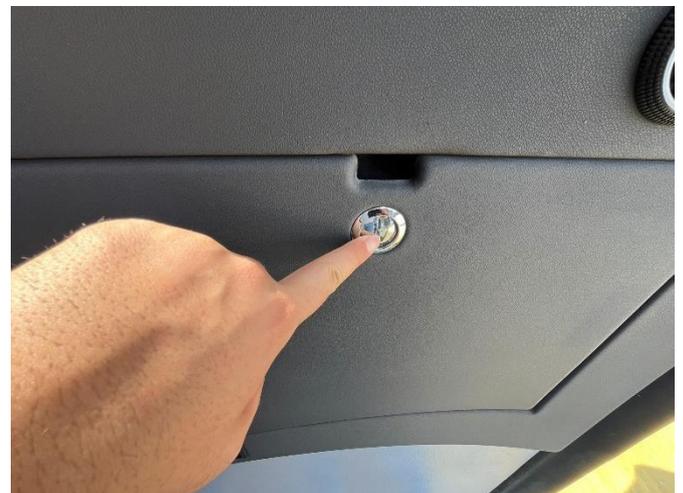
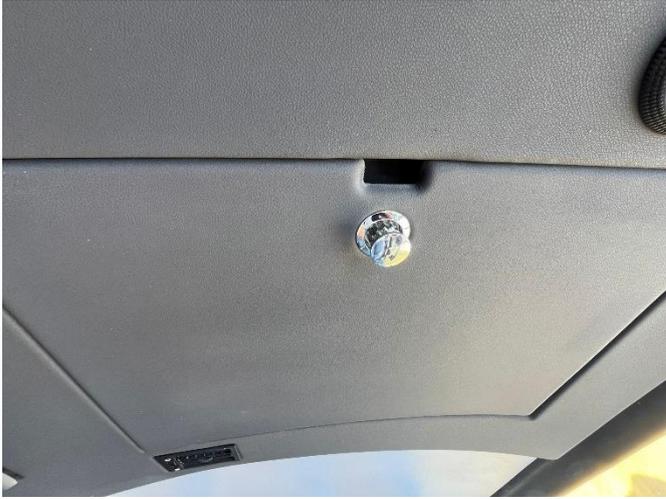
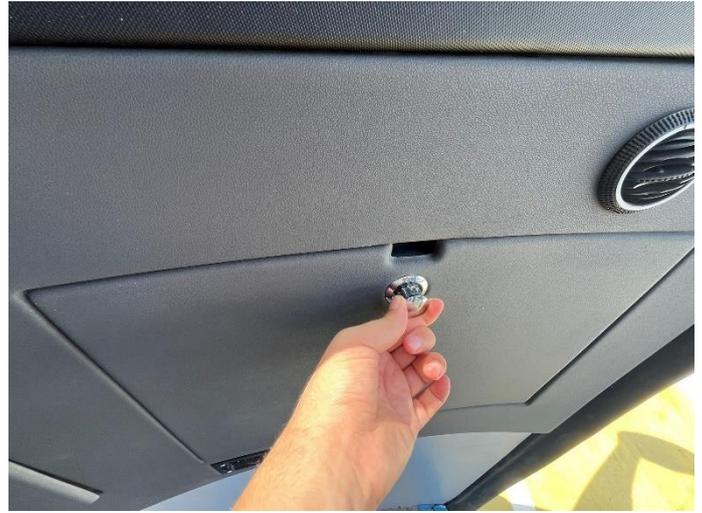
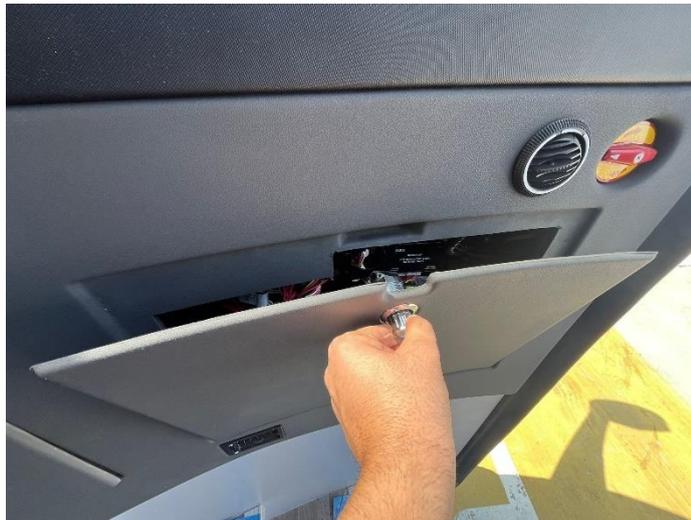
2. Open the right maintenance cover on the dashboard. (Pay attention to the tips below when opening the cover.) (See Figure-6-7-8-9-10-11).

- There is a lock mechanism on the maintenance cover. Press the lock mechanism. After pressing, the spring-loaded mechanism will pop out. Turn the mechanism to the right. Now open the maintenance cover.

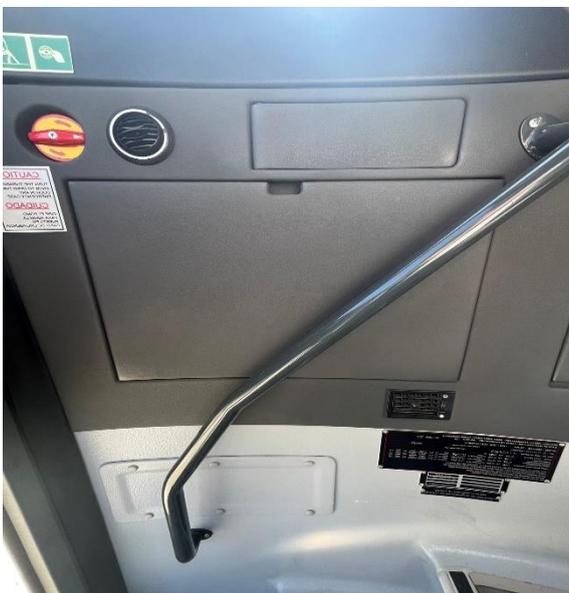
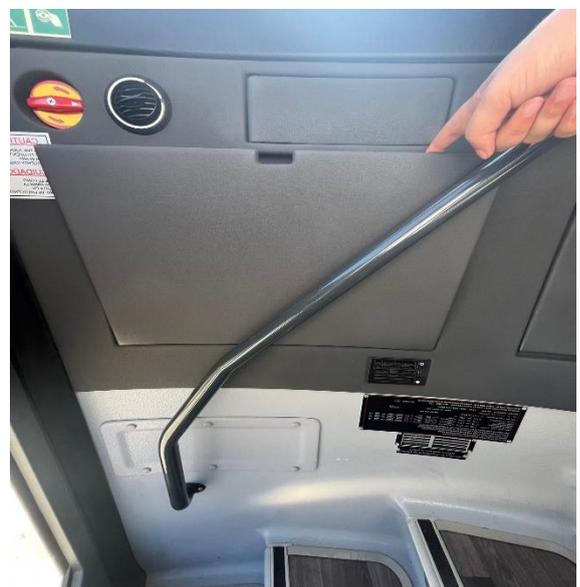
Note; Some vehicles have an old dashboard design, the maintenance cover will open by pulling it toward.

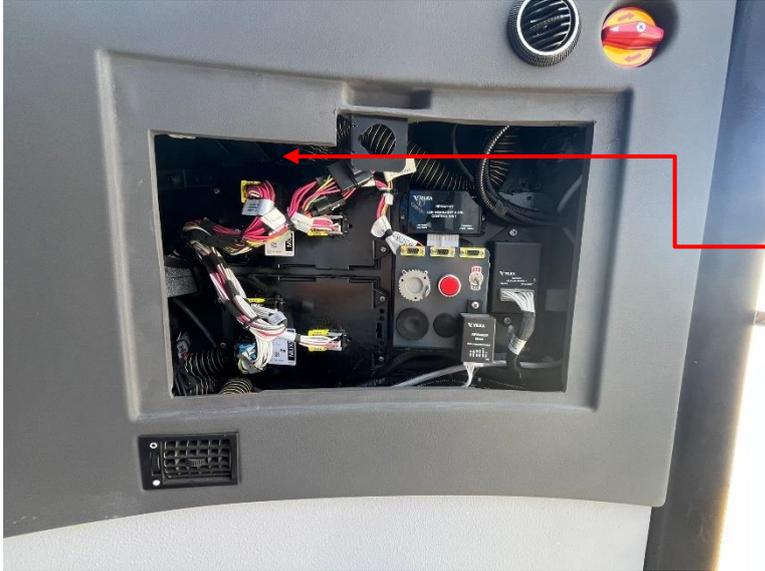
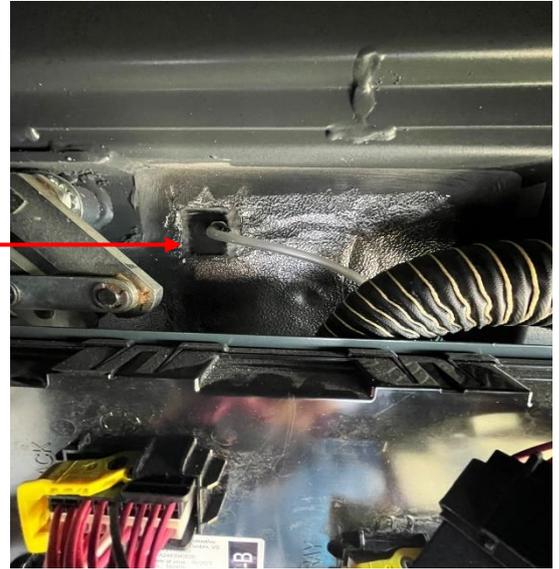
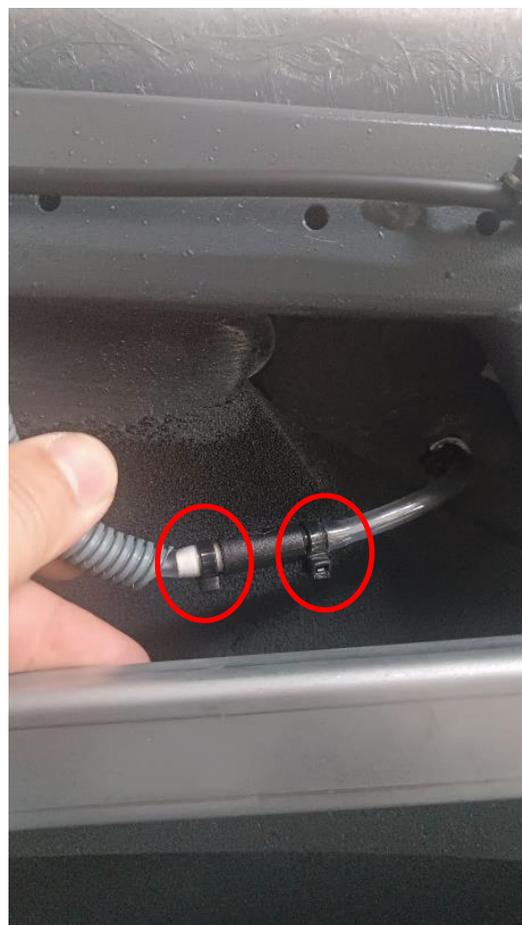
3: Determine the location of the wiper mechanism's connecting equipment. Apply zip ties to the connection equipment. (figure 12-13-14)

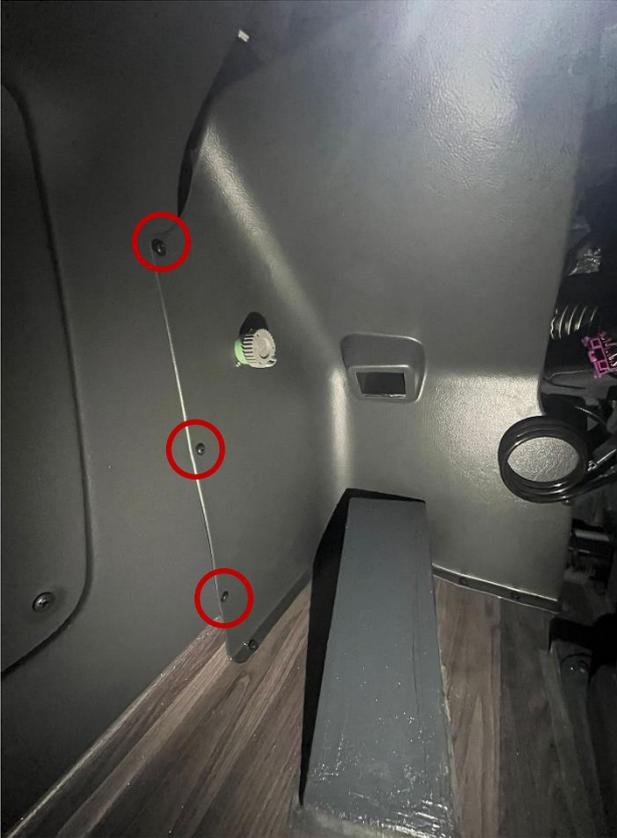
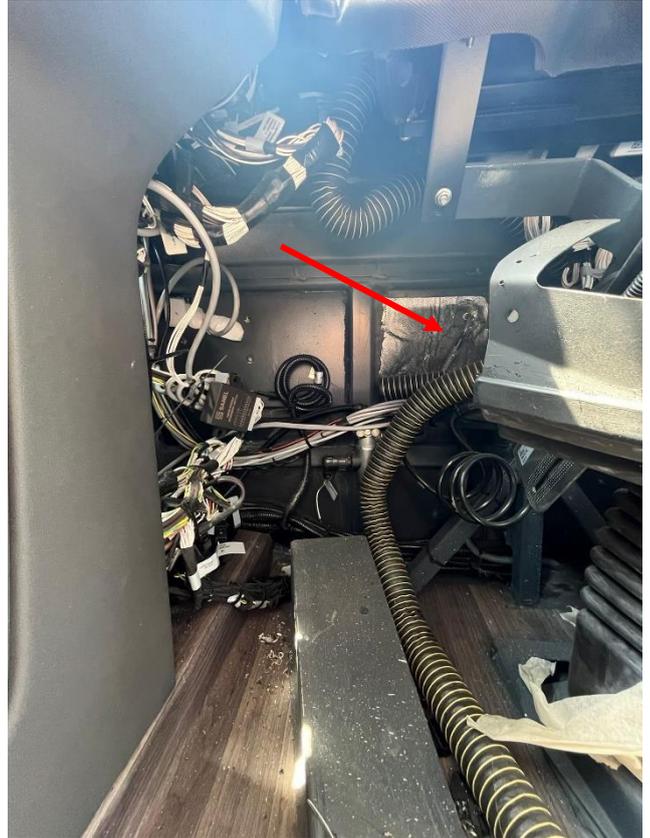
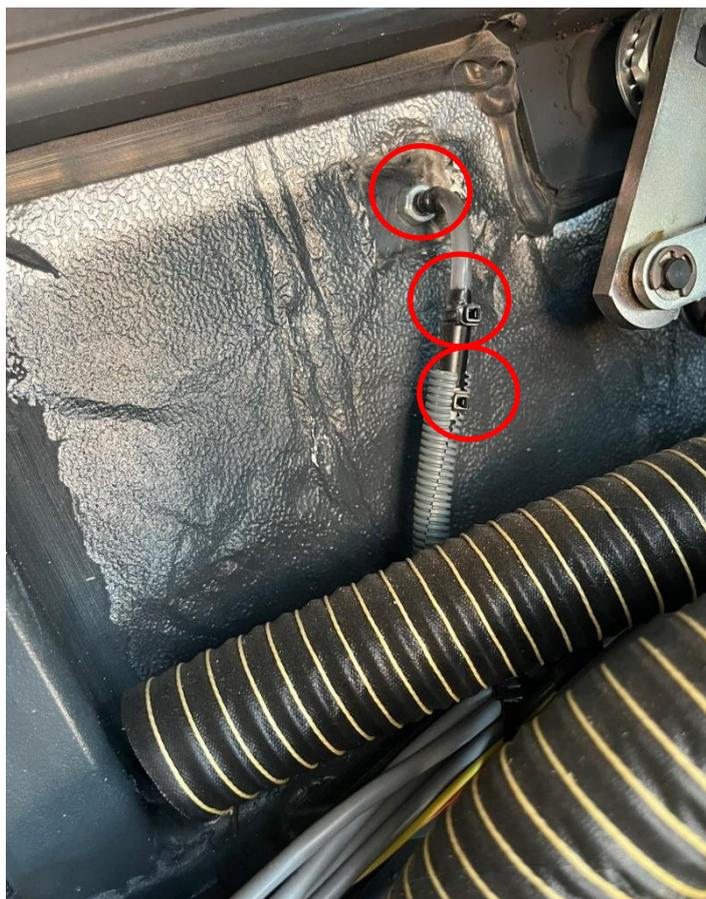
4. Remove the cover parts located in the driver's area. Identify the location of the wiper mechanism's connection equipment. Apply zip ties to the identified parts. After application, reassemble the parts in the order they were removed. (See Figure-15-16-17).
