# Technical Service Bulletin

CHECK ENGINE LIGHT ON WITH DTC P0126:00

Bulletin No.: 01-001/26

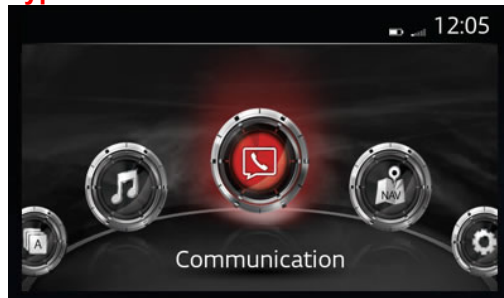
**Type A:**

**NOTE:** 2020 CX-5 with **Type B** Mazda Connect (7th Gen Infotainment) use MDARS and models with **Type A** Mazda Connect (6th Gen Infotainment) use IDS.

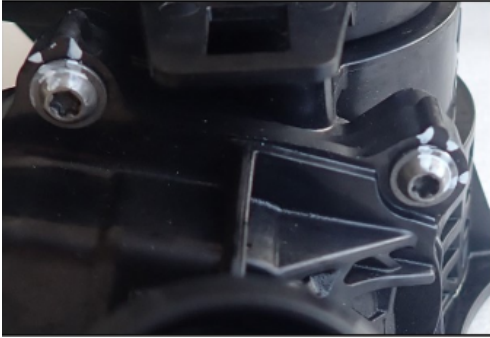
**Marking Example 1:** Draw marking lines over the screws and the thermostat cover as shown above.

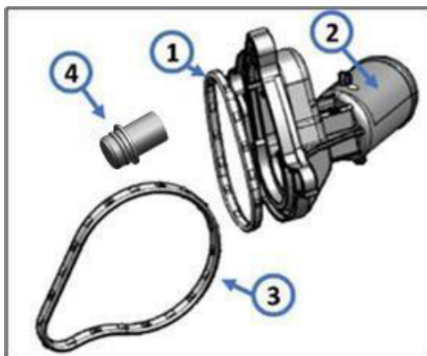
**Dummy Plug for CCV set includes:**

1. Thermostat cover gasket\*
2. Thermostat cover
3. Water outlet gasket
4. **Dummy** Plug

\*Thermostat cover gasket is already assembled to the thermostat cover.

Fig. 2: Correct dummy plug (4) orientation to the thermostat cover (2).
