Subject: CRACK IN DOOR SIDE OF FRONT SEAT CUSHION TRIM	Bulletin No.: 09-004/26
	Last Issued : 01/12/2026

2023-2025 CX-50 (with Leather/ Leatherette Front Seat) with VINS lower than 7MMVA*****333832 (produced before November 16, 2024)

2025 CX-50 Hybrid (with Leather/ Leatherette Front Seat) with VINS lower than 7MMVA**W***104340 (produced before November 16, 2024)

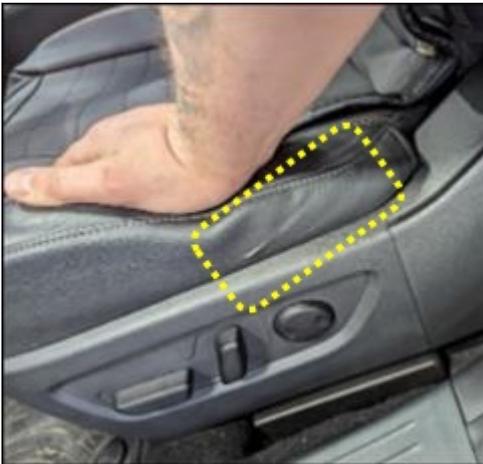
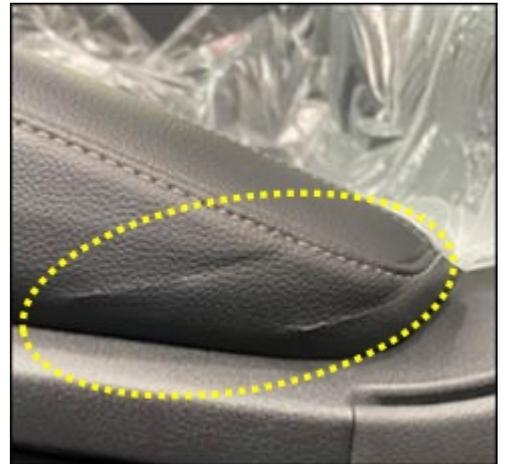
Sample Pictures:

Cracks develop along the areas where wrinkles form when weight is applied to the seat.

When exiting the vehicle, the door-side surface of the cushion trim may be folded and compressed. When entering the vehicle, the surface of the cushion bolster may be rubbed and stretched. Repeated occurrences of these conditions may result in a crack forming in the surface of the seat cushion trim. To eliminate this concern, the material of the door-side surface of the front seat cushion trim has been modified to improve tear strength and scratch resistance. Customers having this concern should have their vehicle repaired using the following repair procedure.

1. Verify the customer concern.
2. Replace the front seat cushion(s) with a modified one(s) according to the following repair procedure.

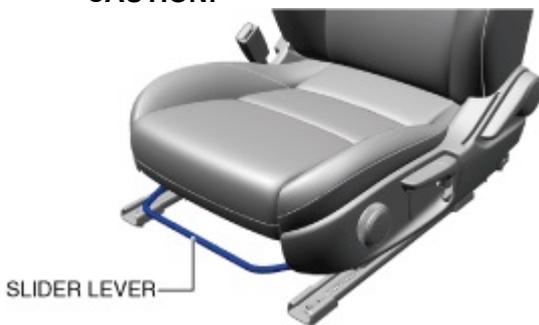
- After removing the front seat, do not operate the slider lever.
- After the front seat has been removed, if the slider lever is operated and the front seat is reinstalled with the left/ right slide positions deviated, the adjuster unit could be damaged.
- Verify that there are no malfunctions in the forward/back slide of the seat and in the adjuster unit after installing a front seat.

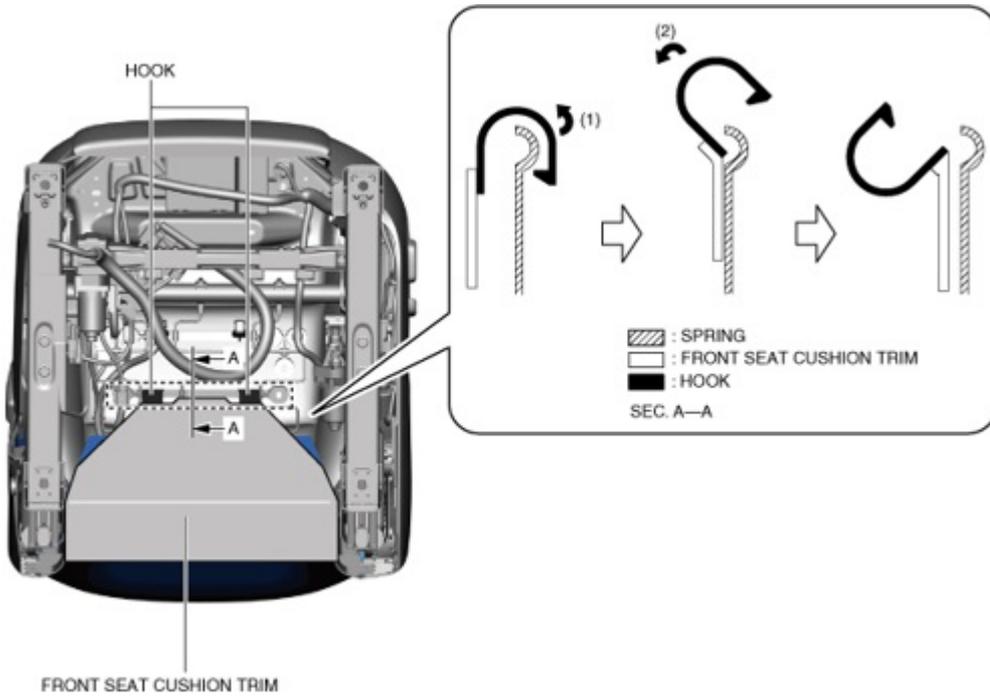
i. Move the hooks in the order of arrows (1) and (2) shown in the figure to detach the hooks from the springs.

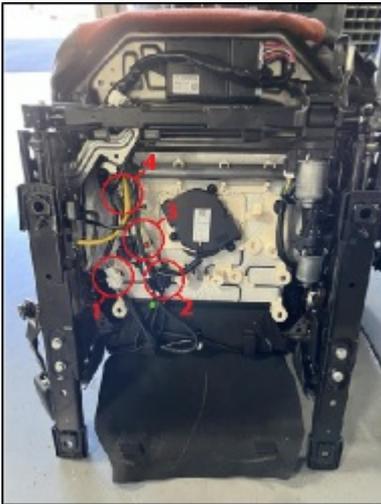
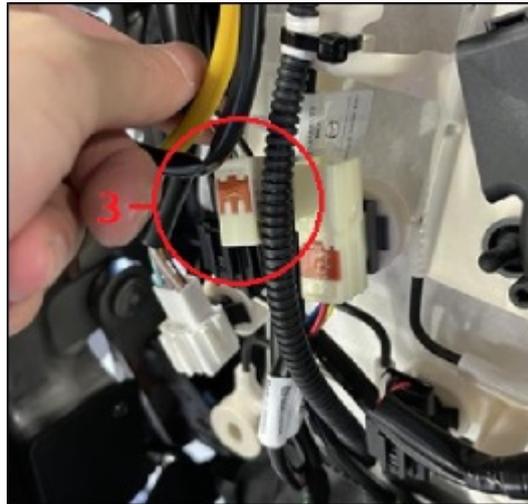
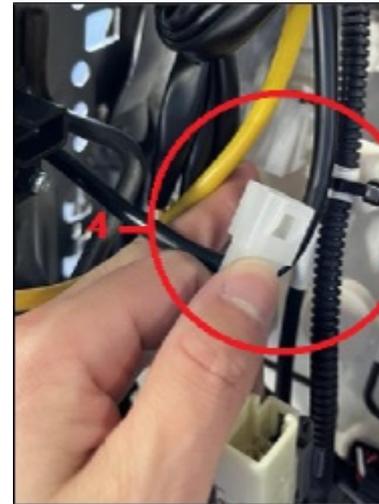
j. Disconnect the connectors shown below.

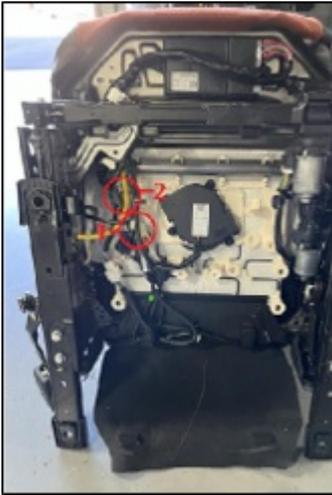
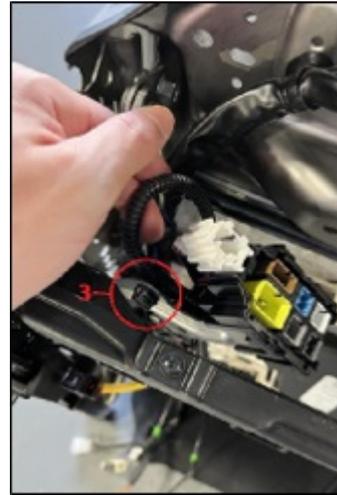
k. Remove the wiring harness clips.

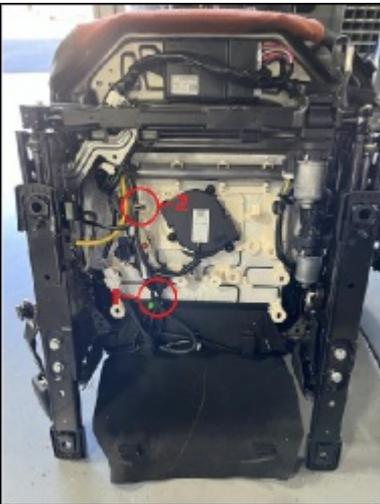
l. Cut the bands.

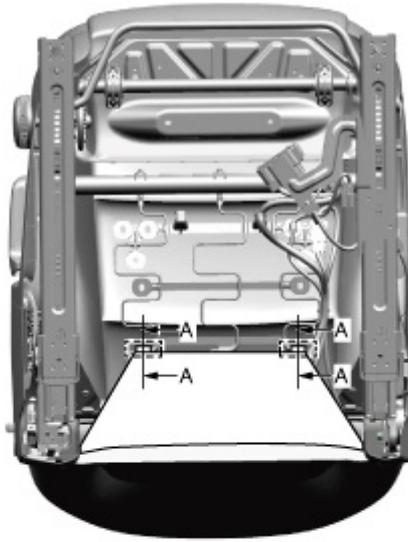
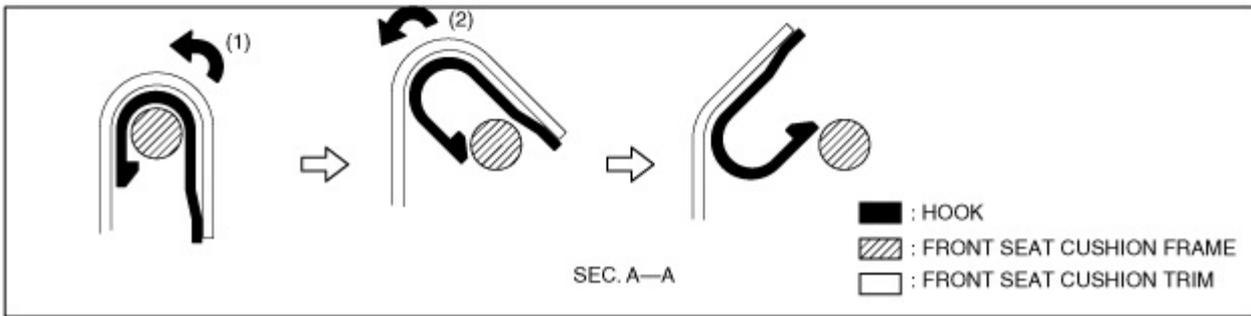
m. Move the hooks in the order of arrows (1) and (2) shown in the figure to detach the hooks from the front seat cushion frame.

□ : HOOK

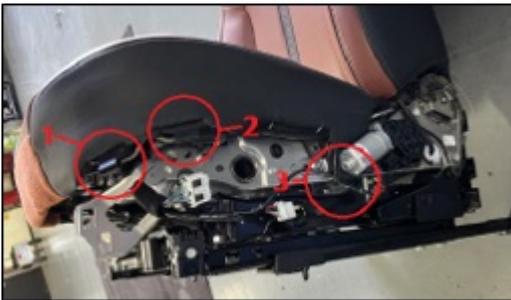
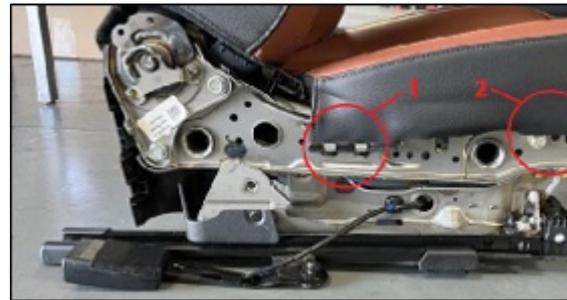
n. Disconnect hooks between the seat cushion and the seat frame as shown below.

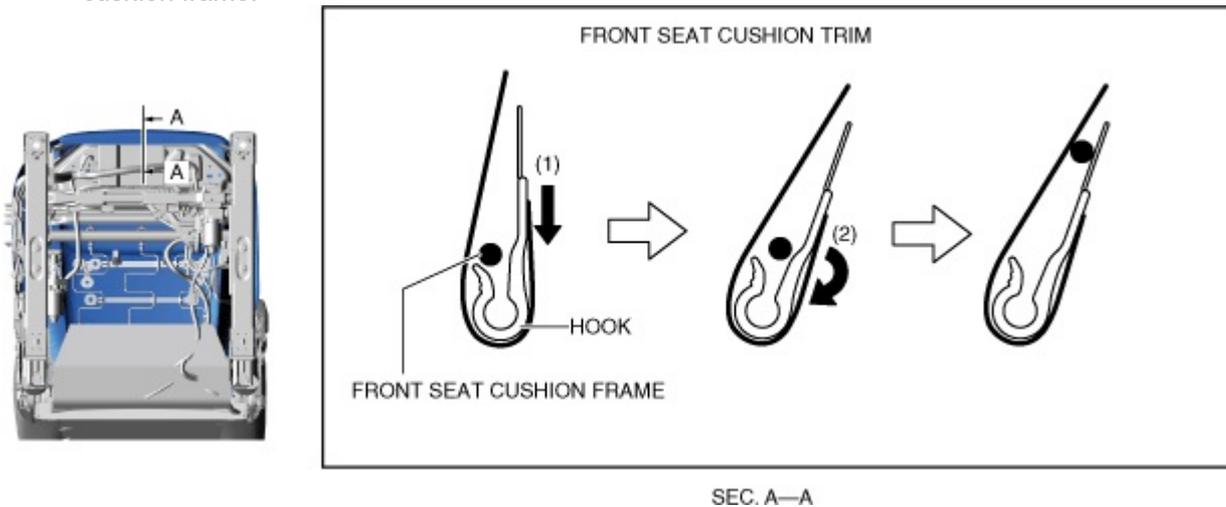
- o. Move the hooks in the order of arrows (1) and (2) shown in the figure to detach the hooks from the front seat cushion frame.

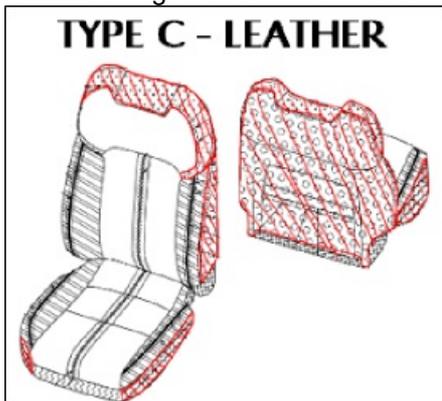
NOTE: DO NOT use the steam iron on areas made of leatherette (red areas in the image below) or the trim will be damaged and will not be covered under warranty.

If the new leather seat trim has wrinkles, see TSB 09-001/26 - WRINKLES ON LEATHER SEAT SURFACE OF NEW (UNSOLD) VEHICLE OR ON NEW UPHOLSTERY UNDER WARRANTY REPAIR for the procedure to remove the wrinkles.
