Technical Service Bulletin

Topic	Electronic Parking Brake (EPB) functionality issues
Market area	Bentley: worldwide (2WBE), China 759 Audi China Beijing (6759), China 796 VW Import Comp. Ltd (Vico), Beijing (6796)
Brand	Bentley
Transaction No.	2062184/10
Level	EH
Status	Released for publishing
Release date	Jan 27, 2026

Continental GT/GTC and Flying Spur

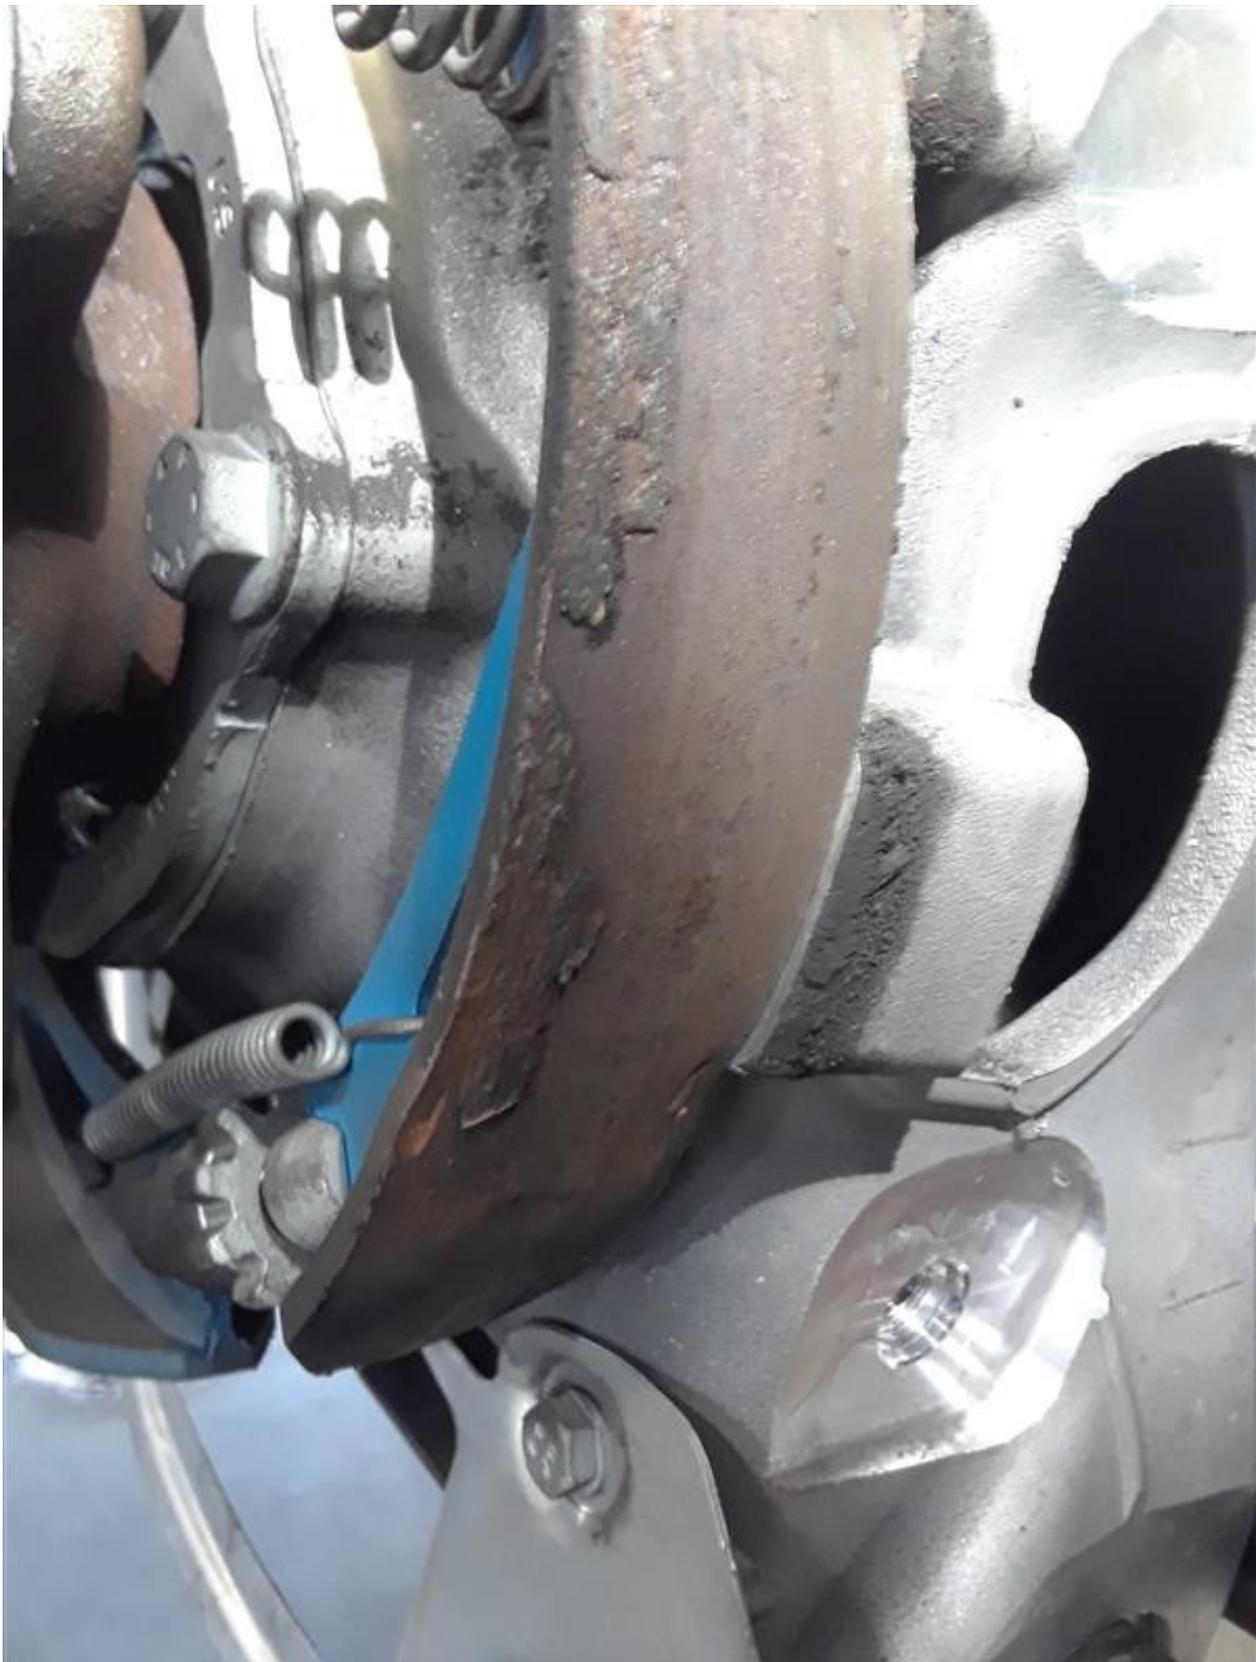
- Right and left hand (EPB) Actuators
- Right and left hand rear brake shoes (EPB) - See example shown in Figure 2

2. Clean the brake shoes (EPB)

- a. Remove the brake callipers as per ElsaPro repair group 43 (do not disconnect hydraulic lines unless required).
- b. Remove the EPB brake shoes from the calliper. Refer to ElsaPro Repair Group 43.
- c. Inspect shoes for contamination (dust, debris, corrosion).
- d. Clean the shoe surfaces and the EPB mechanism using a suitable brake cleaner.
- e. Ensure all sliding surfaces are free from corrosion and move freely.
- f. Reinstall or replace shoes if worn beyond specification.

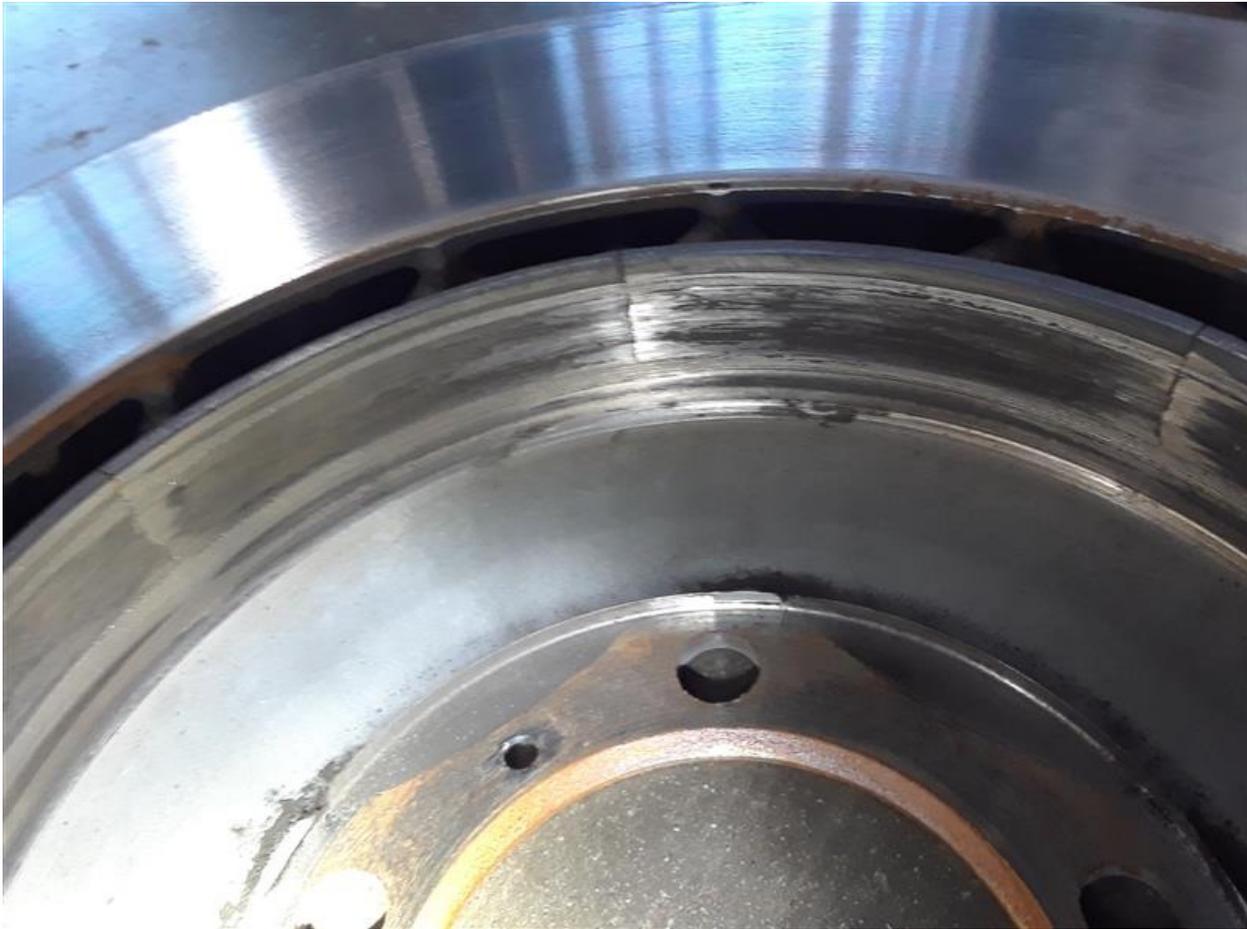
- Right and left hand rear brake discs - See example shown in Figure 3

- If there is no damage, refer to steps 2-5 below.
- If damage is identified, raise a full DISS technical query and include all information outlined in Step 6.
