24KWE: Kongsberg Automotive Right-Hand Shift Stalk

24KWE NHTSA: 24V190 / Transport Canada: 2024-161

24PBE: Kongsberg Automotive Right-Hand Shift Stalk

24PBE NHTSA: 24V190 / Transport Canada: 2024-161

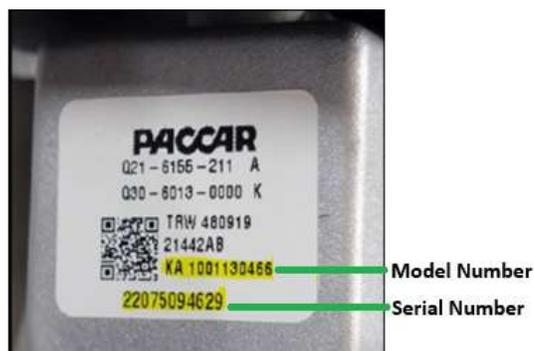
- Serial number into the Causal Part Serial Number field
- Model number into the Causal Part Model Number field

Right-hand shift stalk part/serial number label

- Once the upper and lower steering column covers are removed, you **MUST** take a **CLEAR** photo of the part label showing the model and serial numbers of the old part. This is required to be attached to the Claim Unit for reimbursement consideration. Claims filed without this photo may be denied.

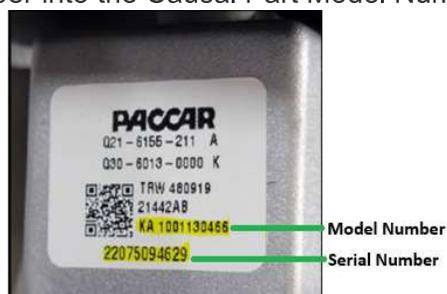
Right-hand shift stalk part/serial number label

- Once the upper and lower steering column covers are removed, you **MUST** take a **CLEAR** photo of the part label showing the model and serial numbers of the old part. This is required to be attached to the Claim Unit for reimbursement consideration. Claims filed without this photo may be denied.
