# 24KWE: Kongsberg Automotive Right-Hand Shift Stalk

24KWE NHTSA: 24V190 / Transport Canada: 2024-161

# 24PBE: Kongsberg Automotive Right-Hand Shift Stalk

24PBE NHTSA: 24V190 / Transport Canada: 2024-161

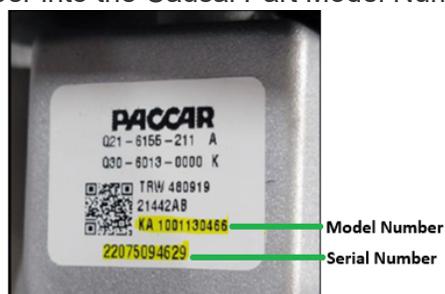
*Right-hand shift stalk part/serial number label*

- **0.4 hours** to inspect the right-hand shift stalk for the affected part number, R&R shift stalk with part number **Q21-6124-217**, attach connector photos, and dispose of the old shift stalk per bulletin procedures. Use Recommended Repair Code **24PBEF**.
- **0.4 hours** to inspect the right-hand shift stalk for the affected part number, R&R shift stalk with part number **Q21-6124-213**, attach connector photos, and dispose of the old shift stalk per bulletin procedures. Use Recommended Repair Code **24PBEG**.
- **You must enter all the following information from the as-installed right-hand shift stalk into the warranty claim:**
  - Serial number into the Causal Part Serial Number field
  - Model number into the Causal Part Model Number field

- Once the upper and lower steering column covers are removed, you **MUST** take a **CLEAR** photo of the part label showing the model and serial numbers of the old part. This is required to be attached to the Claim Unit for reimbursement consideration. Claims filed without this photo may be denied.
