Technical Service Bulletin

GROUP	NUMBER
CAMPAIGN	26-01-003G
DATE	MODEL(S)
JANUARY 2026	GV70 (JK1) GV80 (JX1) GV80 COUPE (JX1)

SUBJECT: LOOSE WINDSHIELD GLASS GARNISH SEAL
(SERVICE CAMPAIGN T84G)

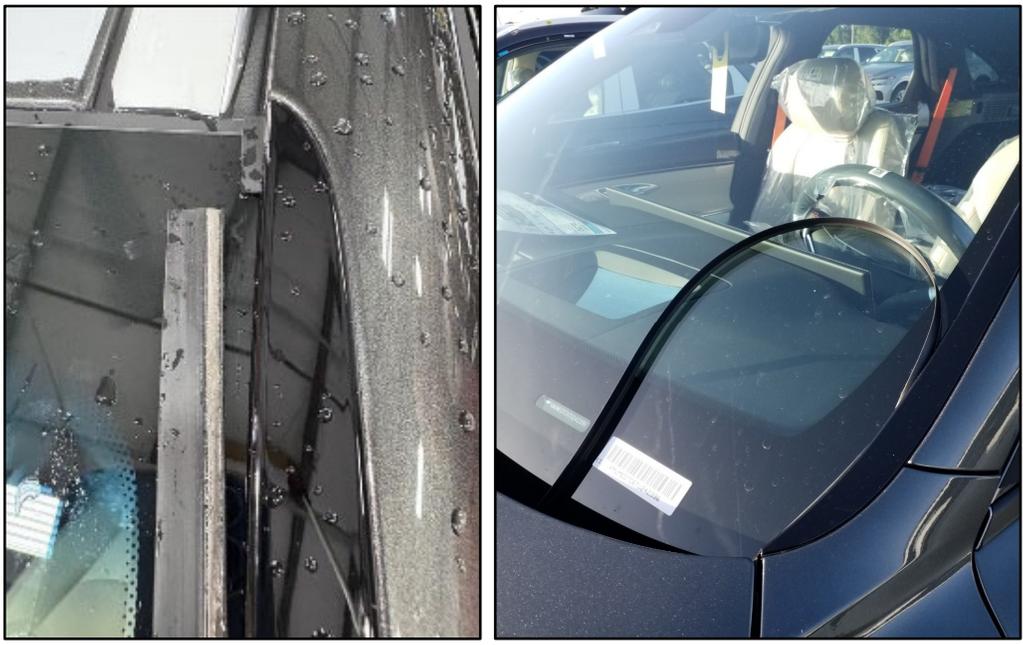
Description: Certain GV70 (JK1), GV80 (JX1), and GV80 Coupe (JX1) vehicles may exhibit a loose windshield glass garnish seal. This bulletin provides instructions to remove the old garnish and install new parts.

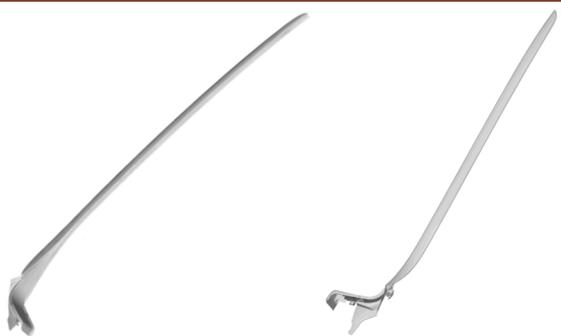
Model	Part Name	Part Number	Figure
GV70 (JK1)	Garnish Assy – Windshield Glass Kit	86130-AR400QQH

GV80 & GV80 Coupe (JX1)		86130-T6400QQH

NOTE: 1 kit contains both garnishes for each side.

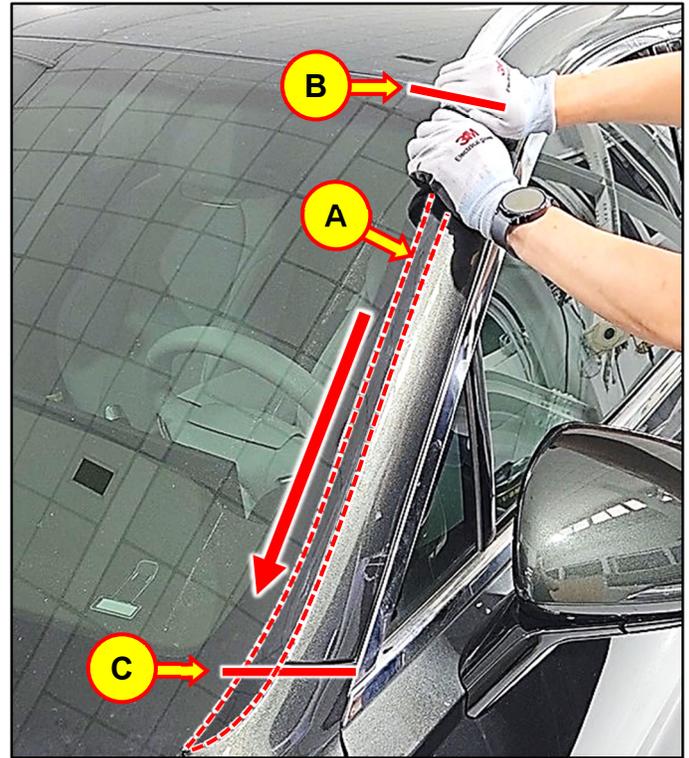
1. Lift the windshield glass garnish (A) to separate the clips, starting at the top of the windshield (B). Continue lifting the garnish towards the bottom of the windshield (C).

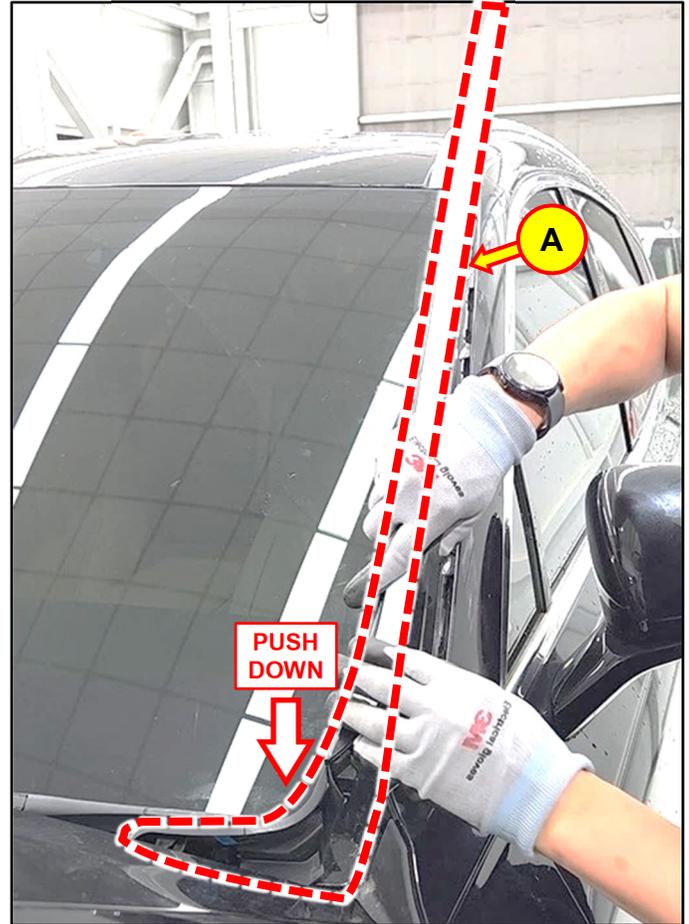
2. Push the lower end of the garnish downward to separate it from the cowl top cover and remove it from the vehicle.

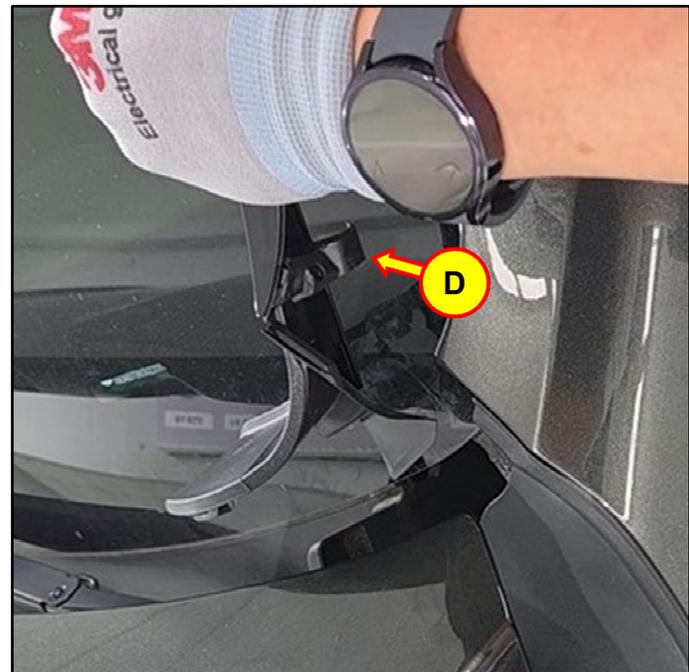
Ensure that the locking tab (D) at the bottom of the garnish is fully disconnected before removing the garnish from the vehicle.

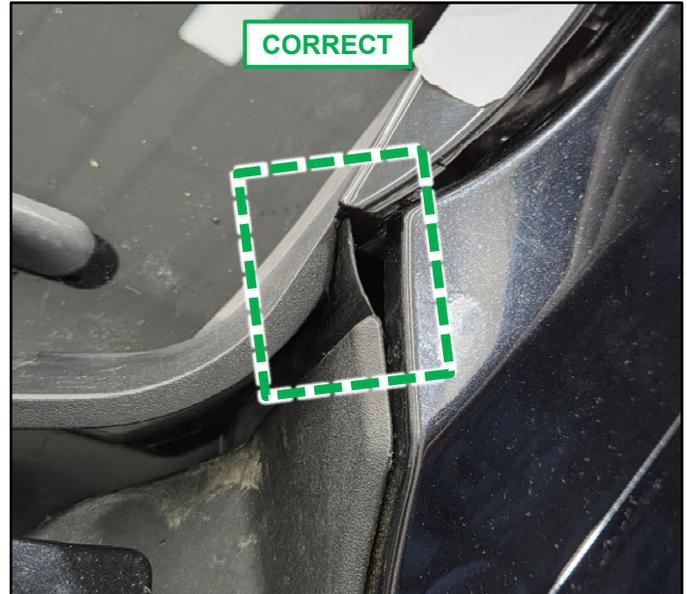
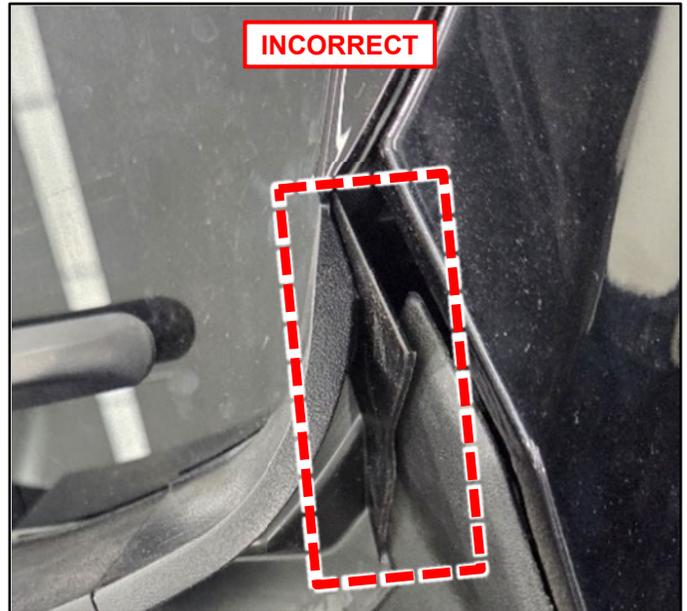
3. Install the new windshield glass garnish in the reverse order of removal.

Refer to the photos for examples of correct and incorrect installation:

- **CORRECT:** Lower end of garnish is inserted between the cowl top cover and fender panel.
- **INCORRECT:** Lower end of garnish is **NOT** inserted between the cowl top cover and fender panel.

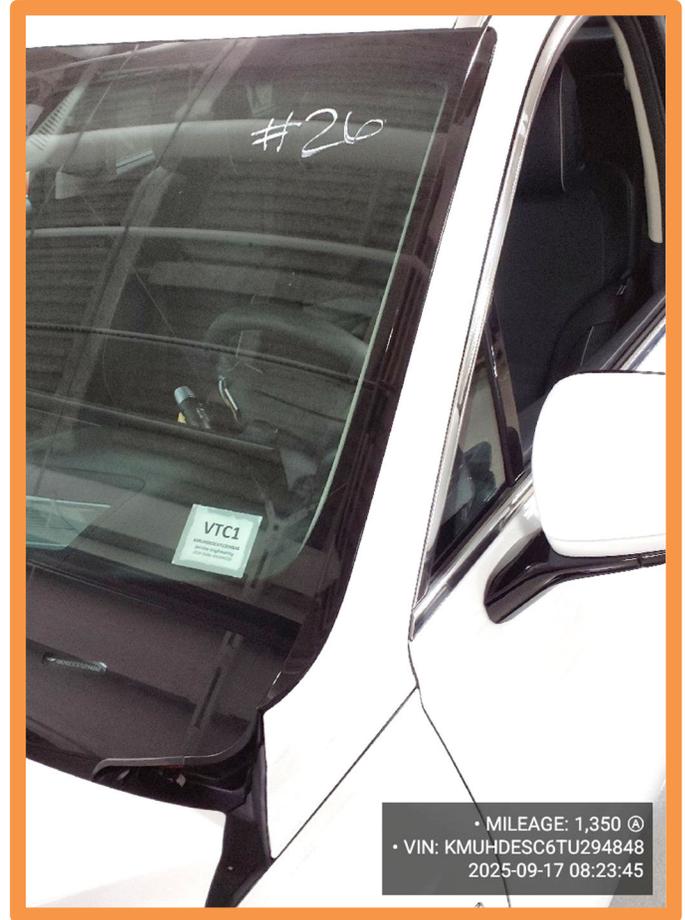
Using the STUI camera function, take a photo of the new windshield glass garnish installed on the vehicle.

Upload the photo to STUI.

NOTE: If the STUI camera function is **NOT** used, write the last 6 digits of the VIN and date of repair on a piece of paper to include in the photo.
