To: After Sales Official Network
Subject: E-Gear Paddles shift verification
Date: 19/01/2026
Pages: 5

Campaign code:
L634-A.04.26

Campaign name:
E-Gear Paddles shift verification

Model:
Temerario

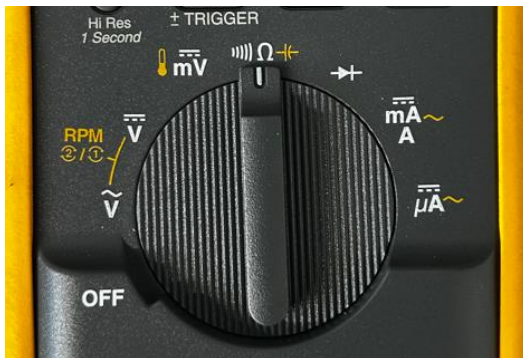
4. Take a multimeter and set it to resistance measurement (Ohm) and perform the following measurements.
