January 21, 2026

Seat Belt Reminder System Not Operating Properly

Year	Model	Trim Level	VIN Range
2023–24	Pilot	ALL	ALL
2025	Pilot	ALL	5FNYG1...SB000001 thru 5FNYG1...SB180976

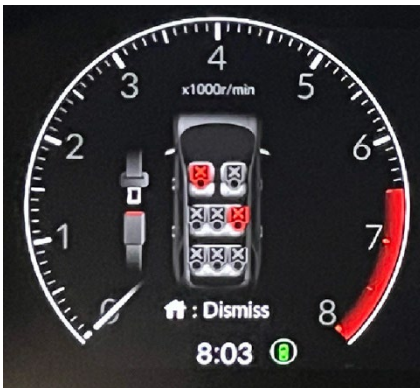
Red

1. Confirm on the driver-information interface that the seat belt reminder illuminates red or grey when the second-row right passenger's seat belt is fastened:
 1. Turn the vehicle to the **ON** mode.
 2. Fasten the second-row right passenger seat belt.
 3. Does the seat belt reminder illuminate **RED** or **GRAY**?
 - **YES** - Proceed to REPAIR PROCEDURE.
 - **NO** - Wiggle and twist the fastened seat belt buckle assembly while checking the seat belt reminder.
 - If the seat belt reminder stays **GREEN**, no repair is needed. Continue with normal troubleshooting.
 - If the seat belt reminder flickers intermittently, proceed to REPAIR PROCEDURE.
