Eliminating Symptoms on Body Exterior: Cleaning Tailpipe Cover(s) on Exhaust System - Dirt on Tailpipe Cover (SY 08/11)

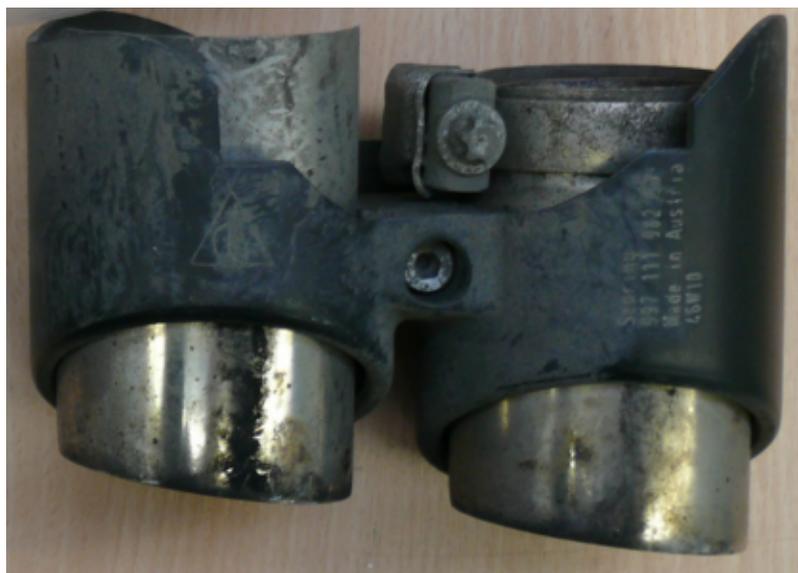
Sample illustration

Tailpipe trim(s) on exhaust system are dirty.

There is a possibility that dirt on the tailpipe trim(s) may be mistaken as corrosion.

The tailpipe covers on the exhaust system are sealed with a **Nano coating**.

⇒ In the event of a complaint relating to **dirty tailpipe covers**:

- **Clean off** loose dirt using **clean water** and a clean **sponge** and then
- Polish the tailpipe covers using a clean cloth and suitable **Porsche paint polish**.

⇒ **The tailpipe covers on the exhaust system must not be replaced because they are dirty.**
