# TECHNICAL SERVICE BULLETIN

## MIL ON WITH DTCS P05D8 AND P05D9 STORED IN THE ECM

**APPLIED VEHICLES:** 2024-2025 Rogue (T33)  
**APPLIED DATES:** VINs starting with 5N1 built on or before January 21, 2025  
VINs starting with JN8 built on or before November 17, 2024  
**APPLIED ENGINES:** KR15DDT

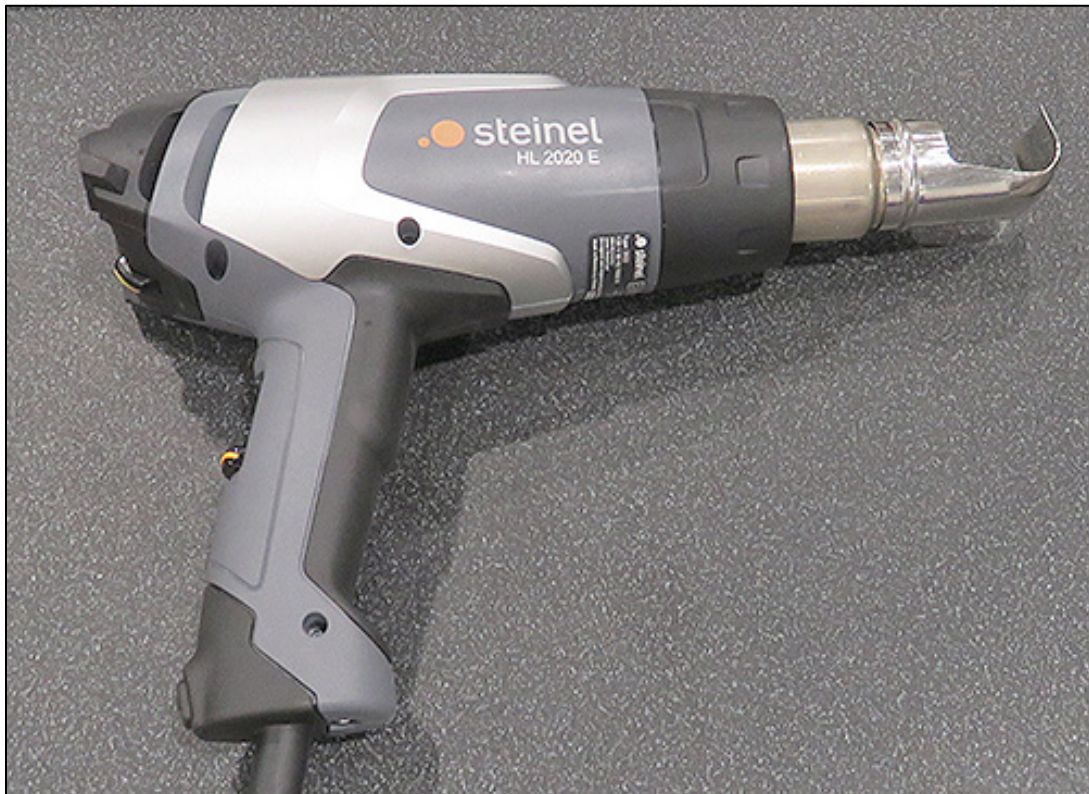
Figure 1

### HL2020E Heat Gun (NI-53359)

12. Install the solder sleeve connector by shrinking it to the wire with essential tool HL2020E Heat Gun (NI-53359) or equivalent flameless heating tool (place attachment nozzle 5 onto the HL2020E Heat Gun).
  - Set the HL2020E Heat Gun airflow setting to 2 and the temperature to 450 degrees Fahrenheit (232 °C).

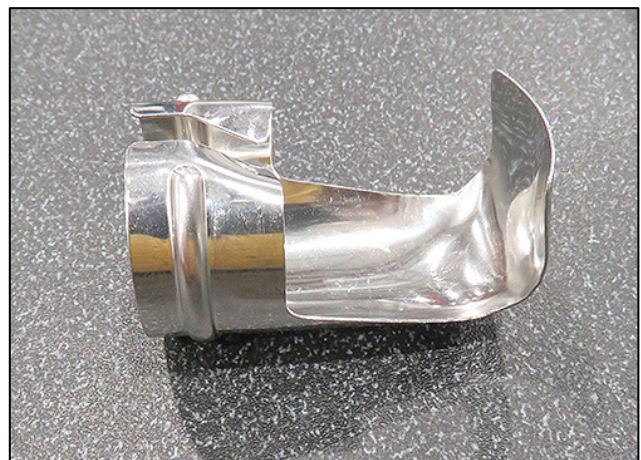
Figure 2

- #5 Adapter, from heat gun kit (Figure 2).

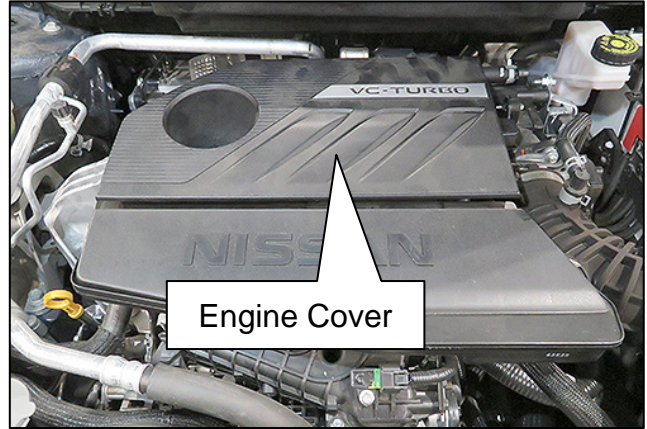
Figure 3

1. Open the vehicle hood and remove the Engine Cover.

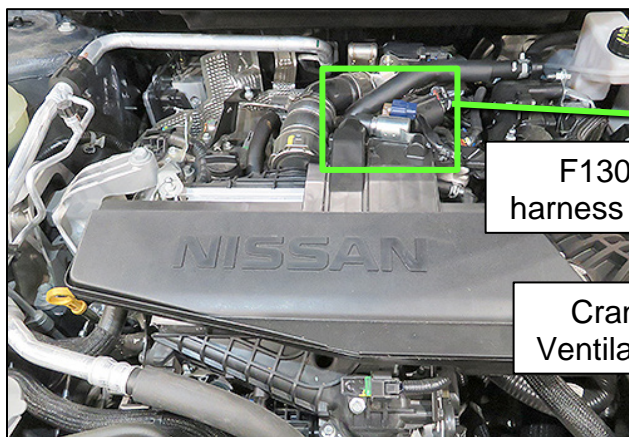
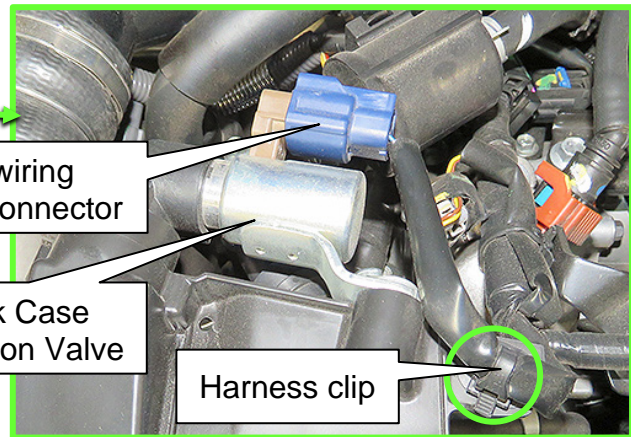
2. Disconnect the F130 wiring harness connector from the Crank Case Ventilation Valve, and then detach the associated harness clip.

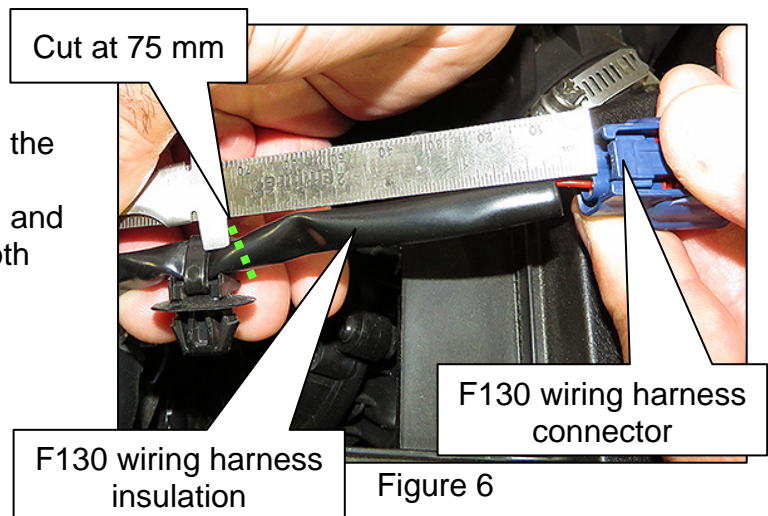
Figure 6

3. Measure 75 mm of harness from the end of the F130 wiring harness connector, as shown in Figure 6, and cut through the insulation and both wires.
  - Save the harness insulation (covering) from the removed portion of the harness.

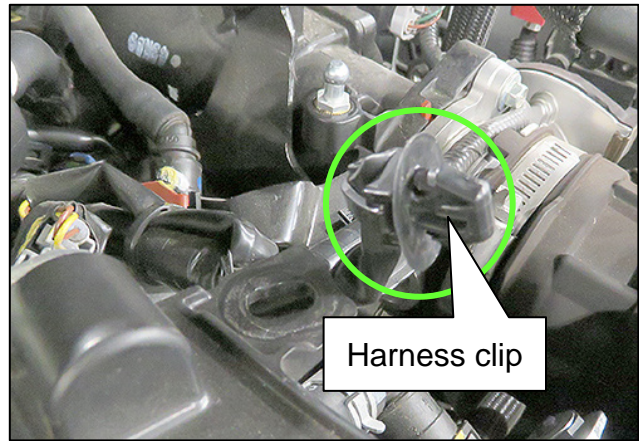
Figure 7

4. Remove the old harness clip from the severed wiring harness.

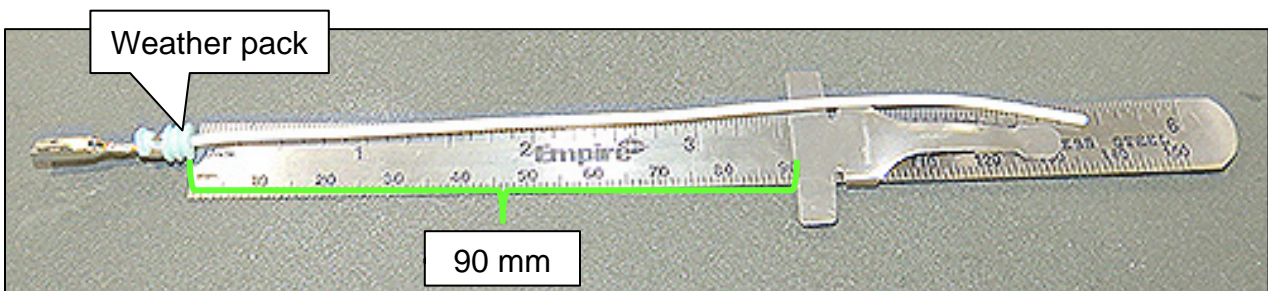
Figure 8

5. Cut the two (2) repair kit wire lengths to 90 mm (Figure 8).
  - Measured from end of weather pack.

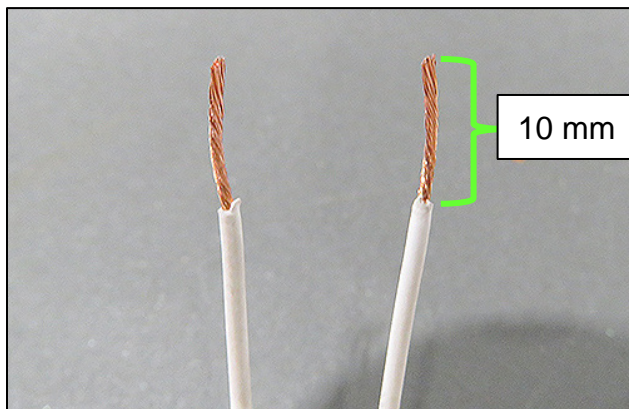
Figure 9

6. Cut the harness insulation down the middle approximately 50 mm, where shown in Figure 10.
7. Remove approximately 10 mm of insulation from the four (4) wires that are to be joined (Figure 9 and Figure 10).

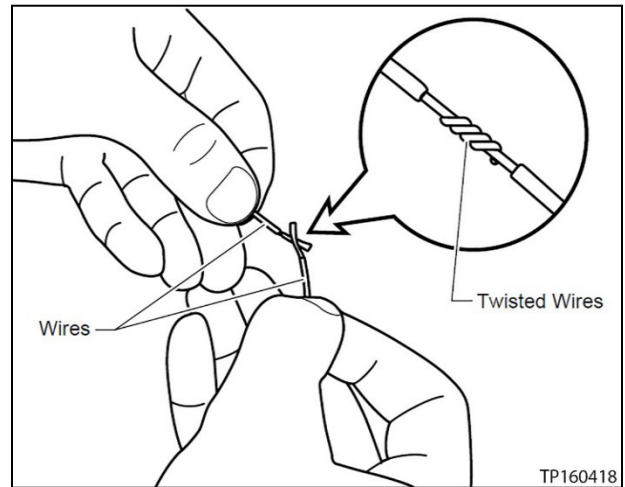
9. Twist the new harness connector wire (with solder sleeve) together with one of the F130 wiring harness wires that was stripped in step 7.
  - Refer to Figure 11 for an example of twisting wires.

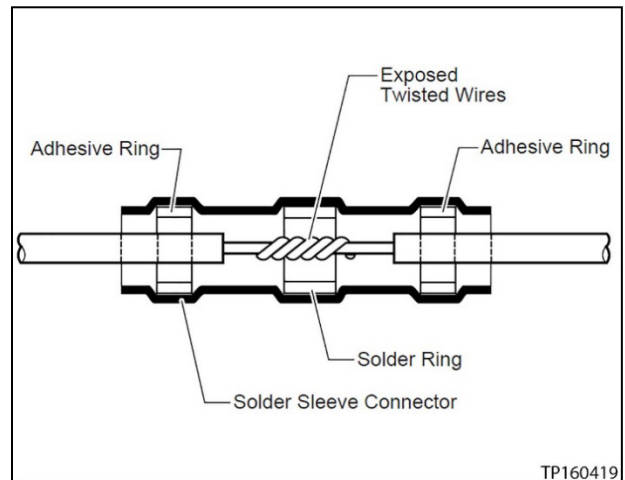
Figure 12

10. Slide the red solder sleeve over the twisted pair and position it so that the solder ring is over the two twisted wires as shown in Figure 12.

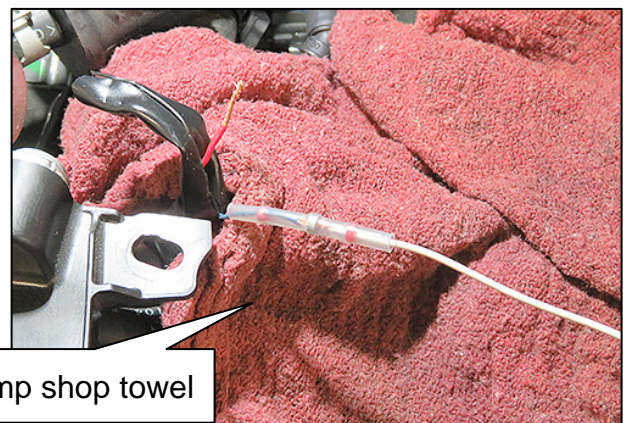
Figure 13

11. To prevent any damage to surrounding components, place a water dampened shop towel (or other heat-resistant covering) below the work area.

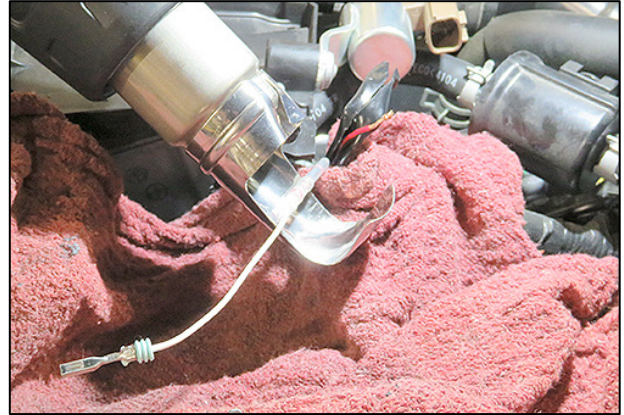
Figure 14

- Melt the solder (silver ring inside the solder sleeve connector) into the exposed twisted wire area.
- Melt the sealant (red rings inside the solder sleeve connector) onto the wires.
- Shrink the remainder of the solder sleeve connector to the wire.

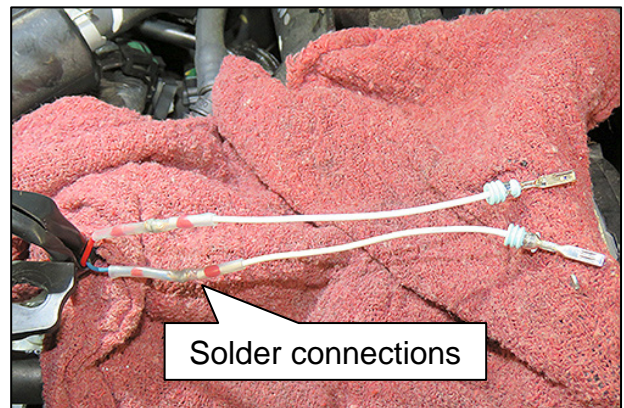
13. Perform steps 8-12 on the remaining wire, and then proceed to step 14.
  - Figure 15 is shown with all solder connections completed.

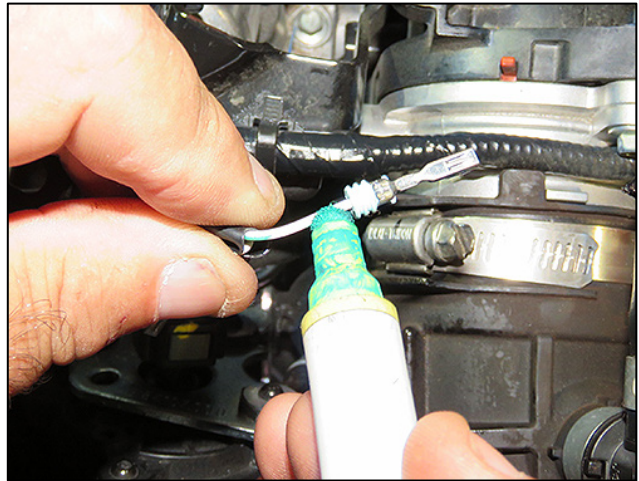
Figure 16

14. Locate the repair kit wire that was soldered-sleeved to the blue wire of the vehicle's wiring harness, and then mark it to ensure the correct pin locations (Figure 16).

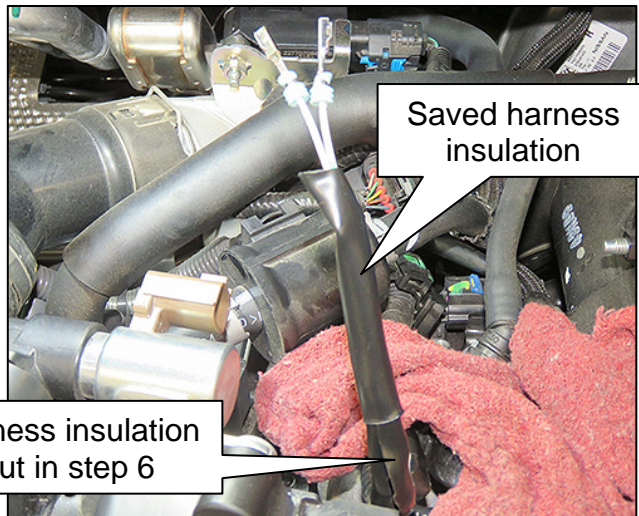
Figure 17

15. Reinstall the harness insulation that was cut in step 6 on page 4 over the vehicle wiring harness.

16. Reinstall the harness insulation saved from step 3 on page 3 over both repair kit wires.

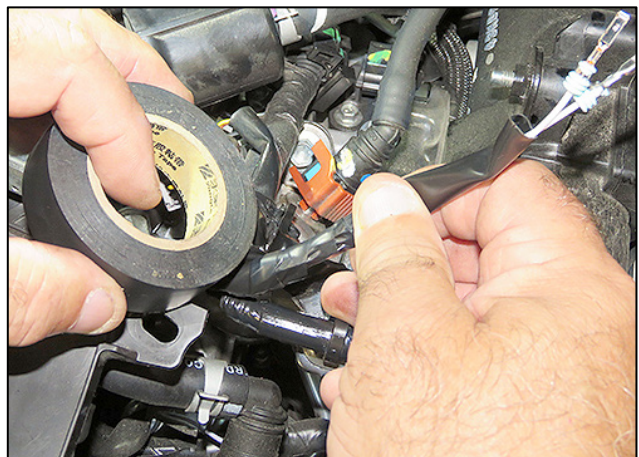
Figure 18

17. Wrap both the saved harness insulation and the cut harness insulation together with electrical tape, as shown in Figure 18.

- Wrap electrical tape such that it completely covers the cut made in the harness insulation in step 6 on page 4.

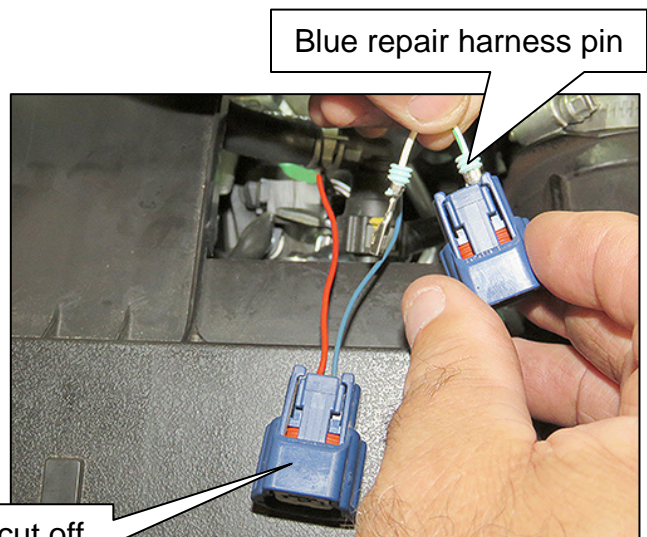
Figure 19

18. Insert the blue repair harness pin into the new connector using the mark from step 14 on page 7, and then insert the red connector (Figure 19). Confirm they are secured with audible click.

Original cut off wiring harness

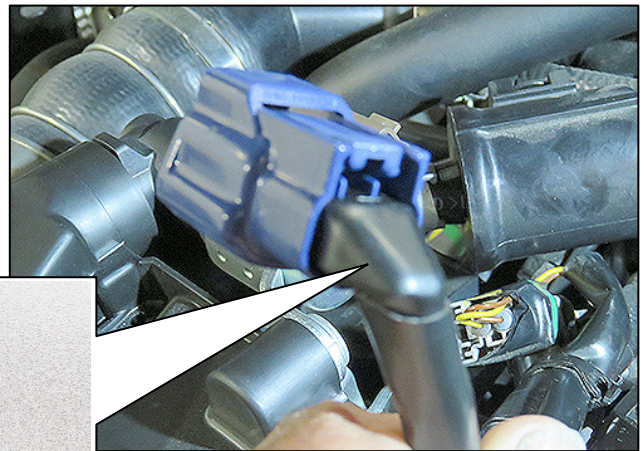
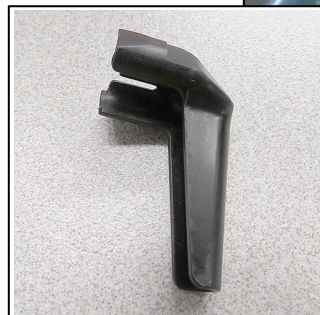
Figure 20

19. Insert the connector cover into the harness insulation, and then snap it into place into the back of the harness connector. Confirm it is secured with an audible click.

Connector cover

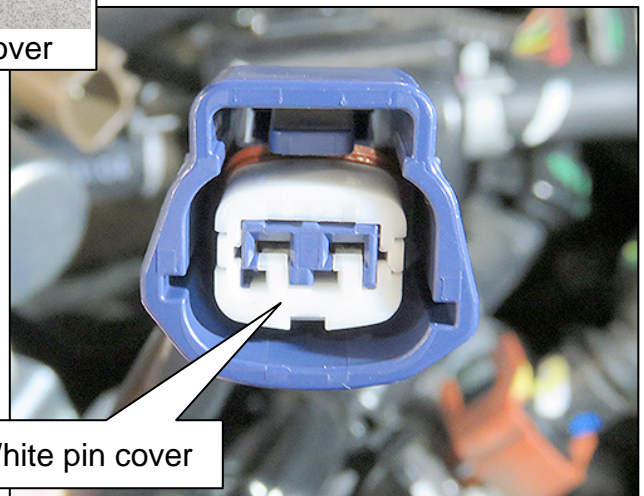
Figure 21

20. Insert the white pin cover onto the front of the connector, and then confirm it is secured with an audible click (Figure 21).

White pin cover

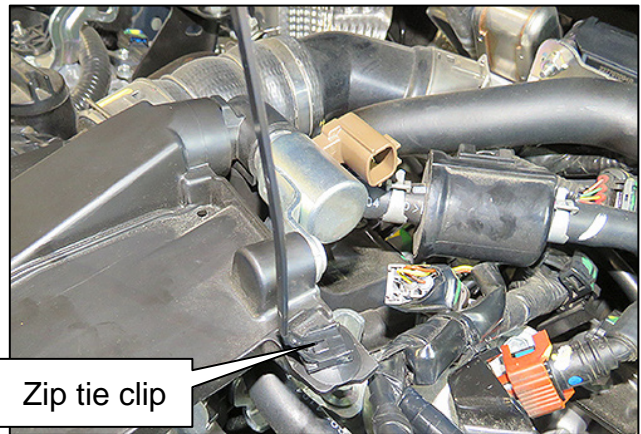
Figure 22

21. Install the new CLIP HARNESS (zip tie clip) as shown in Figure 22.

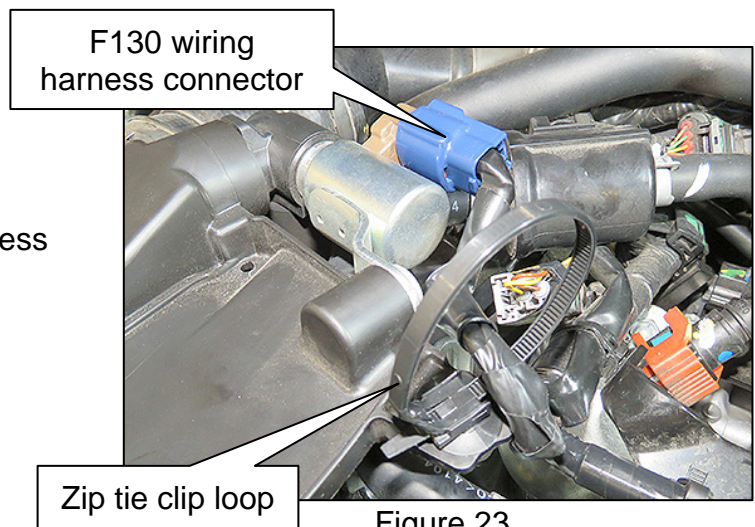
Figure 23

23. Loop the zip tie clip around the F130 wiring harness (Figure 23).

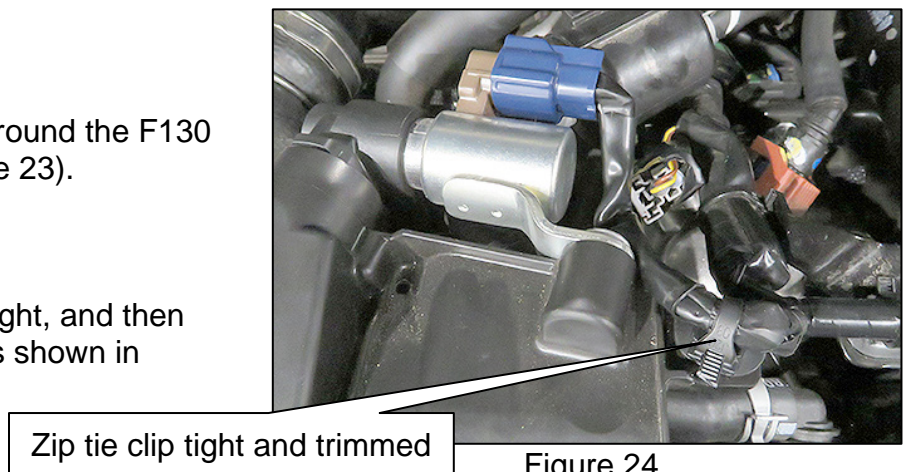
Figure 24

24. Draw the zip-tie clip tight, and then trim off the excess, as shown in Figure 24.
