Model: Aprilia RS-Tuono 457 E5+, Aprilia RS-Tuono 660 E5+

Subject: Left hand grip replacement – Technical update

Campaign Code: PA2ZZQ2504_AP_USCA

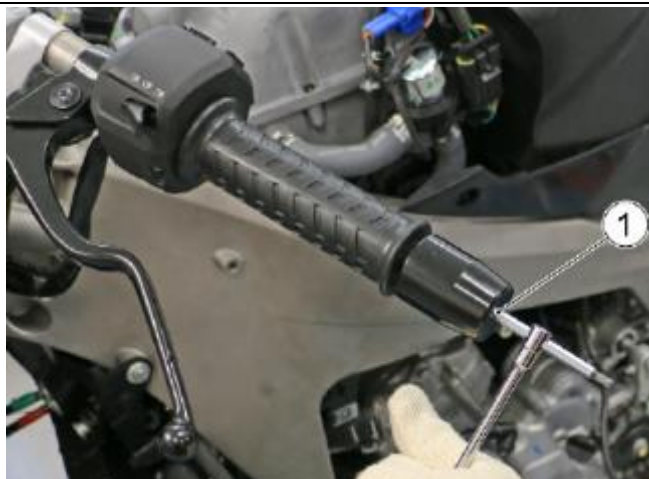
Unscrew the fixing screw (1) of the left handlebar counterweight.

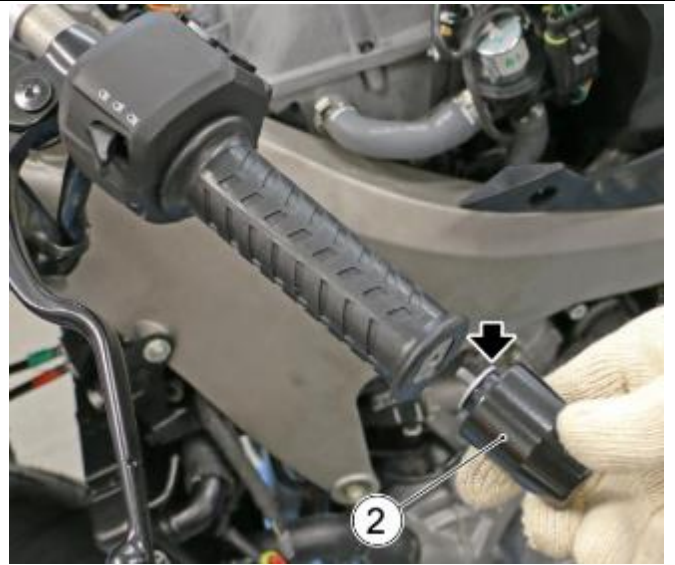
Remove the left counterweight (2) from the handlebar and retain the relative washer.

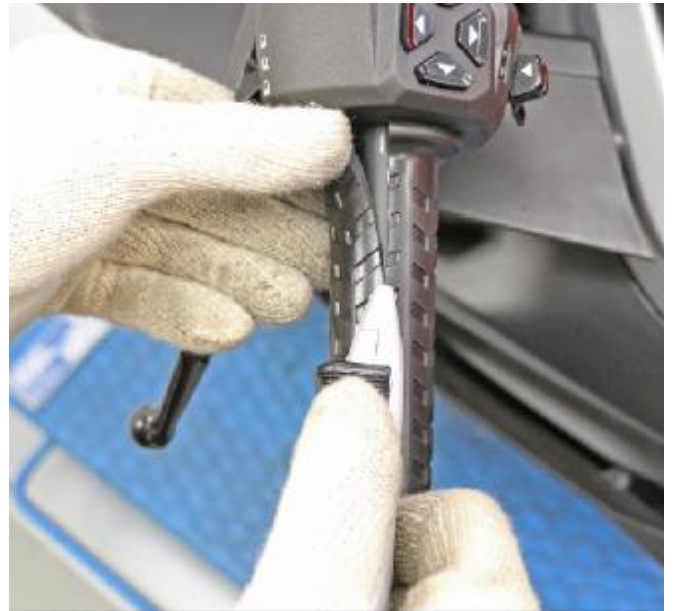
Using a cutter, cut the left grip along its length.

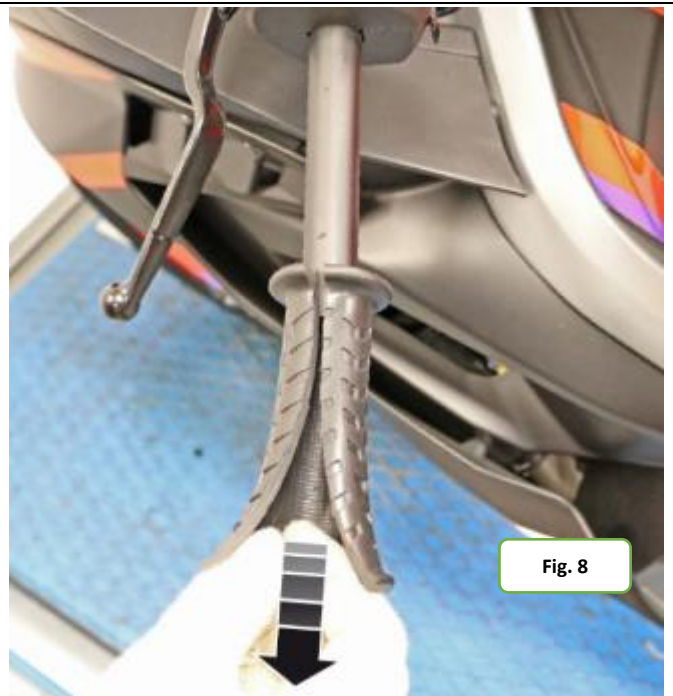
Remove the left grip from the handlebar.

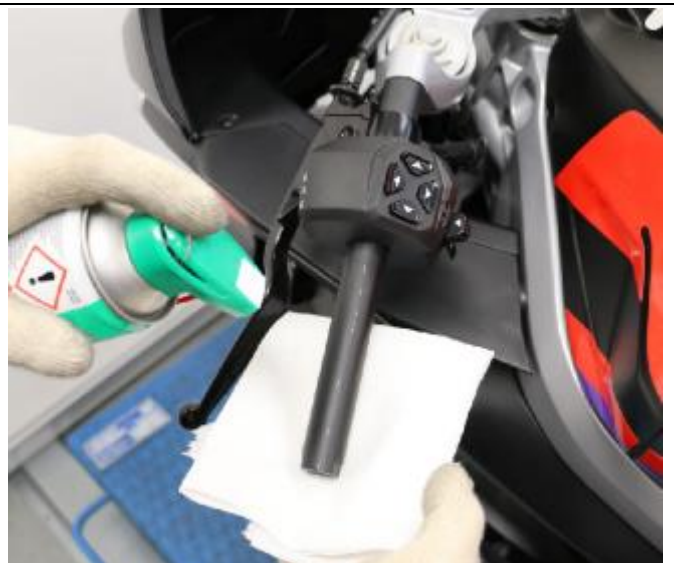
Clean the surface of the left handlebar with a solvent to degrease it and remove any glue residue from the previous handlebar.

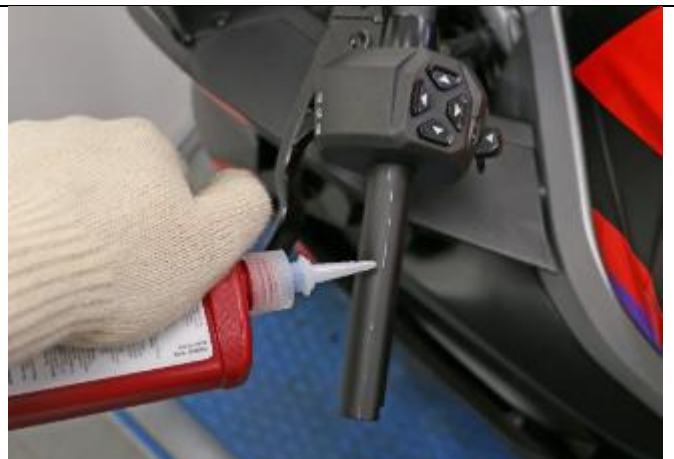
Apply adhesive fevicol pl10 + fevicol Hardner-C or similar to the surface of the handlebar.

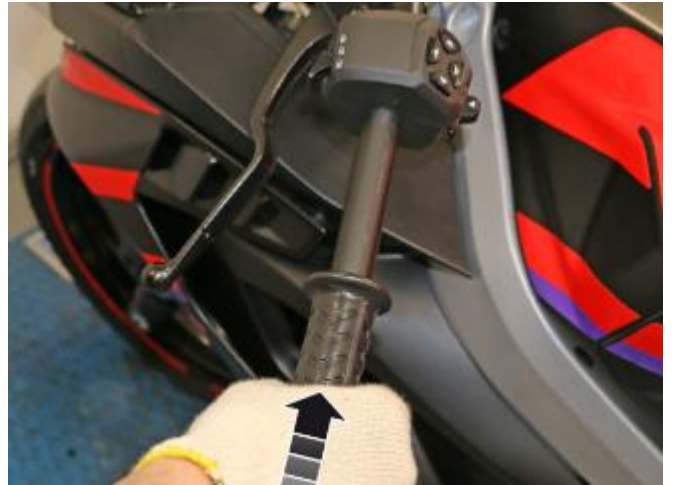
Insert the left hand grip on the handlebar.

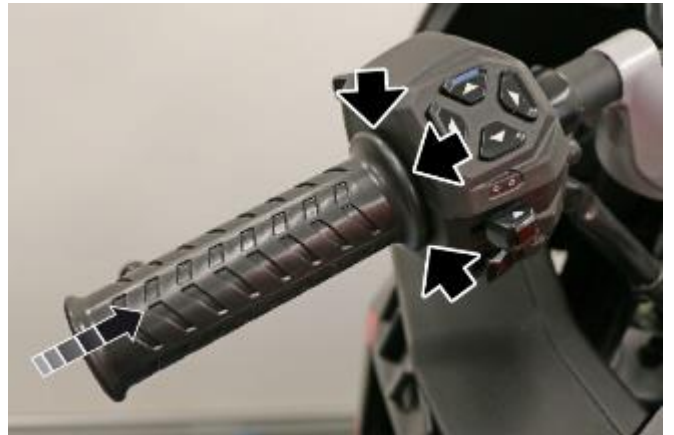
Push the left hand grip on until it is fully seated against the left switch assembly.

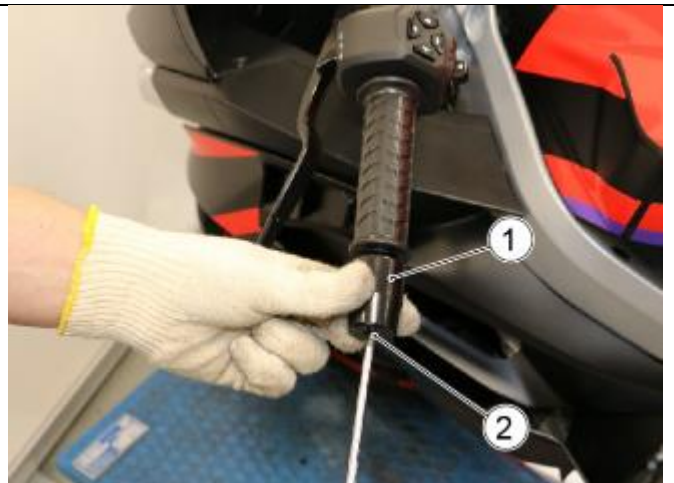
Install the left counterweight (1) and tighten the fixing screw (2).

Tightening torque: 10 ± 2 Nm (7.38 ± 1.48 lb ft).
