TECHNICAL SERVICE BULLETIN

Chatter/Shudder During Low Speed Turning Events

25-2627
06 February 2026

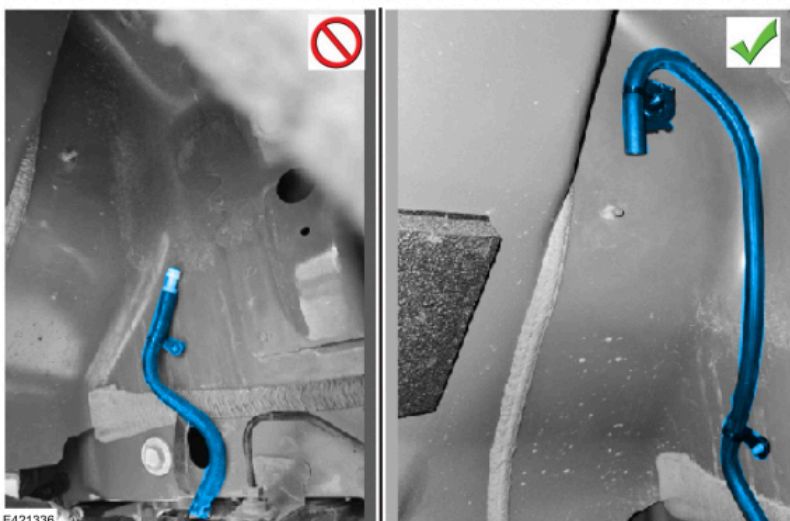
Figure 3

2. Inspect the RDU vent hose mounted behind the right rear fender splash shield. Is the vehicle equipped with the updated RDU vent hose as shown in the image with the green check mark in Figure 3?

- (1). Yes - this article does not apply. Repair is complete.
 - (2). No - proceed to Step 3.
3. Remove the right rear wheel. Refer to WSM, Section 204-04A.
4. Remove the retainers and screws from the right rear fender splash shield shown in Figures 4-6. Lower and fold the right rear fender splash shield in front of the brake caliper to access the RDU vent hose and upper section of the wheel well.
