## Service Campaign Notification

### Replace TIREFIT Bottle in Trunk – Amendment 1

CAMPAIGN NO.	2025090001
CAMPAIGN DESC.	25P5898016
SUBJECT	Replace TIREFIT Bottle in Trunk – Amendment 1
MODEL(S)	A-Class, C-Class, CLA, E-Class, EQB, GLA, GLB, GLC and GLE (177, 205, 206, 118, 213, 214, 243, 247, 253 and 167 platform)
MODEL YEAR(S)	2015 – 2025
CAMPAIGN POPULATION	151

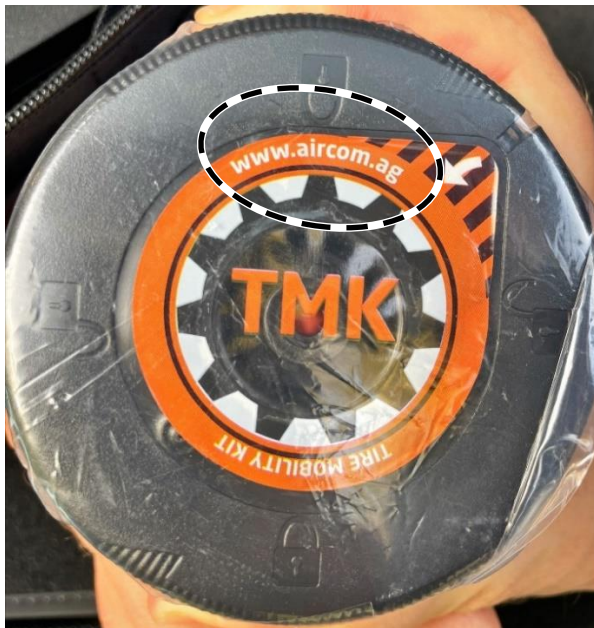
Figure 1

**i** In the case of tire sealant bottles from “Aircom” (Figure 1), the **expiration date** (Figure 2) must be checked.

- a. Tire sealant bottle is **not** from “Aircom”:
  - **No further action required, end measure.**
- b. Tire sealant bottle is from "Aircom" with **expiration date** “2029-01,” “2029-12,” “2030-01” or “2030-02”:
  - Perform **Work Procedure**.

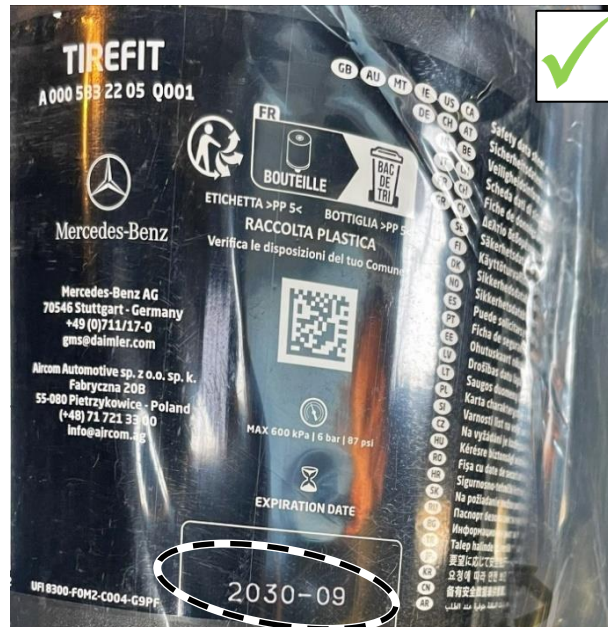
Figure 2 (OK)

**i** If the **expiration date** is “2029-01,” “2029-12,” “2030-01,” or “2030-02,” the tire sealant bottle must be replaced.
