GENERAL MOTORS  
DCS 7437  
URGENT - DISTRIBUTE IMMEDIATELY

Subject: N252536560 - Service Update  
Pressure Relief Valve Leak

Models: 2026 Silverado 1500  
2026 Silverado 2500 HD/3500 HD  
2026 Sierra 1500  
2026 Sierra 2500 HD/3500 HD

## N252536560 Pressure Relief Valve Leak

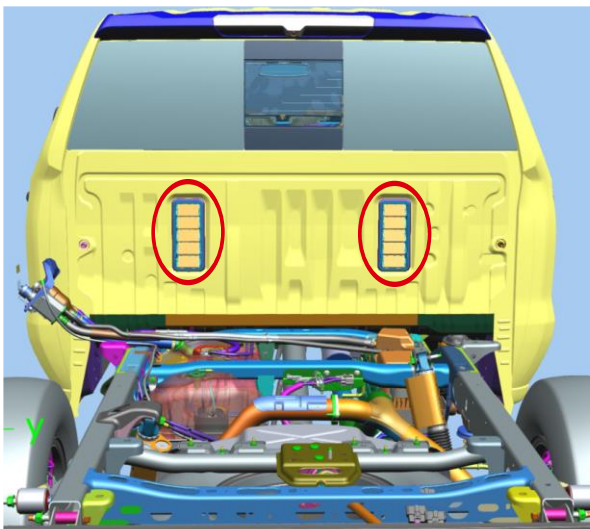
7082902

1. Locate the Cabin Pressure Relief Vents as shown above. They will be visible looking down between the cabin and the bed with a flashlight.

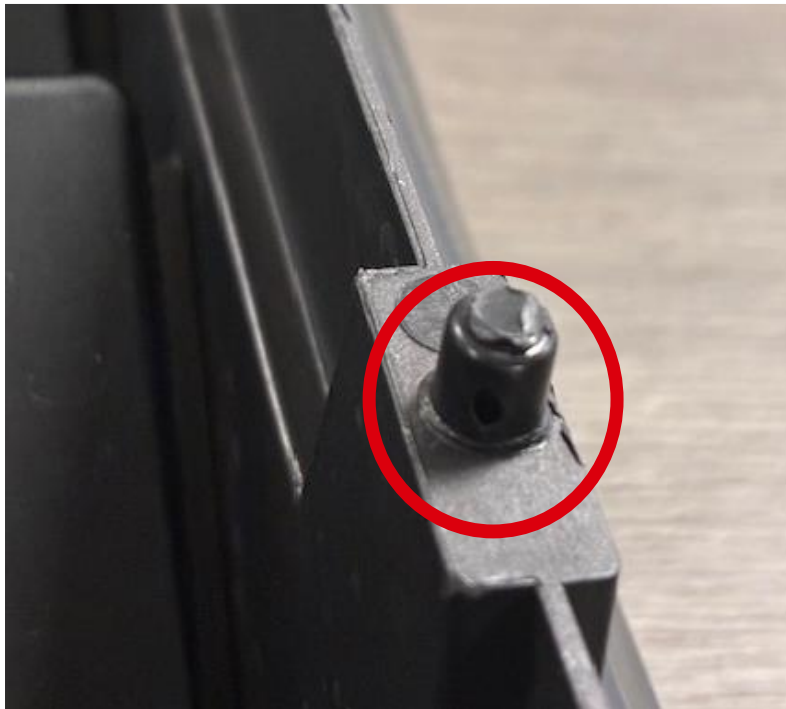
7082903

2. Inspect the posts at each corner of the Cabin Pressure Relief Vents (both sides) to see if any of them have a hole as shown above.
  - a. If there are no holes, no further action is required.
  - b. If there is a hole(s) proceed to step 3.

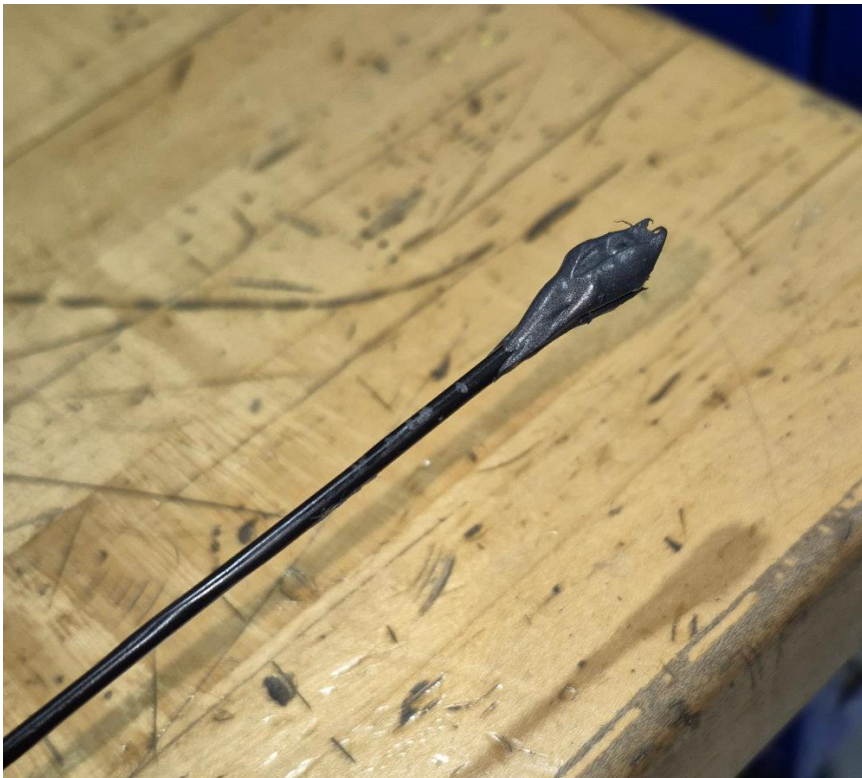
7082905

3. Using a whip antenna, long screwdriver, or long and thin prybar, apply RTV to the end and then apply the RTV to fill any holes in the Pressure Relief Valve on the back of the cab.
