REFERENCE:	TSB: 23-003-26 GROUP: 23 - Body	Date:	February 12, 2026	REVISION:	-
VEHICLES AFFECTED:	2025 (KM) Jeep Wagoneer S This bulletin applies to vehicles built on or after August 13, 2024 (MDH 0813XX) and on or before February 23, 2025 (MDH 0223XX) equipped with 400V G2500 FR/RR Elec Drive Motors (Sales Code ELD).			MARKET APPLICABILITY: <input checked="" type="checkbox"/> NA <input type="checkbox"/> CH <input type="checkbox"/> EE <input type="checkbox"/> IAP <input type="checkbox"/> SA <input type="checkbox"/> MEA NOTE: This bulletin applies to North America markets.	
CUSTOMER SYMPTOM:	The customer may comment on one or more of the following: <ul style="list-style-type: none"> • All door trim panels have the wrong applique installed. • Right front door has the wrong memory seat switch closeout bezel installed. 				
CAUSE:	Improperly built door panels due to lack of correct materials

This bulletin involves replacing applique on all door panels and the front right door panel closeout bezel.

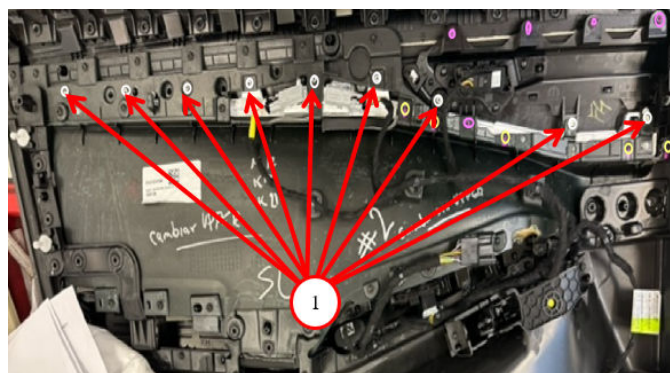
Fig. 1
Door Applique Screws

1. Remove both front door trim panels. Refer to the detailed service procedures listed in DealerCONNECT> Service Library under: 23 - Body / Doors - Front / Panel, Door Trim / Removal.
2. Remove nine screws securing the door applique to the door panel assembly for both front doors [Fig. 1](#).

1 - Door Applique Screws

3. Remove and **DISCARD** both front door panel appliques.
4. Remove five LED light bar screws on the right front door panel [Fig. 2](#).

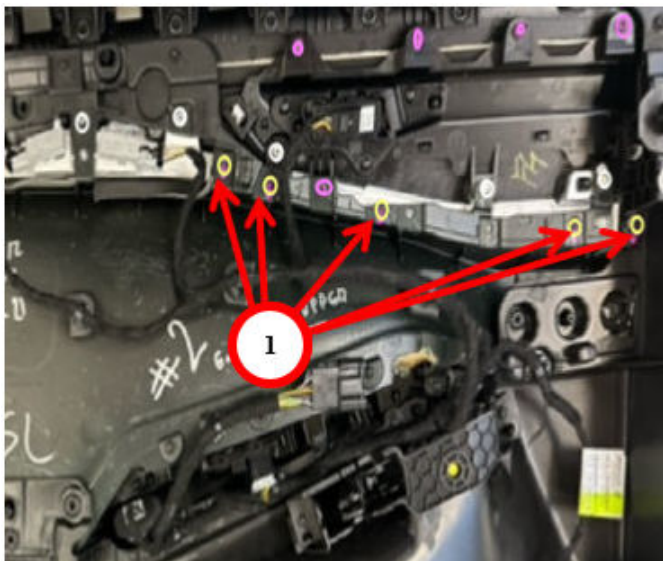
Fig. 2
LED Light Bar Screws

1 - LED Light Bar Screws

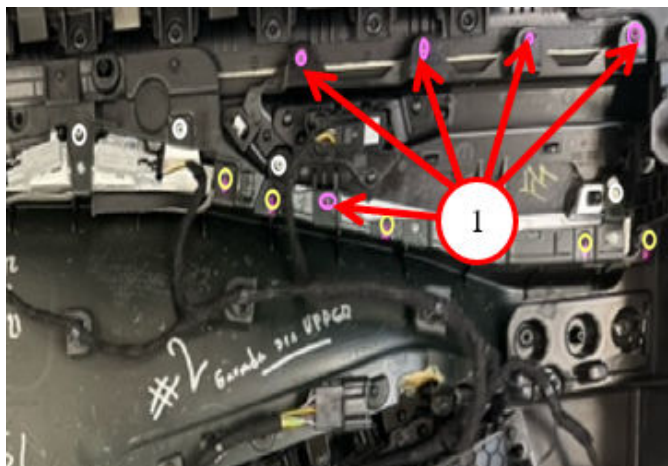
Fig. 3
Remove The Closeout Bezel

5. Remove five screws securing the closeout bezel to the right front door panel [Fig. 3](#).

1 - Closeout Bezel Screws

6. Remove and **DISCARD** the right front door closeout bezel. Keep the memory seat switch.
7. Transfer the memory seat switch to the new closeout bezel.
8. Install the **NEW** right front door closeout bezel to the right front door trim assembly and secure using five screws [Fig. 3](#).
9. Install five screws securing the LED light bar to the right front door panel [Fig. 2](#).
10. Install a **NEW** door applique to both front door trim panels and secure using nine screws [Fig. 1](#).
11. Install both front door panels. Refer to the detailed service procedures listed in DealerCONNECT> Service Library under: 23 - Body / Doors - Front / Panel, Door Trim / Installation.
12. Remove both rear door trim panels. Refer to the detailed service procedures listed in DealerCONNECT> Service Library under: 23 - Body / Doors - Rear / Panel, Door Trim / Removal.

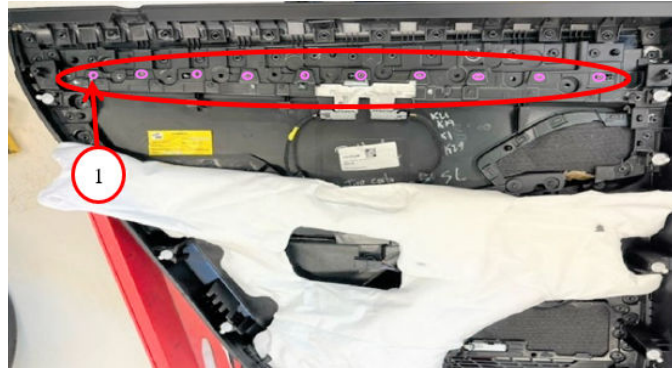
Fig. 4
Rear Door Applique Screws

13. Remove ten screws securing the door applique to the rear door panel for both rear doors [Fig. 4](#).

1 - Remove Door Panel Applique Screws

14. Remove and **DISCARD** the door applique for both rear doors.

15. Install a **NEW** door applique to each rear door panel and secure using ten screws [Fig. 4](#).
