White cloudy spots/shading in the paint finish of matte paints (MAGNO) upon vehicle delivery

| Topic number | LI98.00-P-078306 |
| Validity | Model 463, as of model year 2018, with matte paint (MAGNO); model 465, as of model year 2024, with matte paint (MAGNO) |

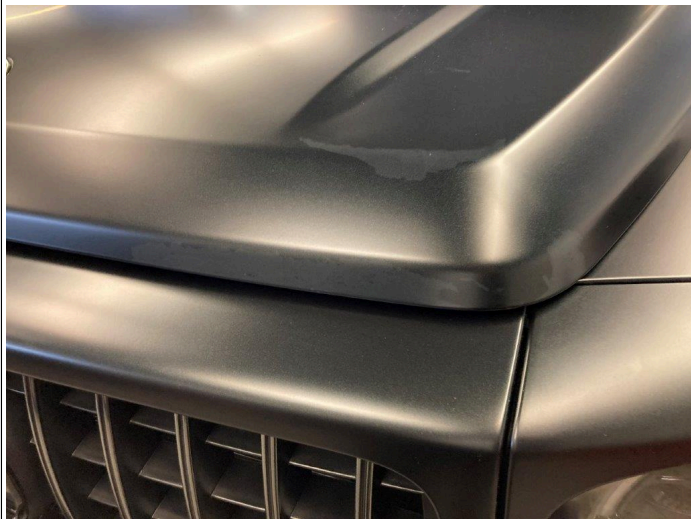
After removing the transport protection from new vehicles, localized cloudy spots or streaks may appear on the paint surface.

These marks are most commonly seen on the hood, fenders, and bumpers and are more noticeable on dark paint colors.

| Attachments | |
|---|---|
| Bild 1.jpg | Example 1 of cloudy appearance |

Carefully heat the affected areas using a heat gun or Infrared Paint Curing Lamp.

- Ensure that seals and other heat-sensitive components, including those behind the heated area, are not exposed to excessive heat or damaged during the process.
- Set the heat gun to 500–600 °C (932–1,112 °F).
- Hold the heat gun approximately 5–10 cm (2–4 inches) from the surface.

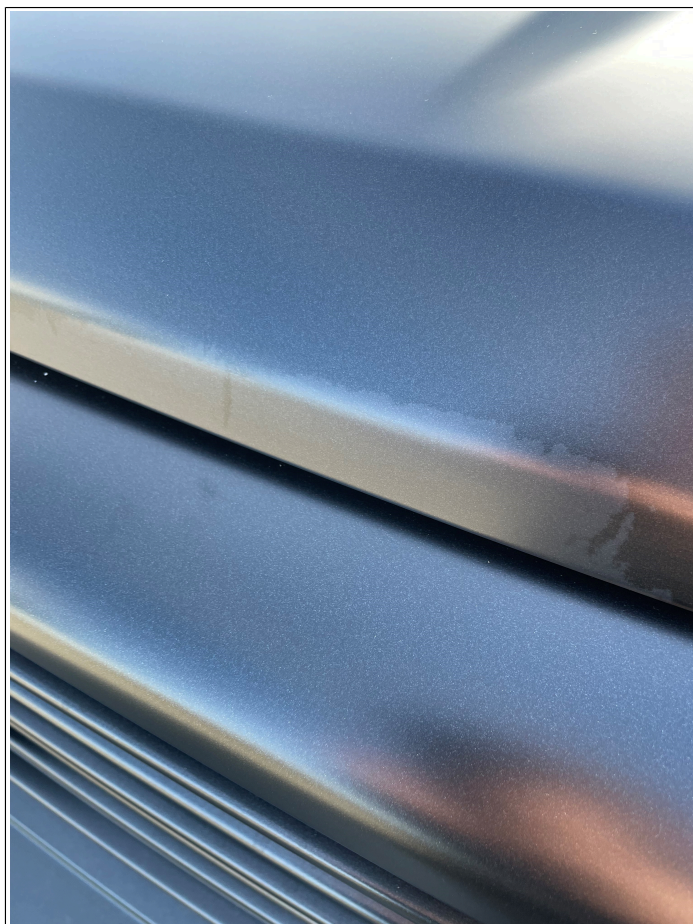
| Attachments | |
|---|---|
| Bild 2.jpg | Example 2 of cloudy appearance |

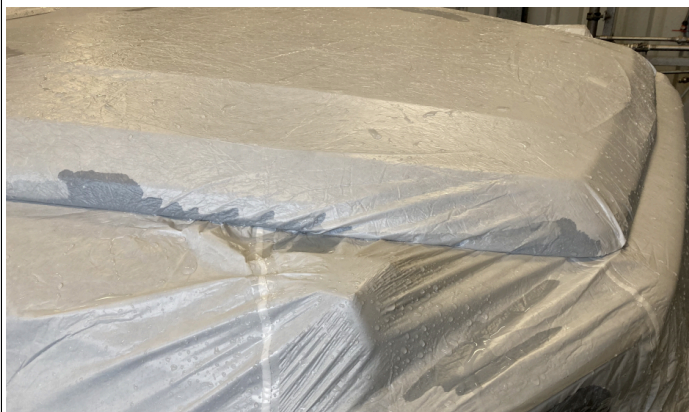
Moisture can become trapped under the full transport packaging.

This moisture may penetrate the fresh paint, causing the paint layer to swell and result in visible white spots or streaks.

| Attachments | |
|---|---|
| Bild3.png | Example of Full Body Covering with trapped moisture |

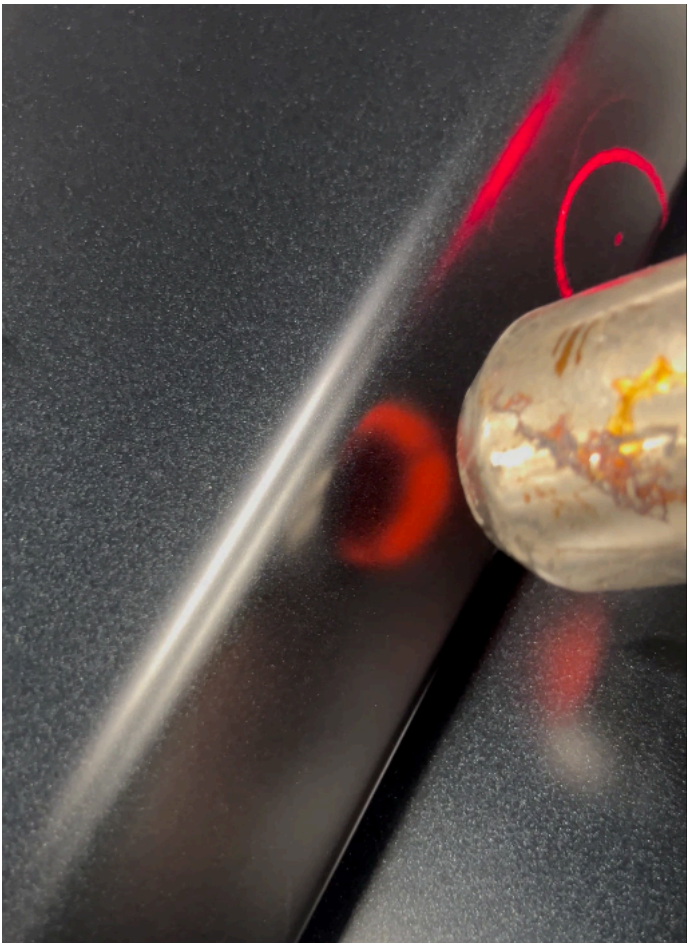
| Attachments | |
|---|---|
| Bild 4.PNG | Example of heating paint using a heat gun |

For plastic components (e.g., bumpers): DO NOT exceed 120 °C (248 °F).

The heating process may need to be repeated several times to achieve the desired result.

IF heating does not improve the appearance OR the paint structure is permanently damaged and cannot be repaired, the affected component must be repainted.
