SIB 51 04 26

DEPRESSION ON TOP OF THE INSTRUMENT PANEL

E-Series	Model Description
G05	X5 Sports Activity Vehicle as of SoP (start of production)
G07	X7 SAV as of SoP

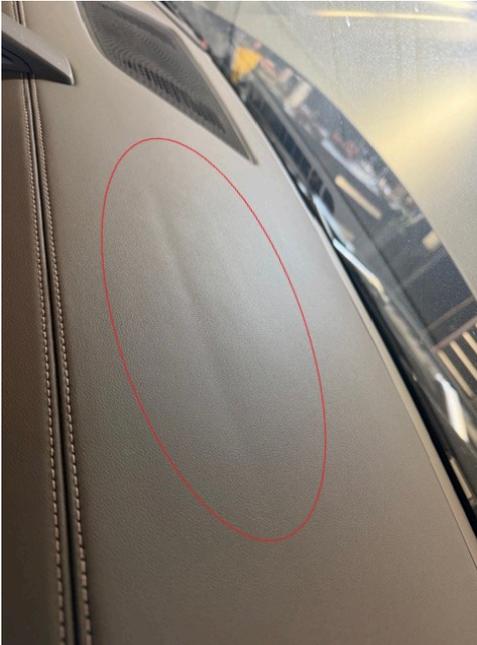
A slight depression or outline (circled) may be visible on the top passenger side of the instrument panel.

This outline is created by the perforated edge for the passenger side air bag. Due to normal variations designed in vehicles, this outline may be more noticeable in other vehicles.

Do not replace any parts for this situation.

This is an Info only Bulletin
