Bulletin #: 2533.1

## XAB – Macan Rear Lid Does Not Open/Close

| Models | Model Year | Model Type | VIN Range | Vehicle-Specific Equipment |
|---|---|---|---|---|
| Macan BEV | As of 2024 up to 2026 | XAB | N/A | N/A |

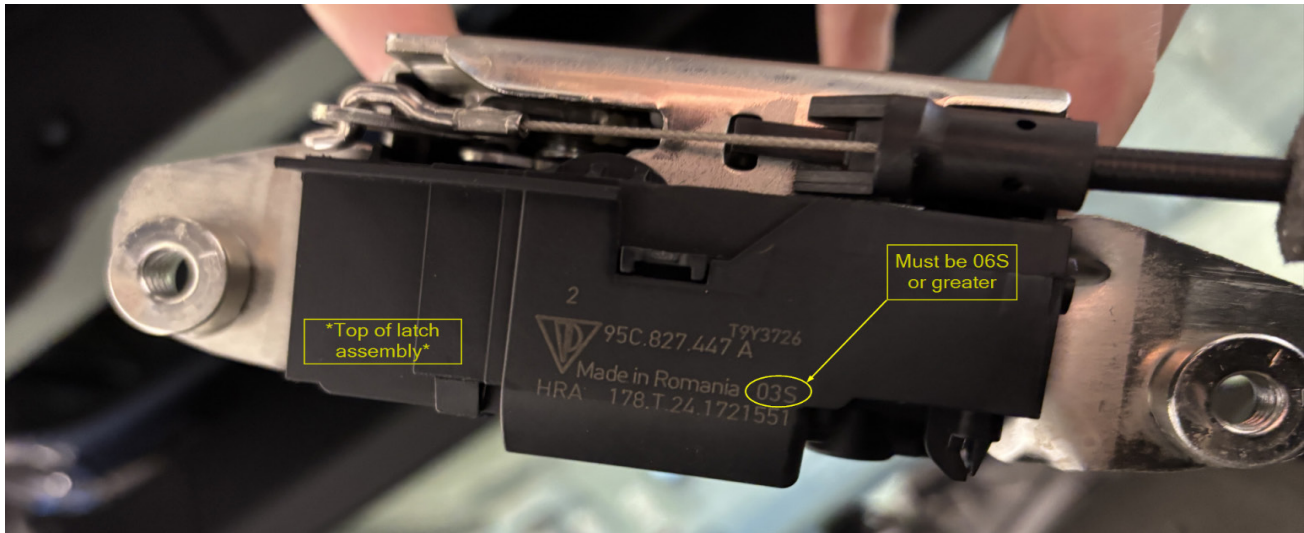
How to check the version for the latch:

In these cases, check the latch for the rear lid for an indicator of version 06S or greater. If the part has a version from before 06S order a new latch. Once the part is received and the version is verified, replace the latch for the rear lid.
