PS Tailgate Hard to Open

REF NO: TJ 37247.4.0	ISSUING DEPARTMENT: Technical Service	CAR MARKET: United States and Canada	
PARTNER: 3 US 7515 Polestar		ISSUE DATE: 2026-01-15	STATUS DATE: 2026-01-29
FUNC GROUP: 8346	FUNC DESC: Handle for hatch; handle for boot lid	Page 1 of 3

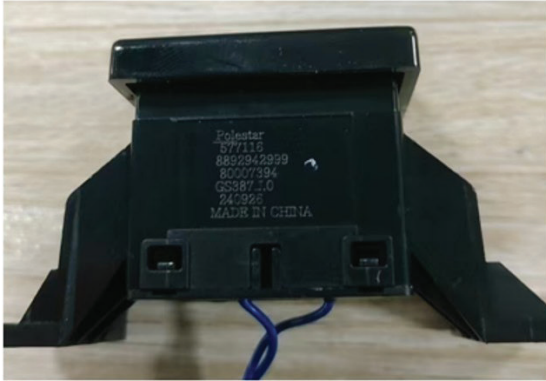
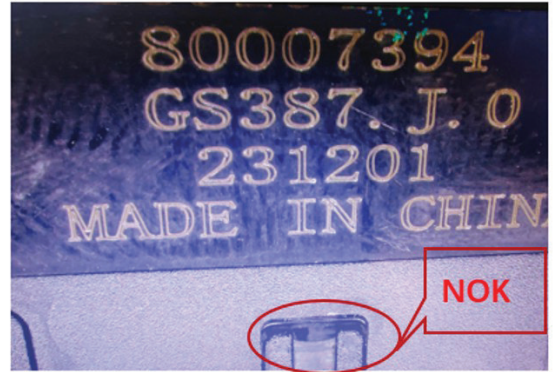
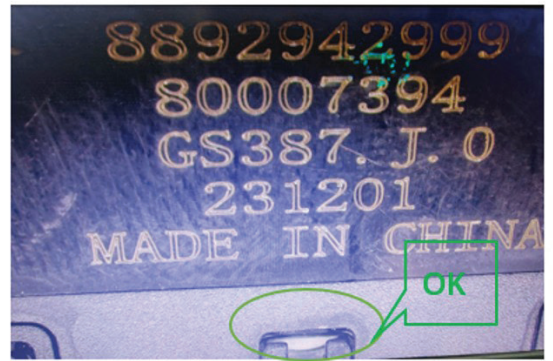
1. Follow VIDA instructions on how to dismantle the tailgate lamp (VCC-527817-1).
2. Check the tailgate switch according to attachment (TJ37247_1.jpg), to see if there is a white cover inside.
3. Check the tailgate switch batch number according to attachment (TJ37247_2.jpg). If the switch is from a batch earlier than 250808 replaced the part.

Failing Part: 80007394 (Switch, Tailgate)

Yes, please submit a Vehicle Report (with a picture of the Tailgate switch included, see TJ_37247_1.png as reference) if the service solution described in this TJ has no effect. Use concern area "Vehicle Report Polestar" and sub concern area "Support not needed Polestar", use function group 8346.
