**PS Cold Cabin Temperature Observed with Infrared Windscreen**

<b>REF NO:</b> TJ 37529.3.0	<b>ISSUING DEPARTMENT:</b> Technical Service	<b>CAR MARKET:</b> United States and Canada	
<b>PARTNER:</b> 3 US 7515 Polestar		<b>ISSUE DATE:</b> 2026-01-28	<b>STATUS DATE:</b> 2026-02-05
<b>FUNC GROUP:</b> 8431	<b>FUNC DESC:</b> Windscreen	<b>Page 1 of 3</b>

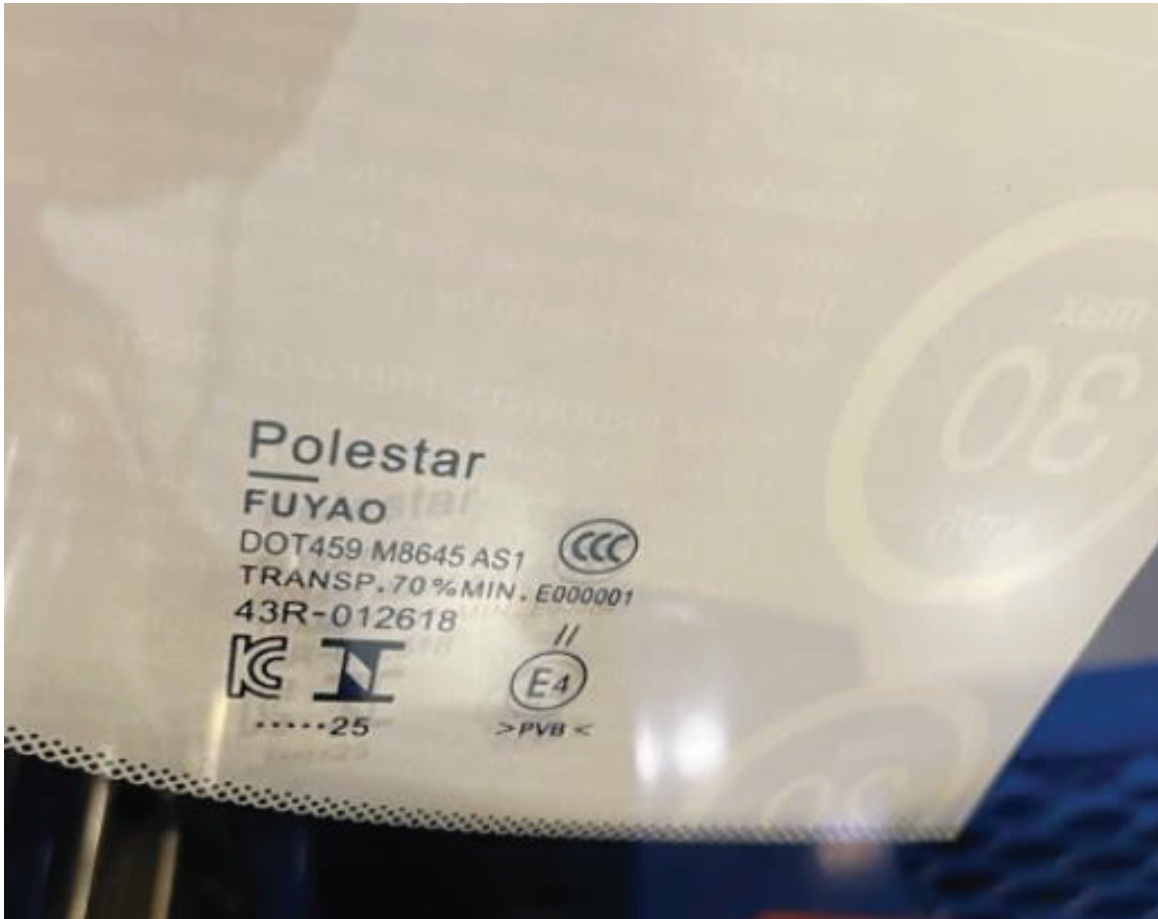
TJ-37529

In cases where the cabin climate feels colder than expected under sunlight, and sometimes that is even difficult to adjust using standard temperature settings, please check if the glass is manufactured by FUYAO (see attached picture). In this case, replace the windshield according to the instruction in VIDA and download the software SP-32489155.
