| Technical Journal Title<br>Check Engine Light with DTCs ECM P2A0000, P050700, P250F68 | | Ref. No.<br>TJ 37710.1.1 | |
| Function Description<br>Crankcase ventilation | | Page<br>Page 1 of 4 | |

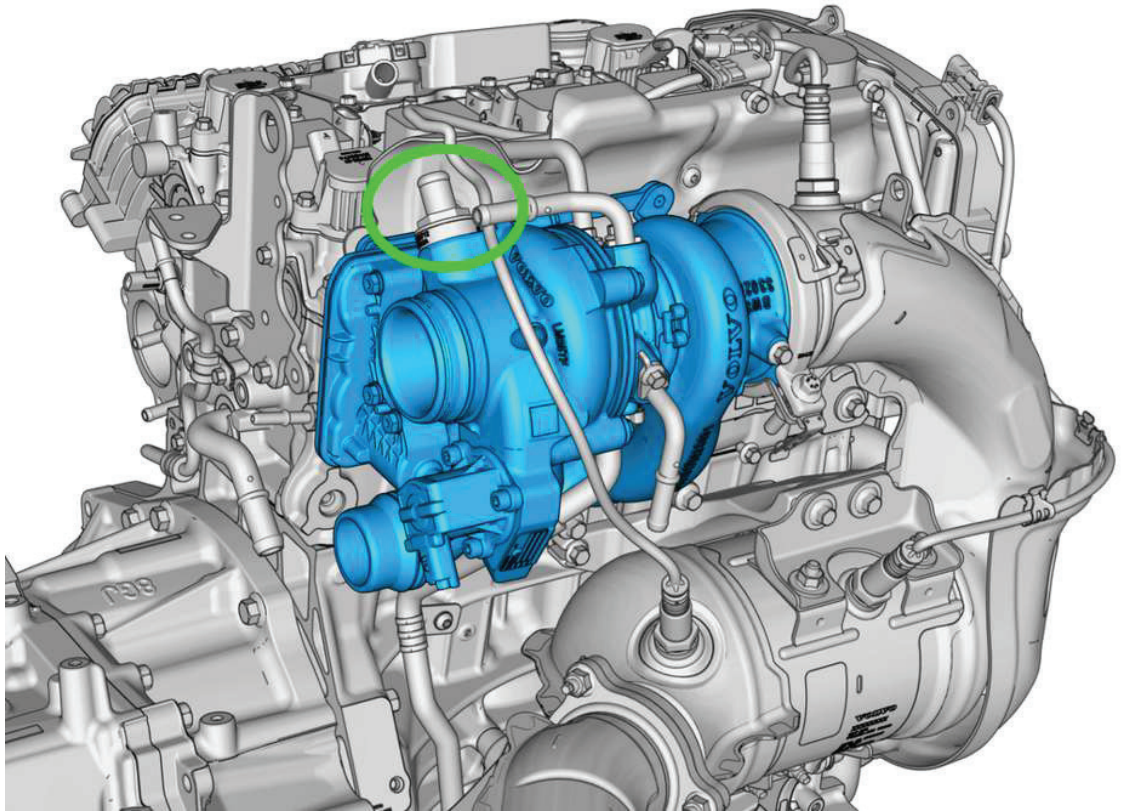
TJ\_37710\_1

Reference the attached images for component location as well as comparison of a good part versus a bad part.

Inspect the non-return valve, part number 32222712, on the turbo inlet for a damaged diaphragm. If the diaphragm is damaged, replace the non-return valve.
