# Technical Service Bulletin

<b>Subject:</b>  <b>CLICKING NOISE FROM LIFTGATE LOCK STRIKER WHEN DRIVING ON BUMPY ROADS</b>	<b>Bulletin No.: 09-010/26</b>
	<b>Last Issued : 02/20/2026</b>

2024 CX-90 with VINS lower than JM3KK\*\*\*\*\*152546 (produced before Decemeber 6, 2023)

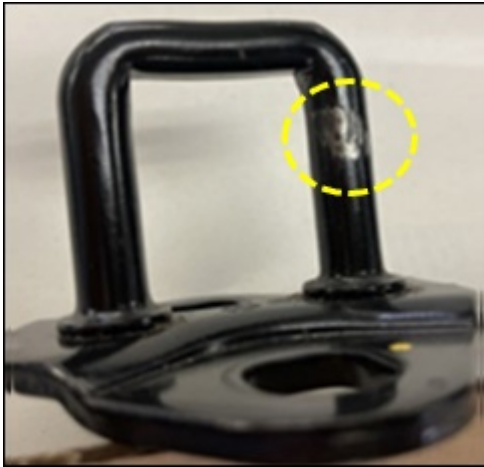
Some vehicles may exhibit a clicking noise from the liftgate lock striker when driving on bumpy roads. This may be caused by stick-slip friction between the lock striker and the lock actuator due to the electrodeposition layer peeling off from the friction between them.

To eliminate this concern, the lock striker coating has been changed to prevent coating wear.

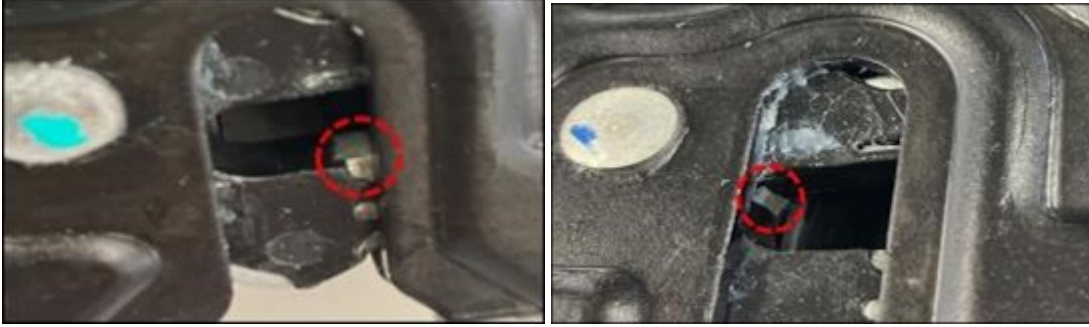
**NOTE:** There are areas without coating as shown in the following images. However, it is normal and DOES NOT cause the clicking noise.

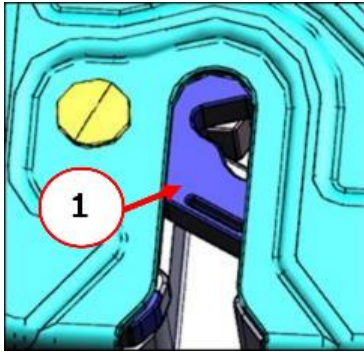
OPEN

1. Verify the customer concern by closing the liftgate several times and checking for the noise by pushing the liftgate from the outside or by pushing the liftgate trim several times from inside the vehicle.
2. Fully open the liftgate.
3. Using a screwdriver, place the lock actuator's latch (1) to the locked position.

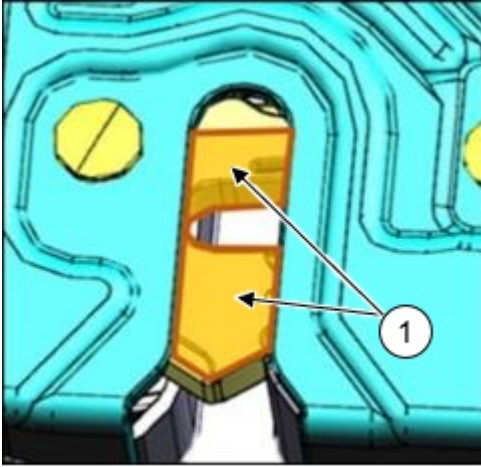
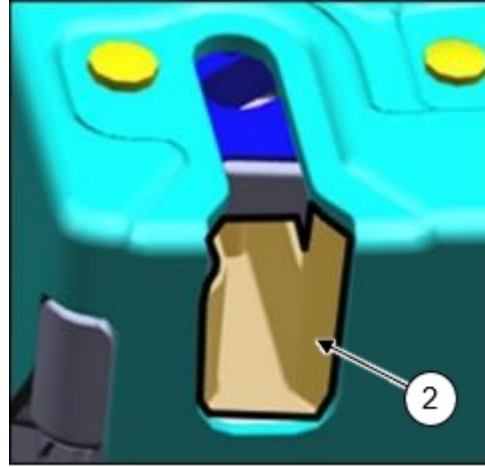
Detail of A

Reference: The old grease mixed with electrodeposited powder has turned gray.

4. Wrap a cloth sprayed with parts cleaner around a screwdriver or prepare a cotton swab saturated with parts cleaner. Completely remove the grease and wear debris from the engagement part on the lock actuator (1) (orange) that receives the lock striker, as well as from the fence block (2) which forms the inner wall of the lock-striker receiving area, according to [Location and Procedures for Grease Wiping and Application].

**CAUTION:** DO NOT spray the parts cleaner directly to the lock actuator.

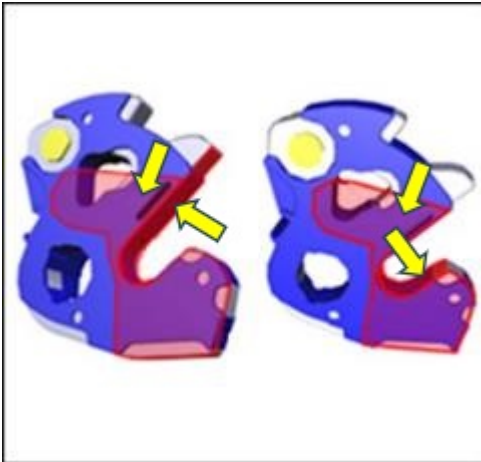
**NOTE:** The backside of the latch also needs wiping and grease application.

Latch Surface  
(red area with yellow arrow)

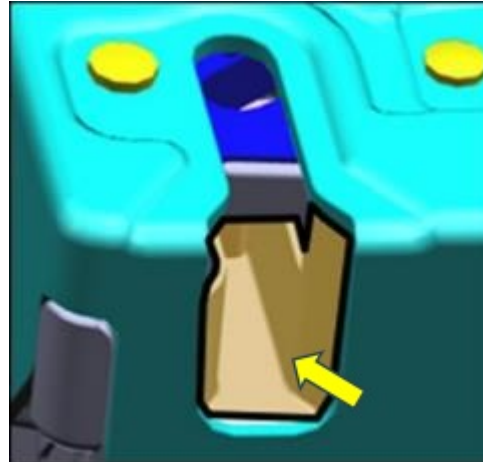
Fence Block Surface  
(beige area with yellow arrow)

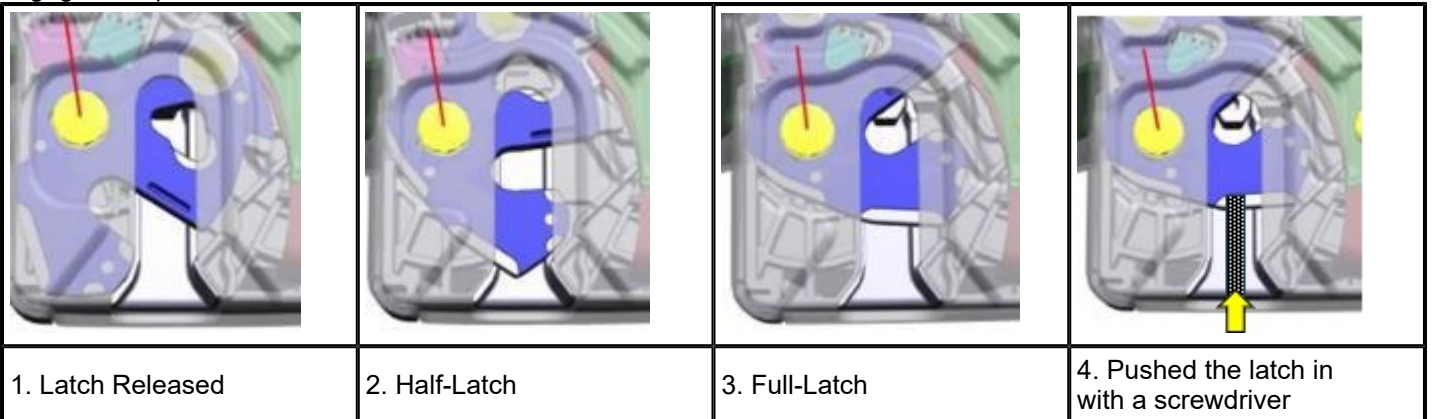
Move the latch of the lock actuator as shown in the figures, and wipe/apply grease around the entire circumference of the engagement part.

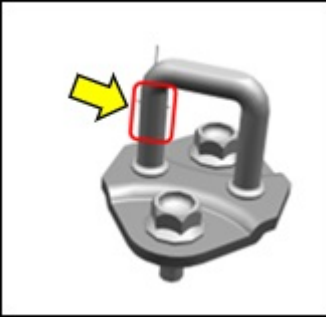
2. Lock Striker Apply grease on the engagement part (latch) of the lock striker as well.

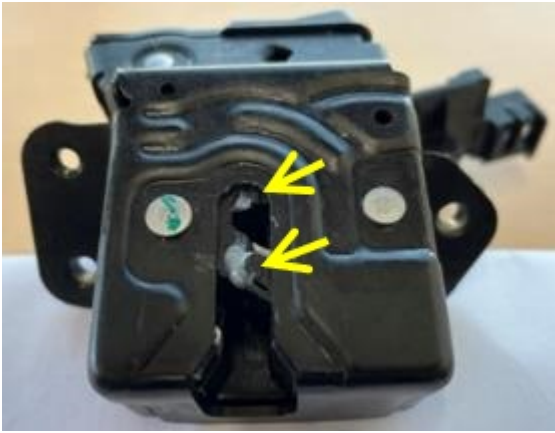
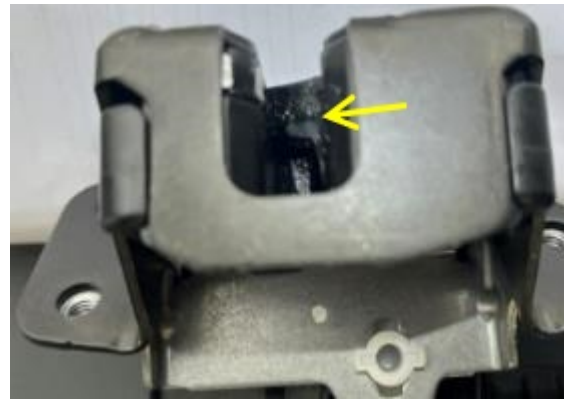
1. Apply and spread the grease approximately 2 mm in diameter at three locations (yellow arrows) with the latch in the released position.

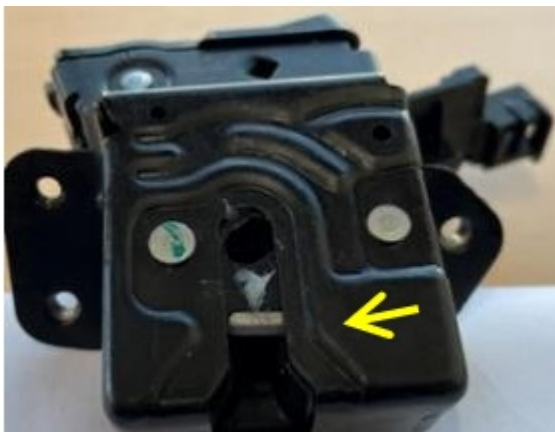
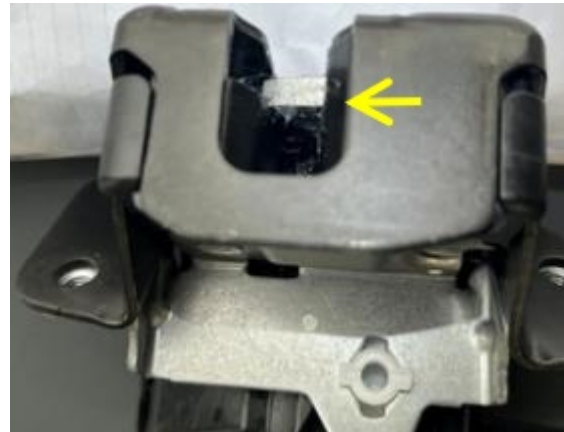
2. Apply and spread the grease approximately 2 mm in diameter at two locations with the latch in the fully latched position (yellow arrows).

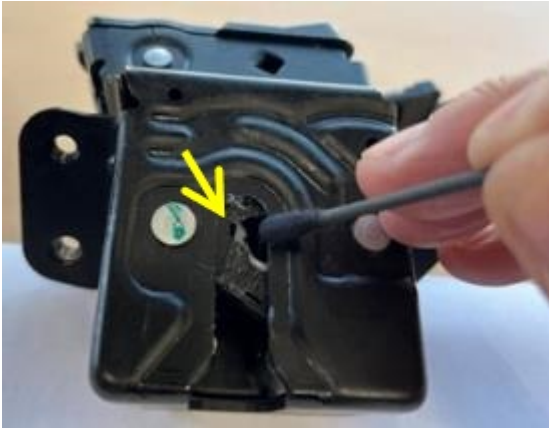
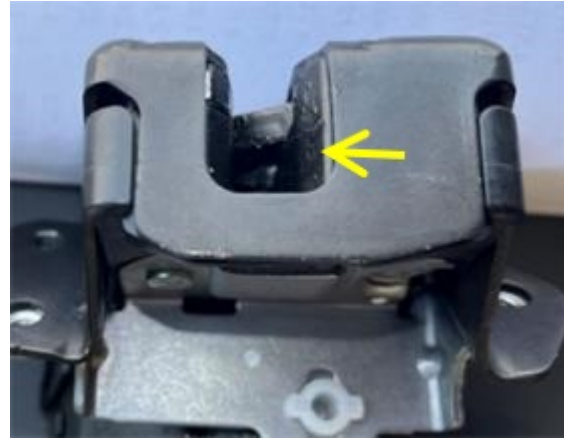
3. To ensure the grease is properly distributed, use a screwdriver or similar tool to open and close the latch five times back and forth. Release the latch using the emergency lever.
4. Scoop up the excess grease with a cotton swab and spread it with the latch in released position (yellow arrows).

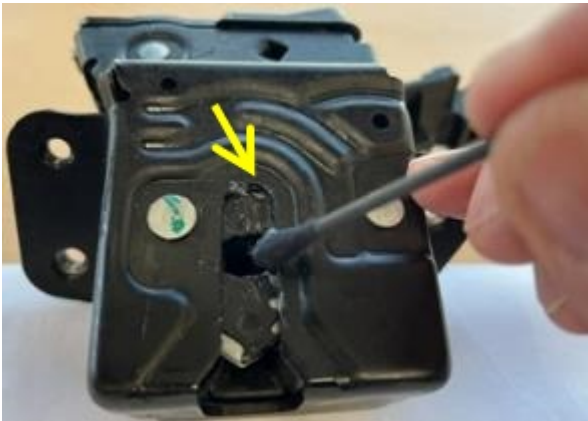
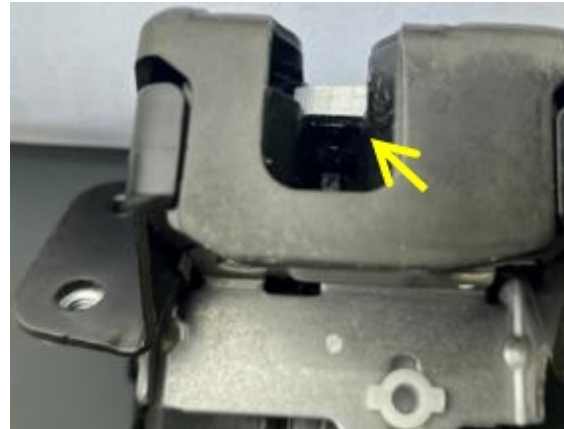
5. Scoop up the excess grease with a cotton swab and spread it with the latch in the fully latched position (yellow arrows).

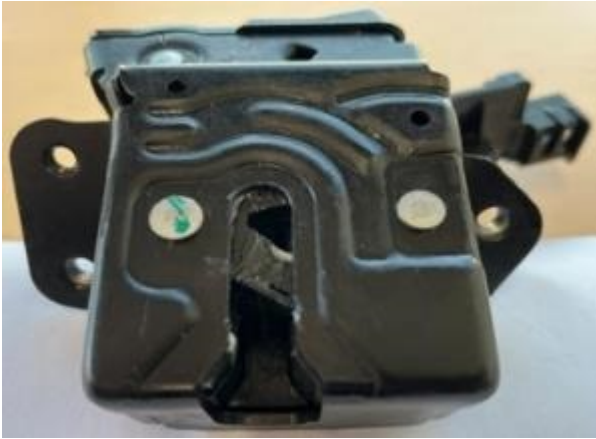
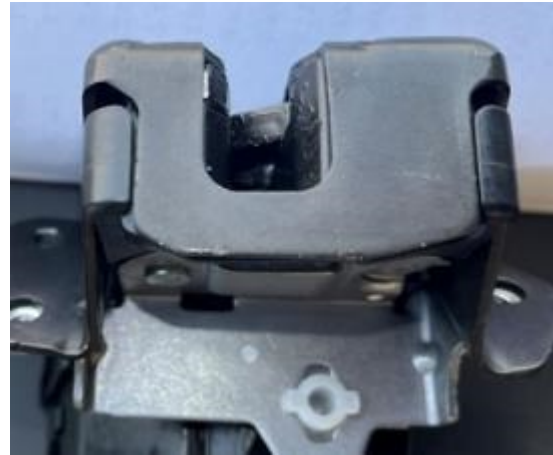
6. Return the latch to the released position to complete the procedure.
