February 24, 2026

Version 4

Air Conditioner Makes Noise (DTC P0530/P0534)

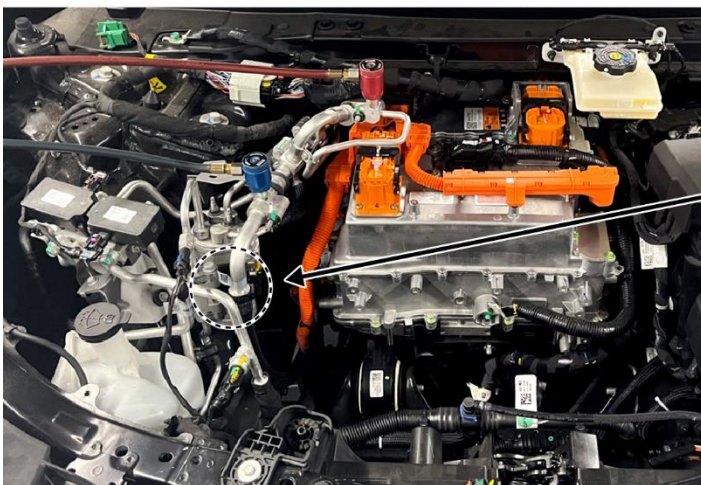
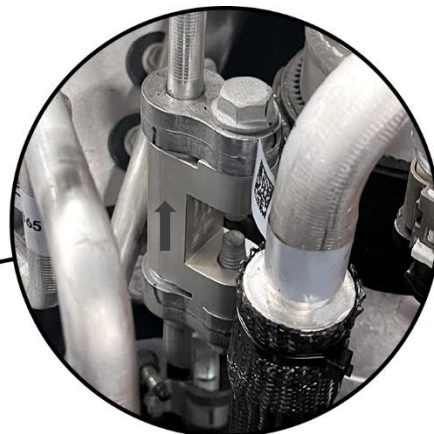
1. Start the vehicle, then set the HVAC system to AUTO HIGH (max heat).
2. Use Tech Line Connect to monitor the refrigerant temperature sensors **6** and **8**.
3. If there is less than a **50° F** difference, inspect the check valve to make sure the arrow is pointing up.

NOTE: If the check valve arrow is pointing down, remove and reinstall the check valve in the correct position.

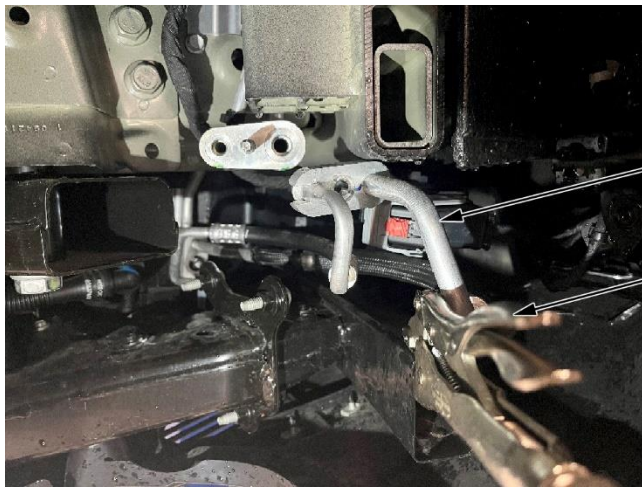
13. Disconnect the lower A/C receiver lines.

- Use a clamp on the frame to hold the A/C line out of the way.
- **DO NOT** clamp the lines as this may damage A/C function.
- Place a shop towel over the end of the A/C line that is being held by the clamp.

A/C LINES

CLAMP

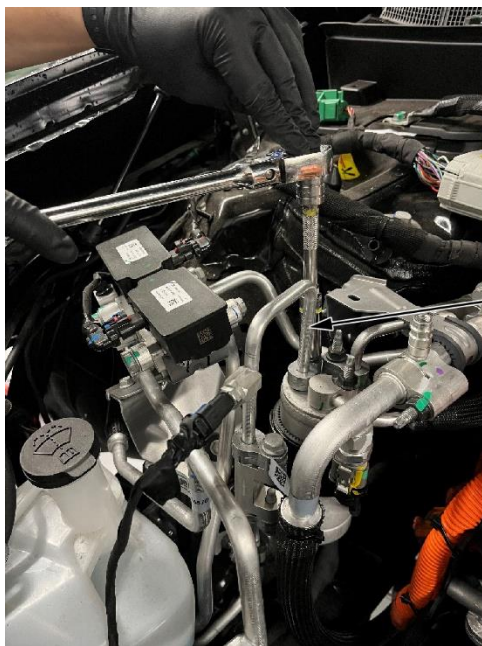
UPPER A/C LINE

14. Disconnect and remove the upper A/C receiver line from the A/C receiver dehydrator. Remove the A/C line seal.

NOTE: Discard the A/C line seal.
