**PRODUCT CAMPAIGN BULLETIN**

**APPLICABILITY:** 2023-2025 MY Solterra **NUMBER:** WRD-25R

**SUBJECT:** Safety Recall and Stop Sale: Solterra HVAC ECU Reprogramming **DATE:** 09/12/25

**NHTSA ID:** 25V577

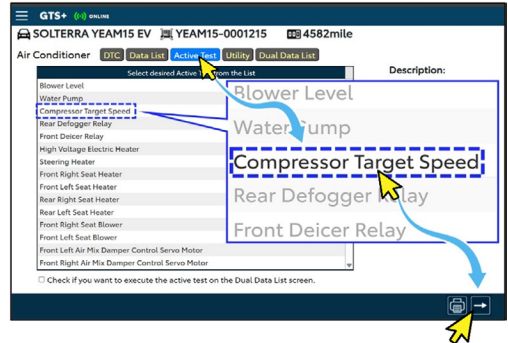
**STEP 8:** Click on “Active Test” and “Compressor Target Speed”. Click the “Next” button to continue.

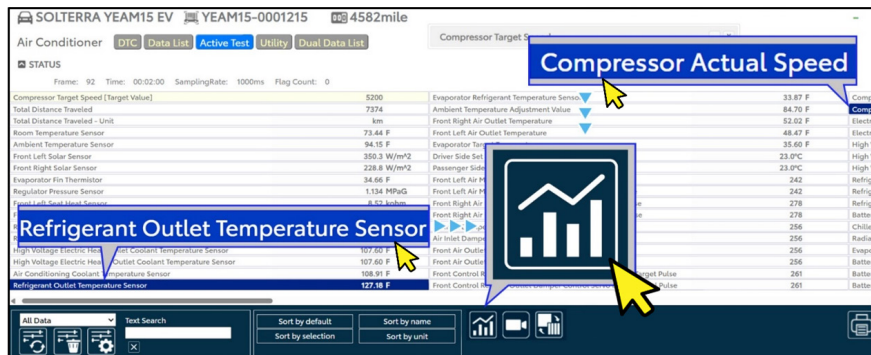
**STEP 11:** Select “Refrigerant Outlet Temperature Sensor” & “Compressor Actual Speed” then click the “Graph” button to continue.

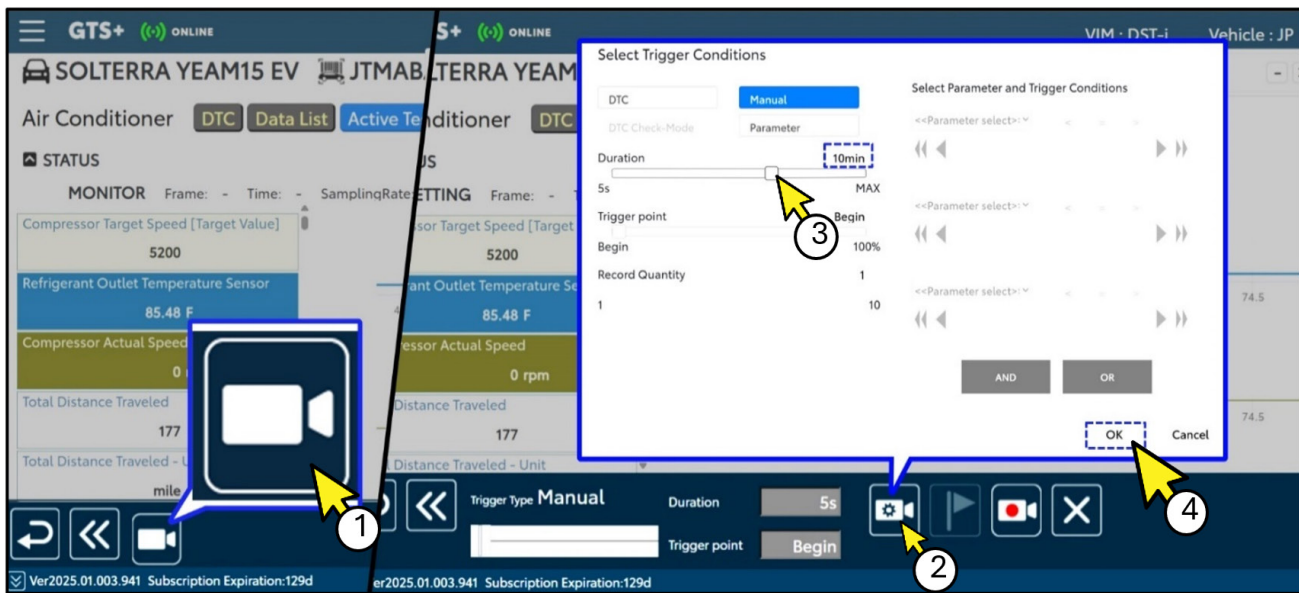
**STEP 12:** Click the “Snapshot” button then click the “Snapshot Configuration” button. Set the duration to ten minutes. Click the “OK” button to continue.

1. Snapshot Button
2. Snapshot Configuration Button
3. Duration Adjustment
4. OK Button

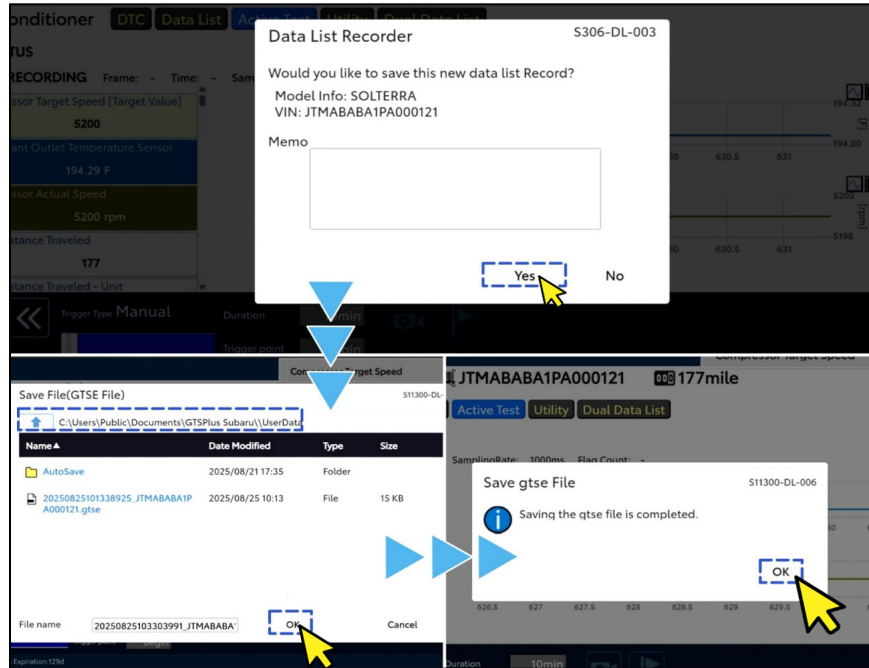
**STEP 14:** After the ten minute recording has been completed, a pop-up will display asking if the data is to be saved. Click “Yes”, select a destination for the data, and click “OK”. Once saving is completed, click “OK” to continue.

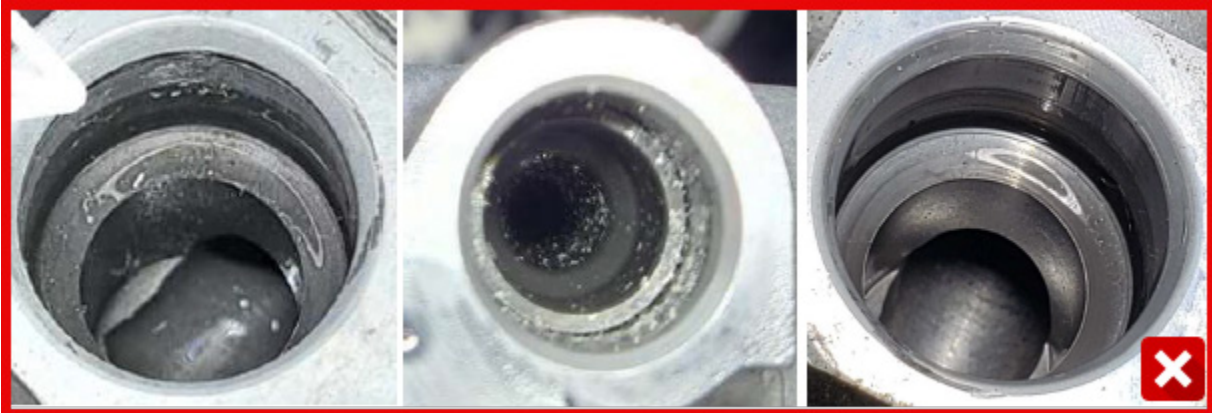
**NOTE:** Blackened oil is not a sign of debris. Metal flakes/debris is a sign of failure.

Example images of foreign material found at the A/C compressor discharge port connection:

**YES:** Replace the compressor and receiver dryer.

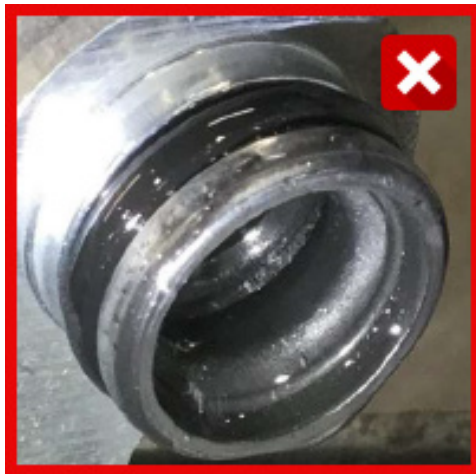
Example image of foreign material found at the A/C discharge hose connection:
