## Slide-out Wall Crack Instructions

| <b>Bulletin #(s):</b> | 25-027 | <b>Make(s):</b> | Jayco & Entegra Coach |

| <b>Incident:</b> | Cracks may form at the upper corners of the Off-door Side (ODS) and/or Door side (DS) Front Slideouts. |
| <b>Affected Units:</b> | 2024 – 2026 Jayco Seneca & Seneca Prestige and 2024 – 2026 Entegra Coach Accolade & Accolade XL |

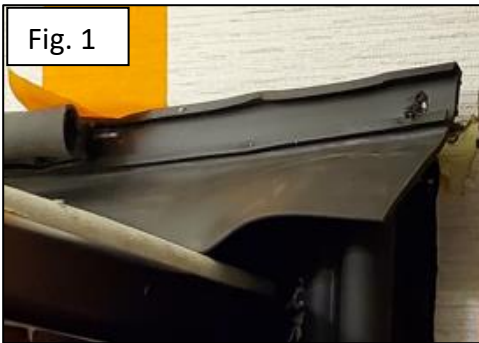
Fig. 1

1. Slide the rubber bulb seal away from the corner and remove the fasteners. (Figure 1)
2. At the front of the slide-out, cut the vinyl board from the slide-out opening to the roof with an oscillating saw. The rear should not need to be cut. (Figure 2)
  - a. **NOTE: When cutting the vinyl board, caution should be used to ensure the aluminum tube is NOT cut.**
3. Utilize a putty knife to smooth out the cut and apply seam tape. (Figure 3)

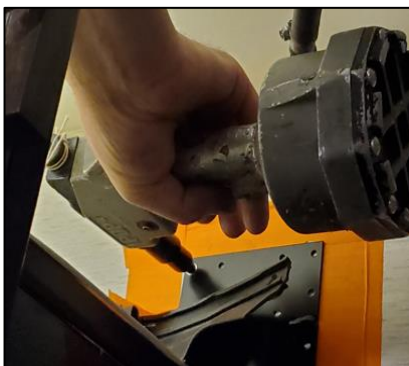
Fig. 7

7. With a rivet gun secure rivets in the corners. (Figure 7)
8. Drill 3/16" holes through the bracket, vinyl board and structural aluminum tube all of the remaining holes in the bracket.
  - a. **NOTE: When drilling, only the interior side of the aluminum tube MUST be drilled.**
9. With a rivet gun secure rivets in all remaining holes.
10. Re-secure the trim with the fastener previously removed and slide the bulb seal back to the corner. (Figure 8)

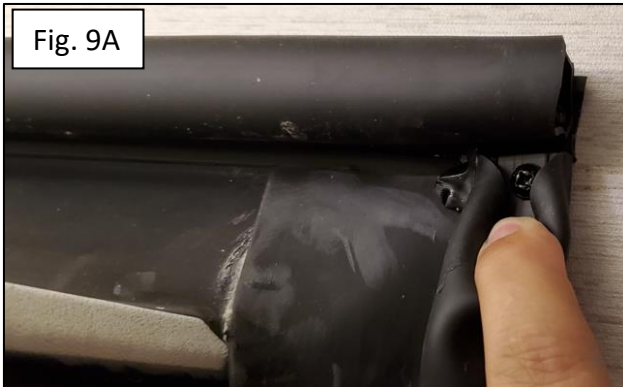
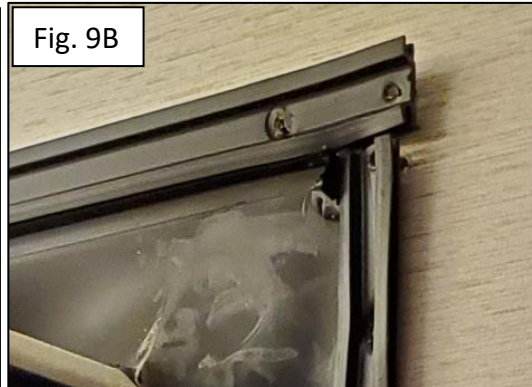
1. Slide the rubber bulb seal away from the corner and remove the fasteners. (Figures 9A and 9B)

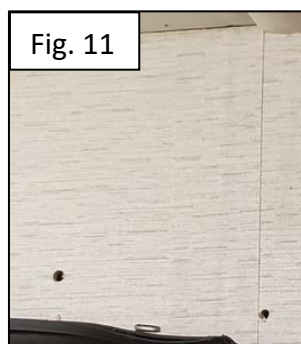
2. Fold the trim out of the way.
3. Using a putty knife, pry the wiper seal from the slide-out opening in the corner.
4. At the front of the slide-out, cut the vinyl board from the slide-out opening to the roof with an oscillating saw. The rear should not need to be cut. (Figure 10)
  - a. **NOTE: When cutting the vinyl board, caution should be used to ensure the aluminum tube is NOT cut.**
5. Utilize a putty knife to smooth out the cut and apply seam tape. (Figure 11)

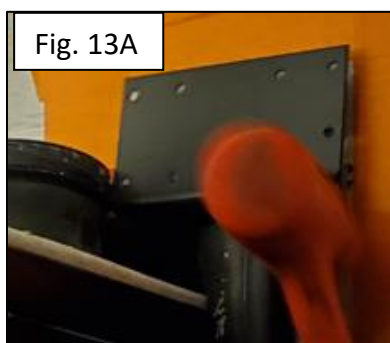
6. Apply sealant to the back side of the corner bracket. (Figure 12)
7. With the assistance of a rubber mallet, install the right hand corner bracket. If needed, use one of the #10 panhead fasteners removed to fasten the bracket flush to the wall. (Figure 13A-13B)

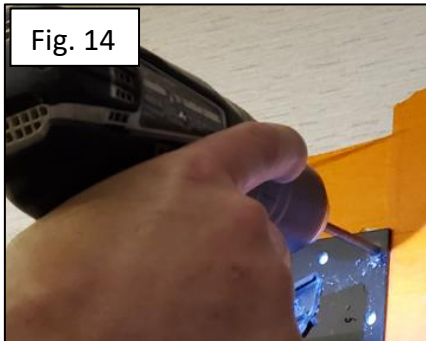
Fig. 14

8. With the corner bracket flush to the sidewall, drill 3/16" holes through the bracket, vinyl board and structural aluminum tube in the opposite corners. (Figure 14)

**NOTE: When drilling, only the interior side of the aluminum tube MUST be drilled.**

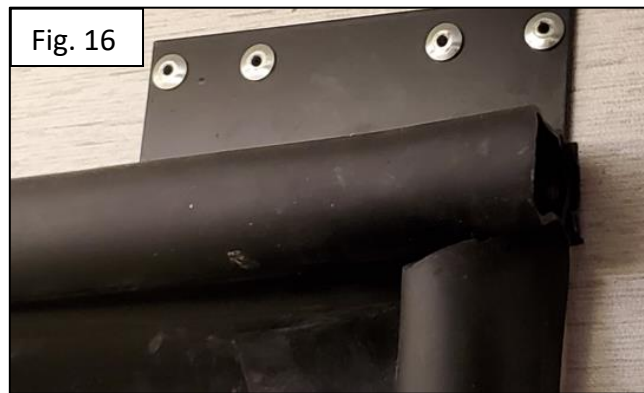
Fig. 16

12. Re-secure the trim with the fastener previously removed and slide the bulb seal back to the corner. (Figure 16)
