Technical Service Bulletin

GROUP	NUMBER
BODY ELECTRICAL	26-BE-005G
DATE	MODEL(S)
FEBRUARY 2026	G70 (IK)

SUBJECT: BLOWER MOTOR MULTI-FUSE & FUSE BOX INSPECTION, & FRONT WIRING REPLACEMENT (WARRANTY EXTENSION Z02G)

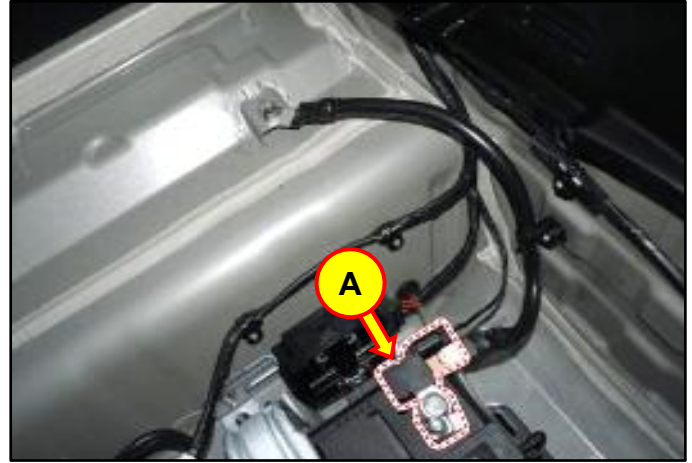
1. Record customer's radio presets prior to starting procedure.
2. Open the trunk of the vehicle and disconnect the negative (-) battery terminal (A).

Tightening Torque:

lb-ft	6.5
lb-in	78
N.m	8.9

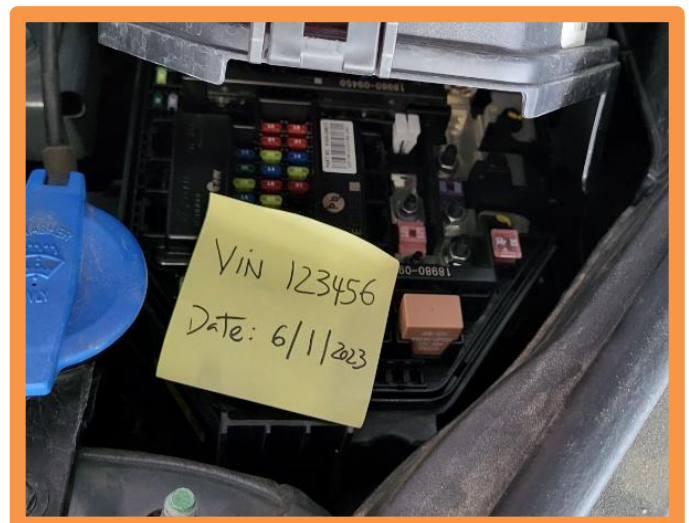
Using the STUI camera function, take a photo of the newly installed front wiring assembly.
