Mitsubishi Motors North America, Inc.

# TECHNICAL SERVICE BULLETIN

## HVAC NOISE IN BLOWER

No: TSB-23-55-001

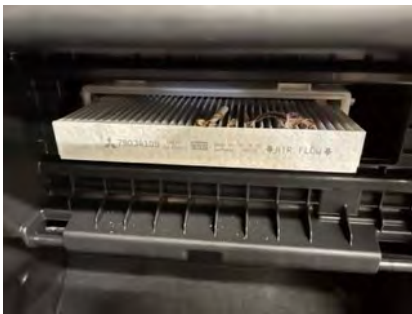
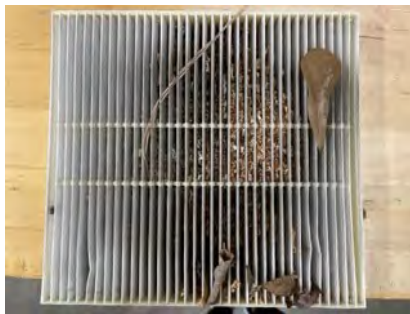
1. Remove the blower motor and remove any leaves accumulated around the HVAC case and blower motor fan.

1. Replace the cabin air filter with a new one (part #7803A109).
2. Install the blower motor and check for noise.
