<b>Topic</b>	Bentayga V8 Kovomo - DTC P310B00 with Symptom Code 2638 - Check Engine Lamp - Fuel Pressure Regulation
<b>Market area</b>	Bentley: worldwide (2WBE),China 796 VW Import Comp. Ltd (Vico), Beijing (6796)
<b>Brand</b>	Bentley
<b>Transaction No.</b>	2058484/15
<b>Level</b>	EH
<b>Status</b>	Released for publication
<b>Release date</b>	Feb 23 2026

Bentayga V8 Kovomo - DTC P310B00 with Symptom Code 2638 - Check Engine Lamp - Fuel Pressure Regulation

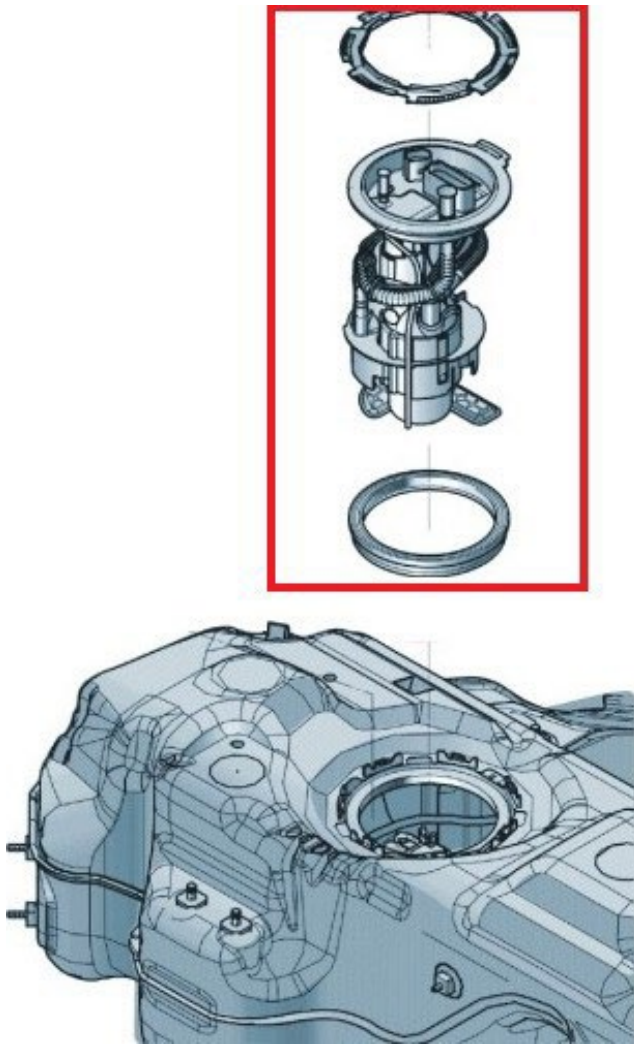
1) Referring to the example shown in Figure 1 - Check the actual pressure value

<b>- Extended ambient conditions:</b>		
Engine rpm	639.5	1/min
Normed load value	13.725490449999999	%
Vehicle speed	0	km/h
Coolant temperature	82	°C
Intake air temperature	42	°C
Ambient air pressure	1000	mbar
Voltage terminal 30	12.4	V
Dynamic environmental data	20 96 28 11 CE 11 94 11 C8 12 80 11 C9 F8 41 11 A4 26 66 12 8AAA 15 9F 66 60 15 A0 66 64	
Unlearning counter according OBD	40	
Low fuel pressure, specified value	450.0	kPa
<b>Fuel low pressure, actual value</b>	<b>501.3</b>	<b>kPa</b>
Fuel pump adaptation	-198.3	kPa
Fuel pump, specified value	14.99939	%
Fuel temperature	79.5	°C
Fuel high-pressure, actual value	13.104	MPa
Fuel pressure rail 2	13.106	MPa

- In the event the fuel pressure actual value is above 450kPa the Fuel Delivery Module within the fuel tank (Figure 2) should be replaced

- In the event the fuel pressure actual value is above 475kPa (2023MY) the Fuel Delivery Module within the fuel tank (Figure 2) should be replaced

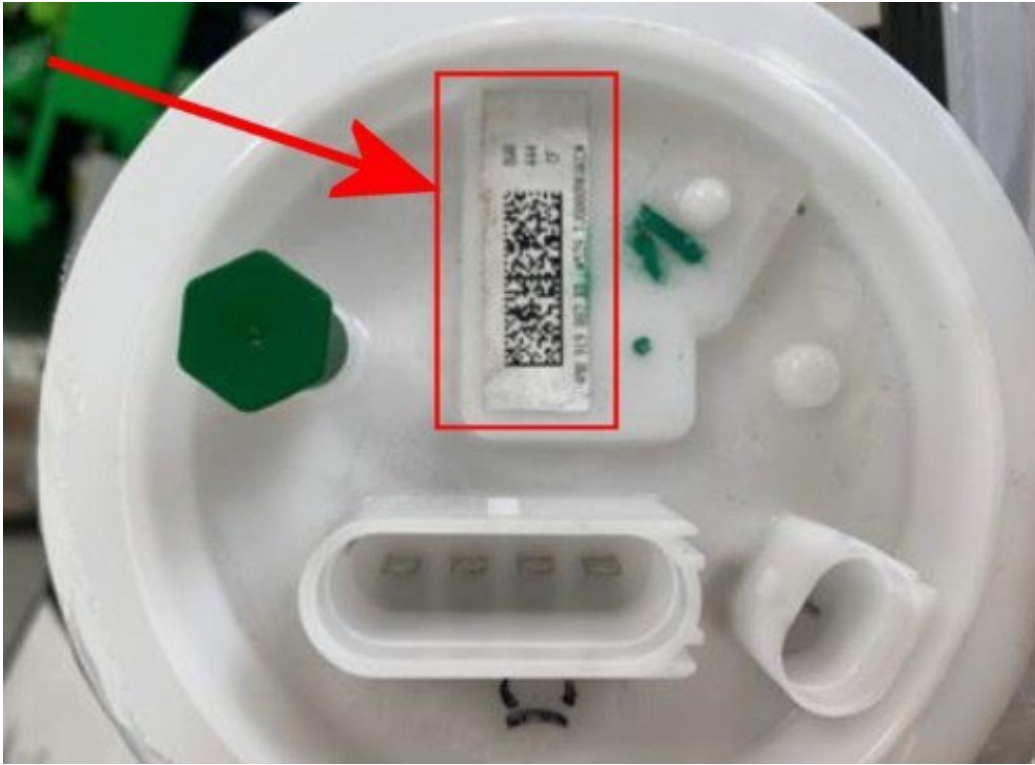
**IMPORTANT:** Once the fuel delivery module has been replaced, the operative should attach a clear photograph of the manufacture information label as shown in Figure 3
