## Noises at front axle when steering

| Topic number | LI32.25-P-070053 |
| Function group | 32.25 - Shock absorbers, damper struts, spring struts |
| Validity | All MFA2 model series |

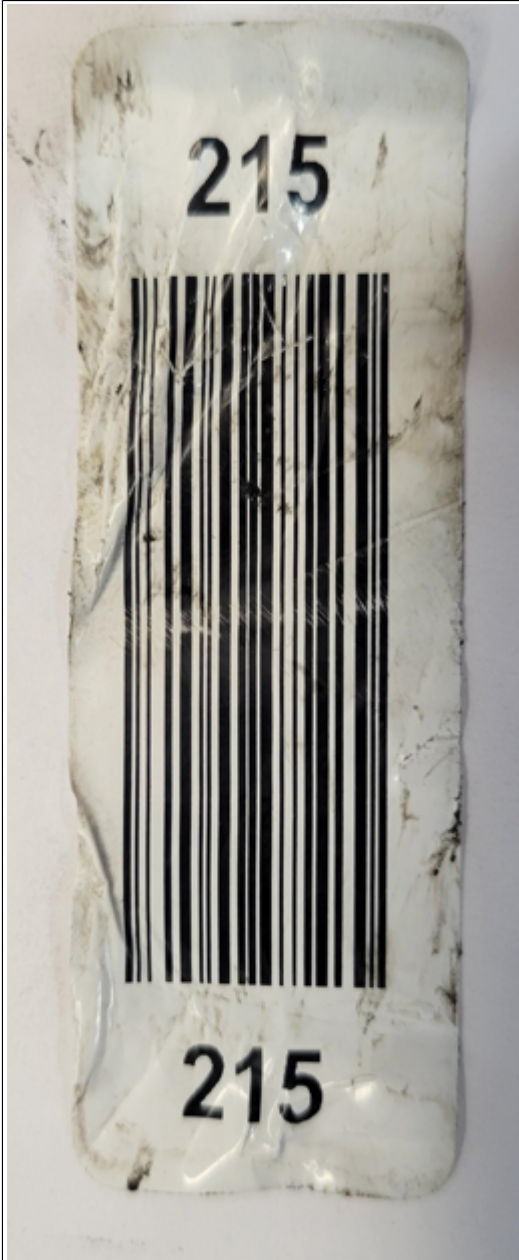
| Attachments | |
|---|---|
| <a href="#">Spring+Barcode.png</a> | |

### How to identify next spring in line with part number tag:

- Navigate to the parts catalog and enter the vehicle VIN/FIN and the part number found from the spring.
- In order to find the correct or next highest spring, the spring filter must be removed in the XENTRY Parts Information tool. To do this, you need to clear the filters by using the funnel icon on the right side column of the page and clicking "no filter" at the top and then "apply filter" (see "Clear Vehicle EPC Filter" for how-to pictures).
- The spring item numbers are normally listed in sequence (observe and verify valid SA code for vehicle). The next strongest spring is selected by the ascending, next highest item number (Example: If the currently installed spring ends in "13 00" then then next spring in line is "14 00".)
