SPEAKER - NONE : INTERVENANT - AUCUN : ORADOR - NINGUNO

Quality Inspection Request

Suspect Part Identification

Part numbers:
 68402778AA and 68403802AA

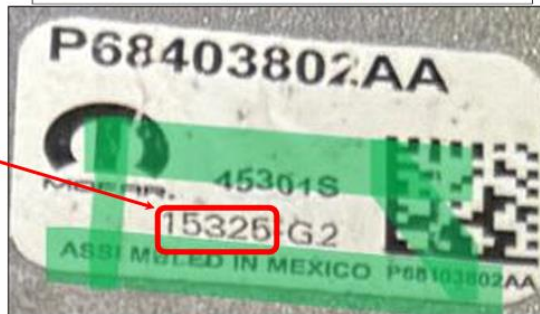
Built date code location:

Built date code shown

15325: DDDYY

153rd Day of 2025

i.e. 2nd June 2025

Part in picture shown is suspect.

Part in picture below is suspect

Suspect parts: Parts built before 25825 (15th September 2025) are suspect parts.

Please check and return suspect stock of part numbers: **68402778AA** and **68403802AA**. Please refer to QIR attachment.

Please return all parts back to your facing depot using **Return Code 02**, before 24th March 2026.

For replacement place new orders.

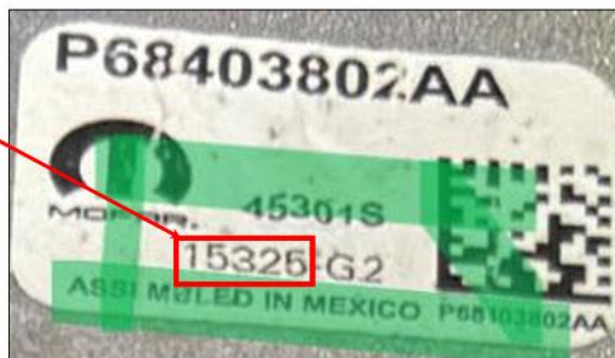
Emplacement du code de date de construction

Code de date de construction affiché

15325 : JJJAA

153e jour de 2025

soit le 2 juin 2025

La partie visible sur la photo est suspecte.

La partie visible sur l'image ci-dessous est suspecte

Pièces suspectes: Les pièces construites avant le **25825** (15 septembre 2025) sont des pièces suspecte

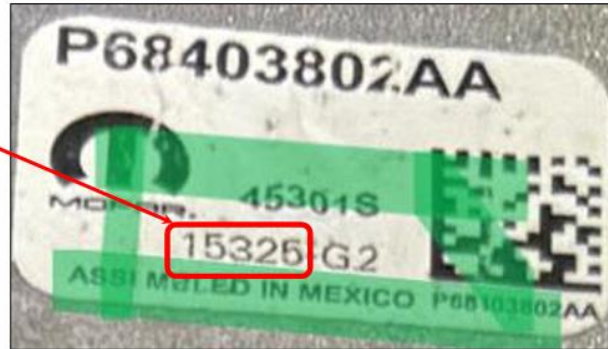
Ubicación del código de fecha de construcción:

Se muestra el código de fecha de construcción

15325 : DDDAA

Día 153 de 2025

Es decir, 2 de junio de 2025

La parte que se muestra en la imagen es sospechosa.

La parte que aparece en la imagen de abajo es sospechosa.

Partes sospechosas: Las piezas construidas antes de 25825 (15 de septiembre de 2025) son piezas sospechosas.
