Yellow warning message in the "Cooling system fault, operating energy input reduced, service required" display in connection with the fault entry "B3A0077" in the powertrain control unit N127 (PTCU)

| Topic number | LI83.30-P-079196 |
| Validity | Model series 294, 295, 296, 297 |

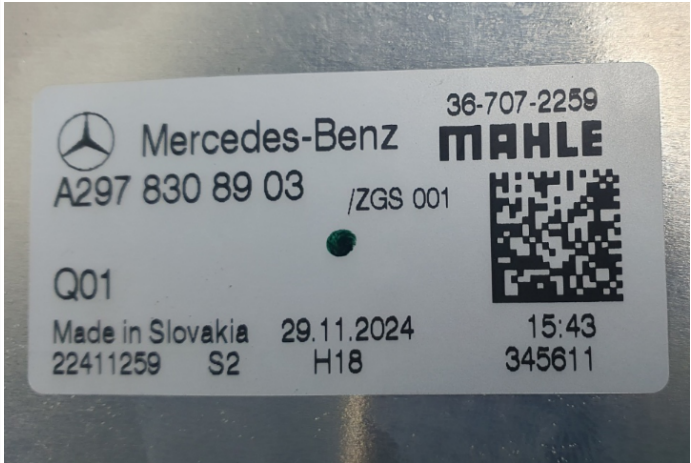
| Attachments | |
|---|---|
| <a href="#">Label ZB Chiller.PNG</a><br> | Example of chiller assembly label |

Do not replace Y140/1 if the installed component has part number A 297 830 8903 and a production date after February 1, 2025!  
Please create TIPS case, attach the current quick test and attach picture of the evaporator assembly component part label and a picture of the production date of the EXV Y140/1 (see example attached).

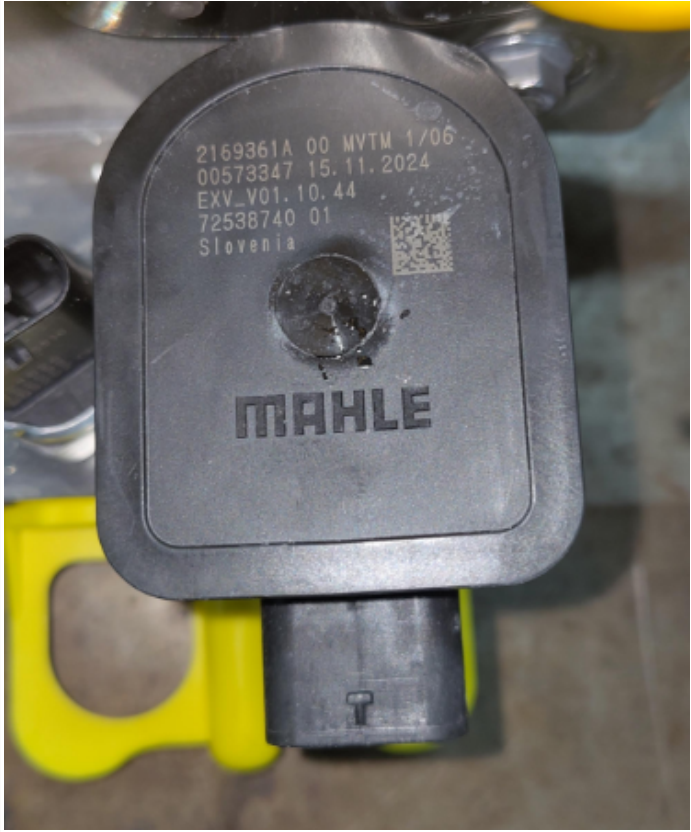
| Attachments | |
|---|---|
| <a href="#">Label EXV.PNG</a><br> | Example of expansion valve Y140/1 label |
