Version 6

Air Conditioner Makes Noise (DTC P0530/P0534)

Year	Model	Trim Level	VIN Range
2024–25	Prologue	ALL	ALL

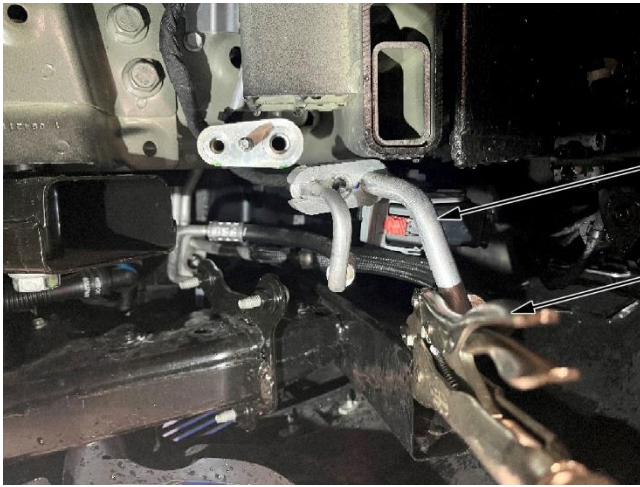
13. Disconnect the lower A/C receiver lines.

- Use a clamp on the frame to hold the A/C line out of the way.
- **DO NOT** clamp the lines as this may damage A/C function.
- Place a shop towel over the end of the A/C line that is being held by the clamp.

A/C LINES

CLAMP

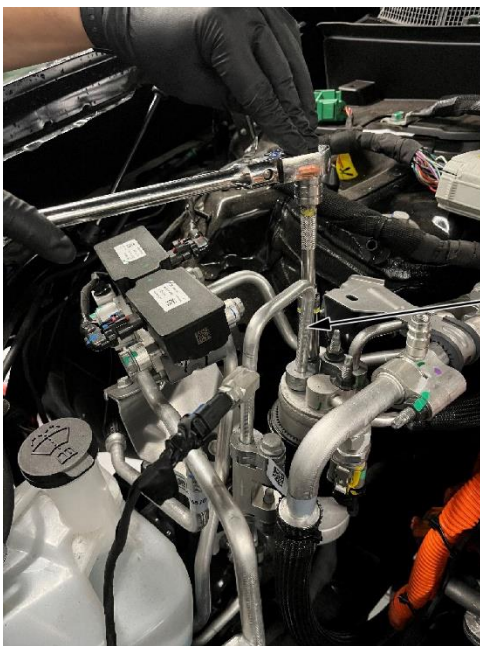
UPPER A/C LINE

14. Disconnect and remove the upper A/C receiver line from the A/C receiver dehydrator. Remove the A/C line seal.

NOTE: Discard the A/C line seal.
