CAN-AM ON-ROAD (3W) 2026-2 Spyder Rear Cargo Module Not Aligned

Vehicle - Quality Bulletin

Can-Am On-Road	March 25, 2026 Bulletin 2026-2 Version A N° 2025-0008 / 2026-0003
----------------	---

Spyder Rear Cargo Module Not Aligned

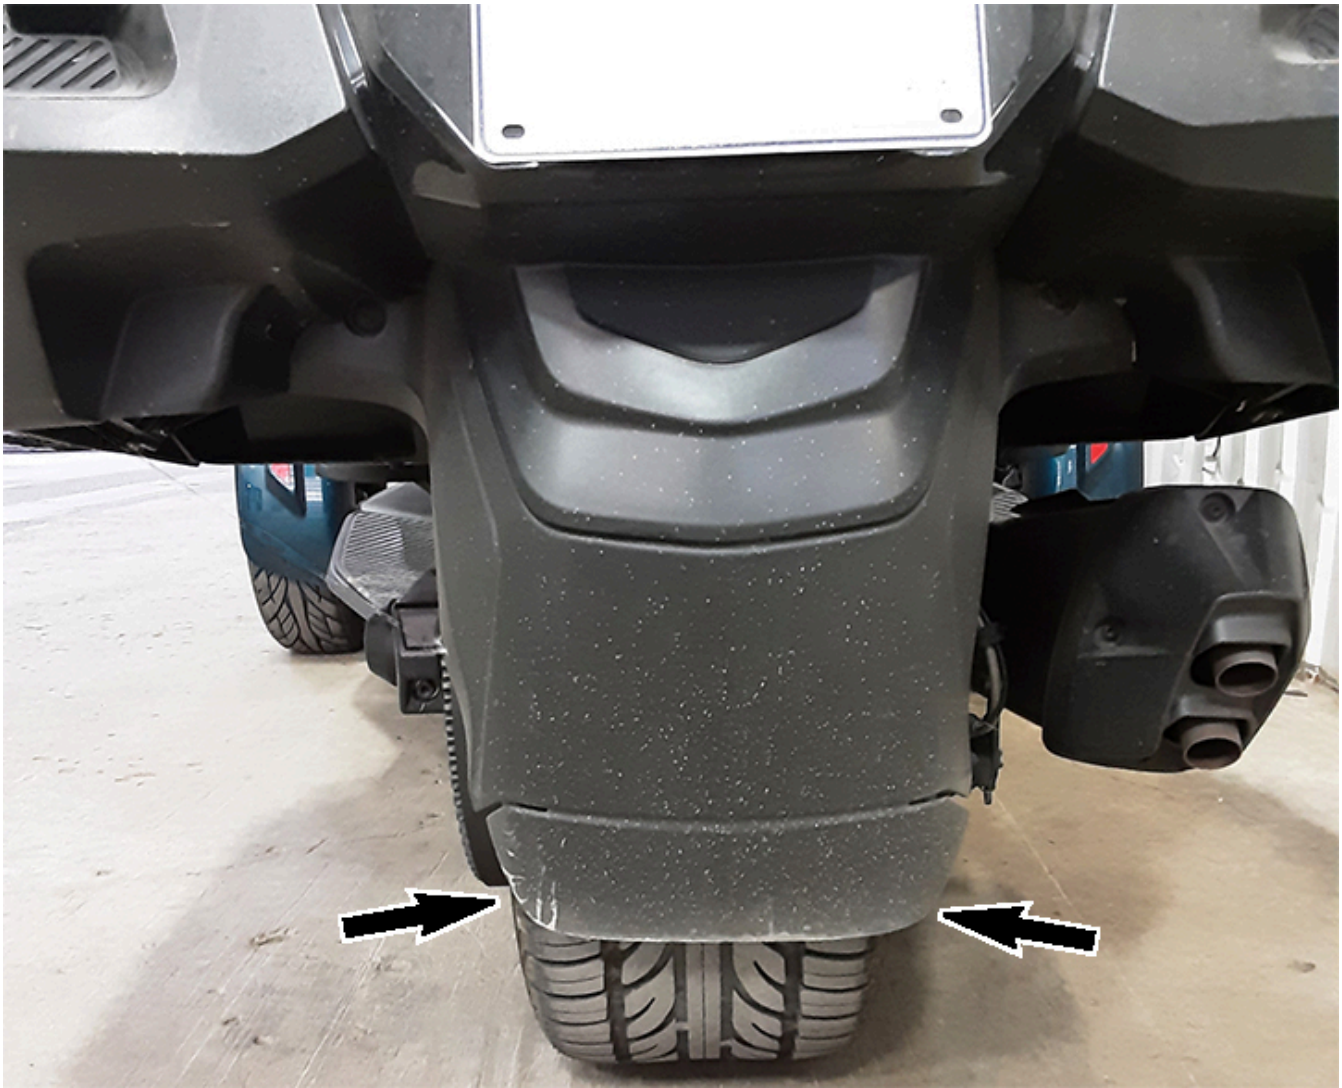
The rear cargo module is not aligned with the rear wheel, the rear fender may look uncentered. In some cases, it may come in contact with the rear tire.

Shim the rear cargo module by using the kit developed by BRP in order to address the issue.
