## Front Emblem

| <b>Bulletin Type:</b> | TSB | <b>Publication Date:</b> | March 2026 |
| <b>Bulletin #(s):</b> | 26-006 | <b>Make(s):</b> | Entegra Coach |

| <b>Incident:</b> | Front Emblem is not properly adhered to fiberglass. |

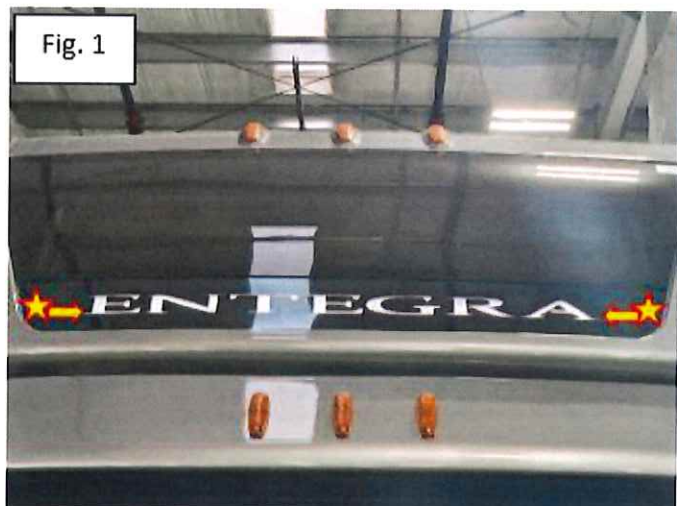
Fig. 1

1. Remove the front emblem from the coach.
  - a. **Note: You can start on either side of the emblem, and you can utilize a putty knife to make removal easier.** (Figure 1)

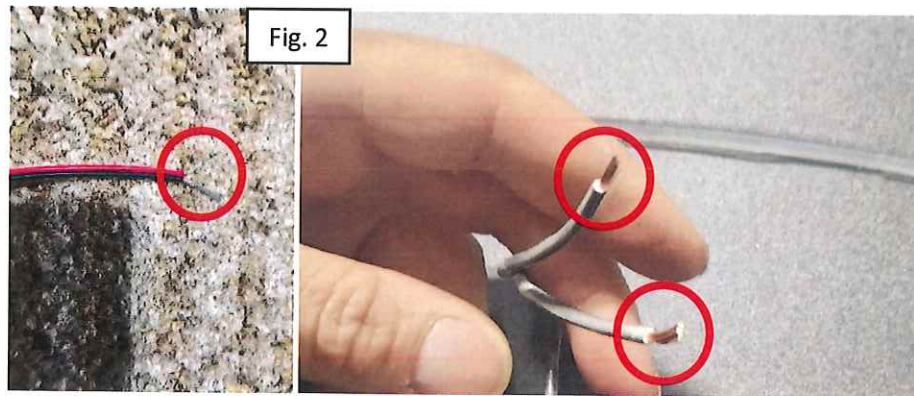
- a. **Note: the below images are for reference and are not from the repair. They are only for reference on stripping the wire.** (Figure 2)

4. Strip the wires coming from the coach using wire strippers.

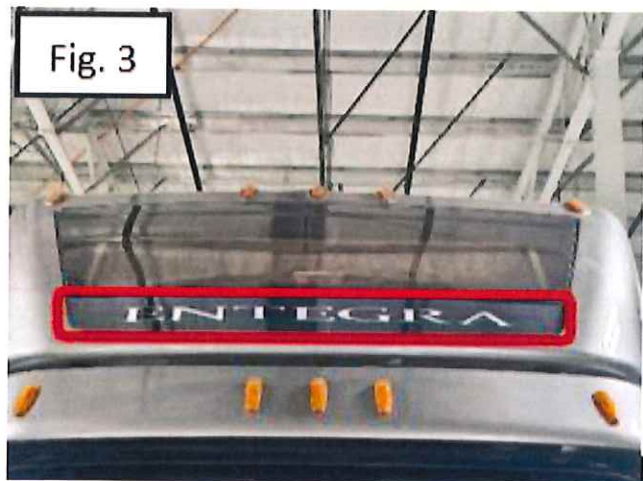
8. Resecure the new emblem to the front of the coach using Plexus and Sika. The Plexus should be run in 2 beads down the sides of the emblem and 3 or 4 evenly spaced dabs on the top and bottom of the emblem. Sika will be used in between each of the dabs of Plexus on the top and bottom of the emblem. (Figure 3)

9. Let Sika and Plexus adhesives fully cure.
